Asbestos and Hazardous Materials Reinspection Assessment

Lake Ainsworth Sport & Recreation Centre

07/02/2023

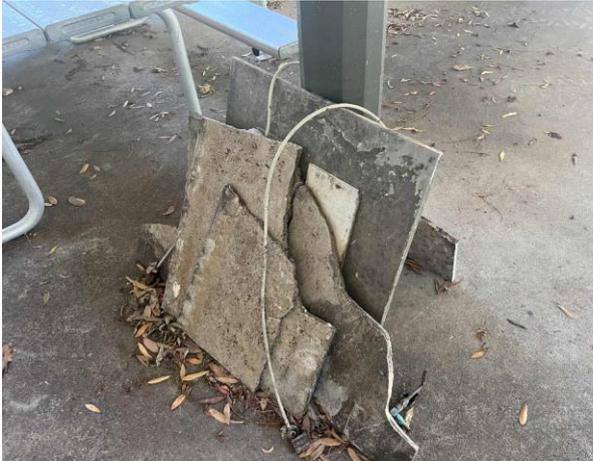
Line ID 1: External, BBQ Area, Throughout, Stored in the Centre of the Floor, Compressed Cement Sheet - No Asbestos Detected

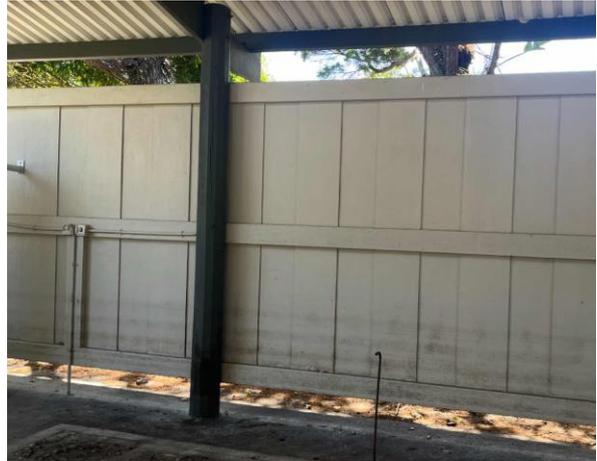
Line ID 2: External, BBQ Area, Throughout, Wall Lining, Fibre Cement Sheet - No Asbestos Detected

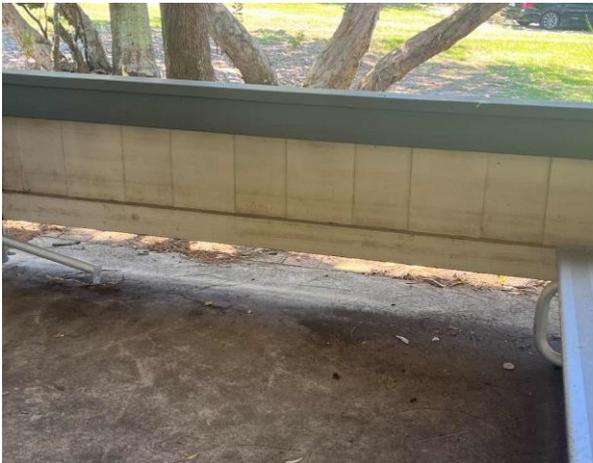
Line ID 2.1: External, BBQ Area, Throughout, Wall Lining, Fibre Cement Sheet - No Asbestos Detected

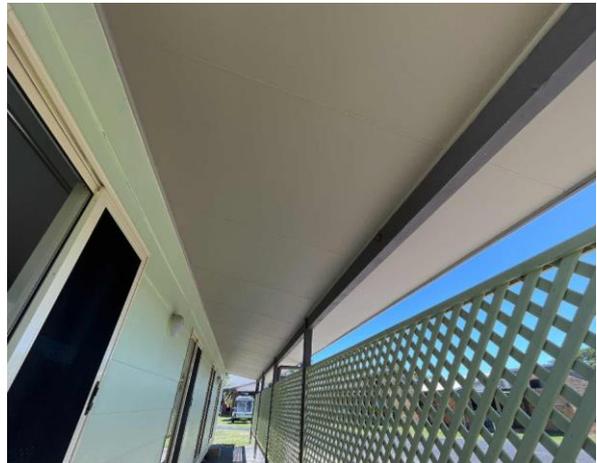
Line ID 3: External, Beachside Lodge, Veranda and Walls, Eaves, Fibre Cement Sheet - No Asbestos Detected

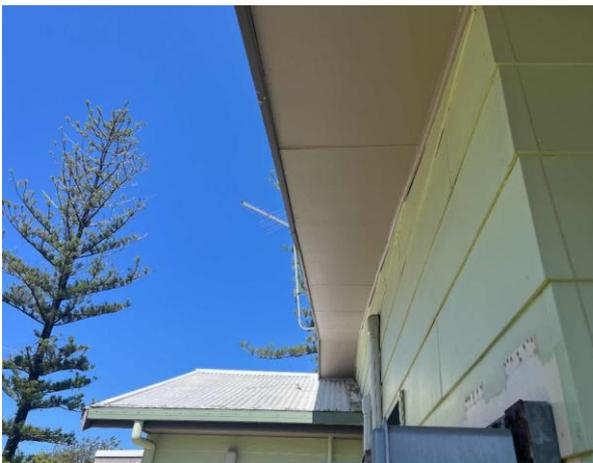
Line ID 3.1: External, Beachside Lodge, Veranda and Walls, Eaves, Fibre Cement Sheet - No Asbestos Detected

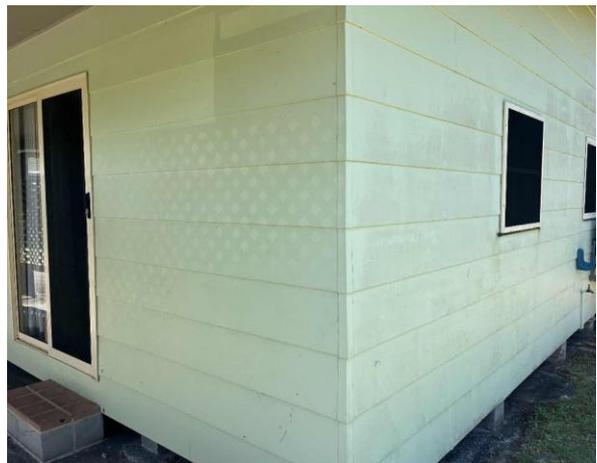
Line ID 4: External, Beachside Lodge, Veranda and Walls, Weatherboard Wall Lining, Fibre Cement Sheet - No Asbestos Detected

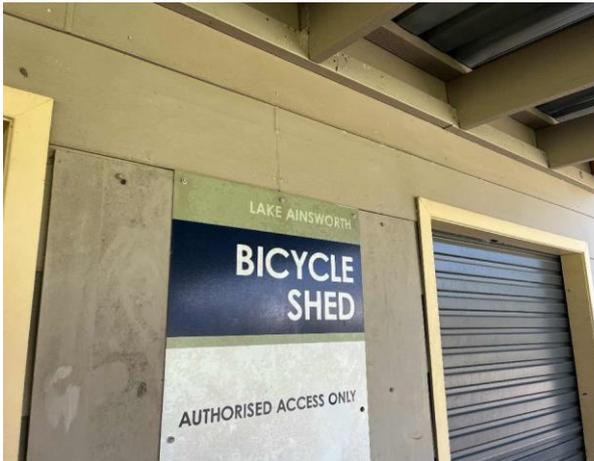
Line ID 5: External, Bike Store, Veranda, Wall Lining, Fibre Cement Sheet - No Asbestos Detected

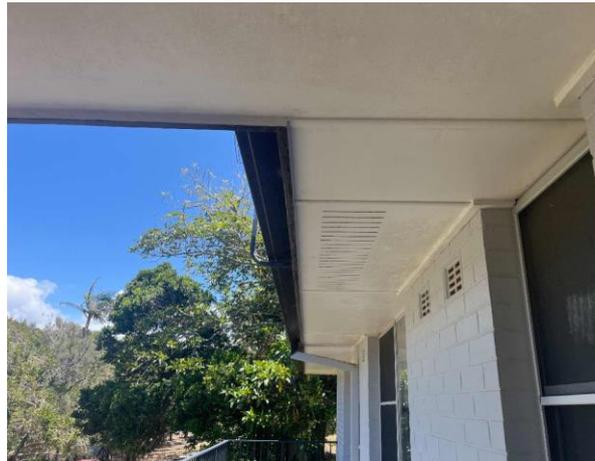
Line ID 6: External, Centre Managers Residence, Veranda, Eave Linings, Fibre Cement Sheet - Chrysotile Asbestos Detected

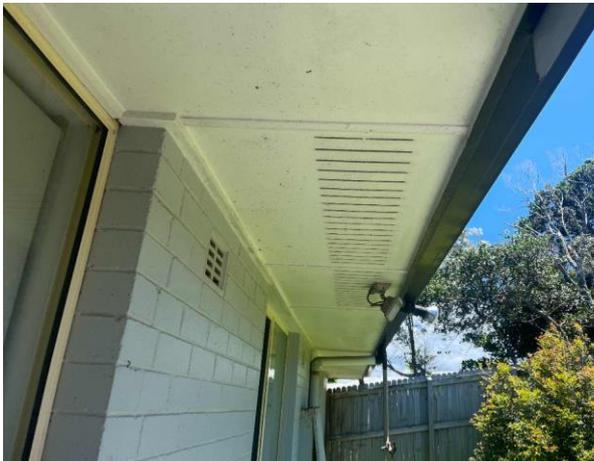
Line ID 6.1: External, Centre Managers Residence, Veranda, Eave Linings, Fibre Cement Sheet - Chrysotile Asbestos Detected

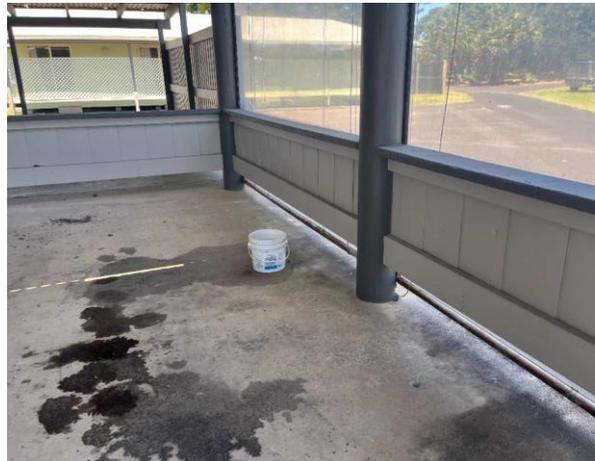
Line ID 7: External, Craft Area, Storage Shed, Wall Lining, Fibre Cement Sheet - No Asbestos Detected

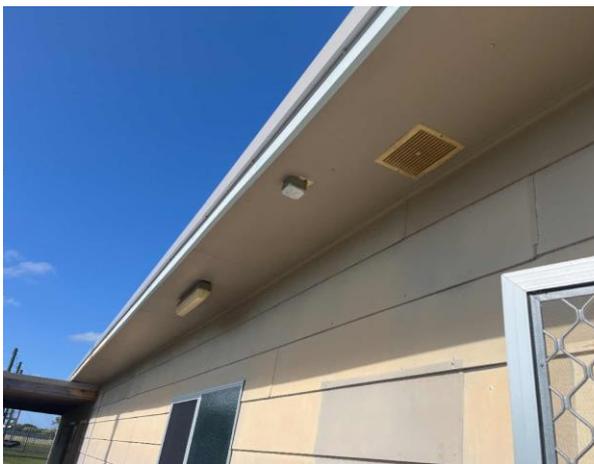
Line ID 8: External, Gym Shed, Entrance and Covered Walkway, Eaves, Fibre Cement Sheet - Chrysotile & Amosite Asbestos Detected

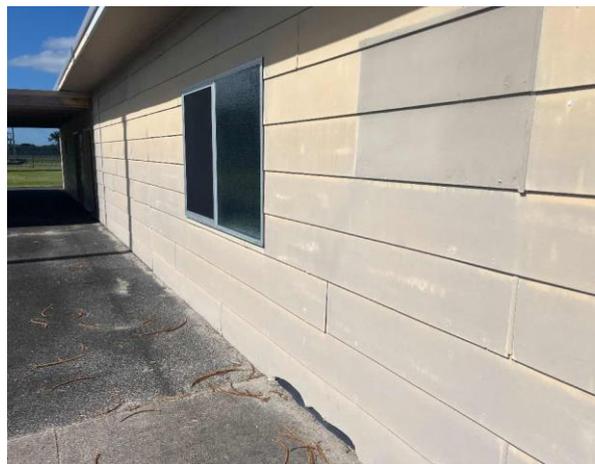
Line ID 9: External, Gym Shed, Entrance and Covered Walkway, Wall Lining, Fibre Cement Sheet - No Asbestos Detected

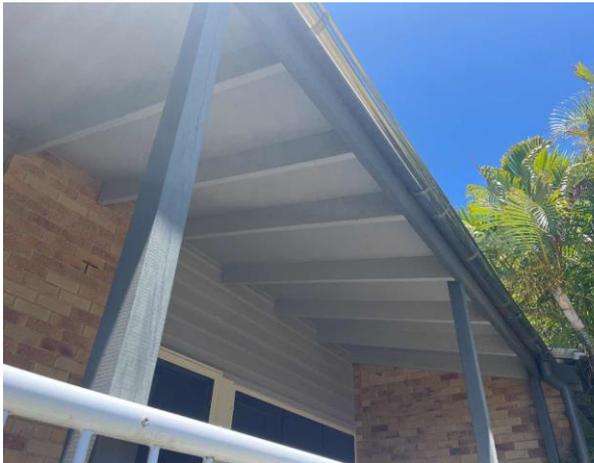
Line ID 11: External, Lodge 14, Covered Walkway, Eaves, Fibre Cement Sheet - Chrysotile Asbestos Detected

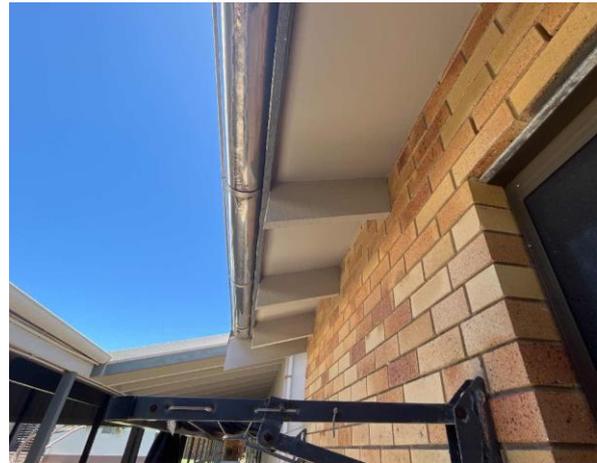
Line ID 11.1: External, Lodge 14, Covered Walkway, Eaves, Fibre Cement Sheet - Chrysotile Asbestos Detected

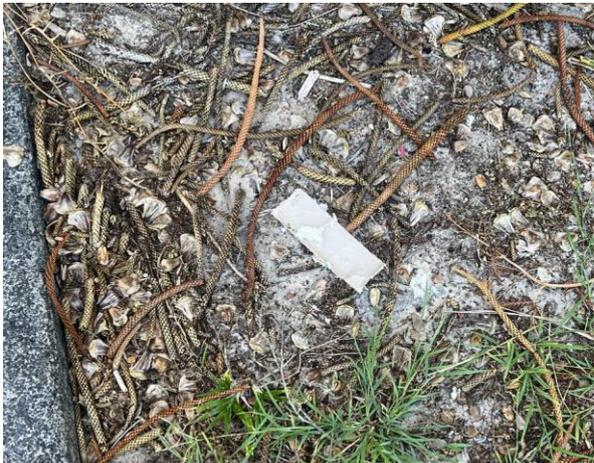
Line ID 12: External, Murphy's Cottage Block, Veranda and Undercover Area, Debris to the Floor From the Eave to Rear of Kitchen, Fibre Cement Debris - Chrysotile Asbestos Detected

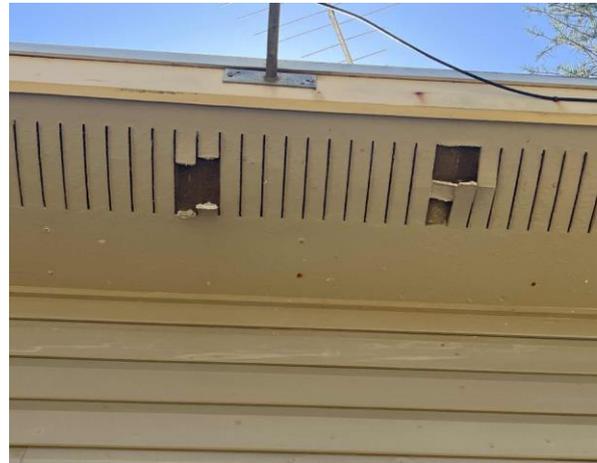
Line ID 12.1: External, Murphy's Cottage Block, Veranda and Undercover Area, Debris to the Floor From the Eave to Rear of Kitchen, Fibre Cement Debris - Chrysotile Asbestos Detected

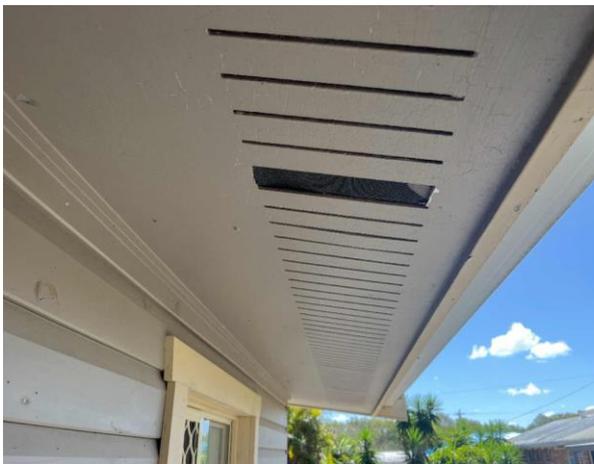
Line ID 13: External, Murphy's Cottage Block, Veranda and Undercover Area, Eave Linings, Fibre Cement Sheet - Chrysotile & Amosite Asbestos Detected

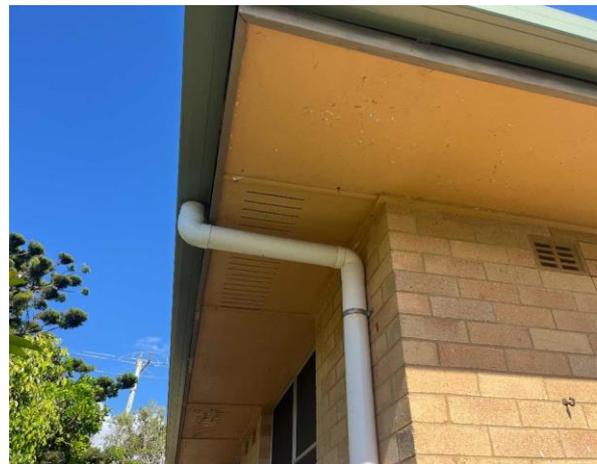
External	Project Coordinators Residence / Entrance Area and Surrounds / Eave Linings	Fibre Cement Sheet	Asbestos	Previously Sampled: A014	Chrysotile Asbestos Detected	Non-Friable	60 m	Low	5 Yearly Reinspection	Encapsulate exposed sections, label as containing asbestos and maintain in a good condition if to remain in-situ. Remove under controlled non-friable asbestos removal conditions prior to refurbishment or demolition works by a Class B (non-friable) licensed asbestos removal contractor in accordance with relevant State Regulations, Compliance Codes, Codes of Practice and Guidance Notes.	14

Line ID 14: External, Project Coordinators Residence, Entrance Area and Surrounds, Eave Linings, Fibre Cement Sheet - Chrysotile Asbestos Detected

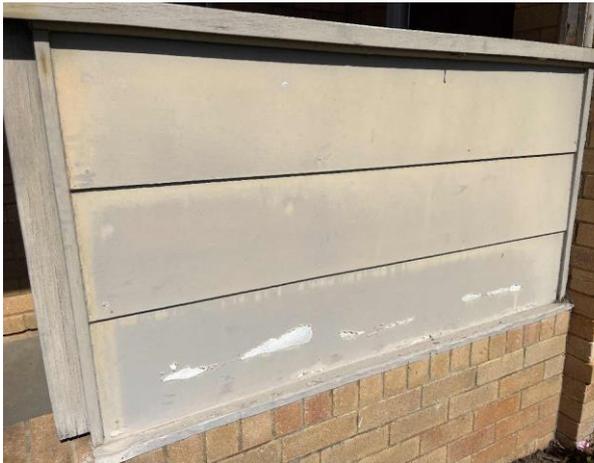
Line ID 15: External, Project Coordinators Residence, Entrance Area, Wall Lining and Entrance Sheeting, Fibre Cement Sheet - No Asbestos Detected

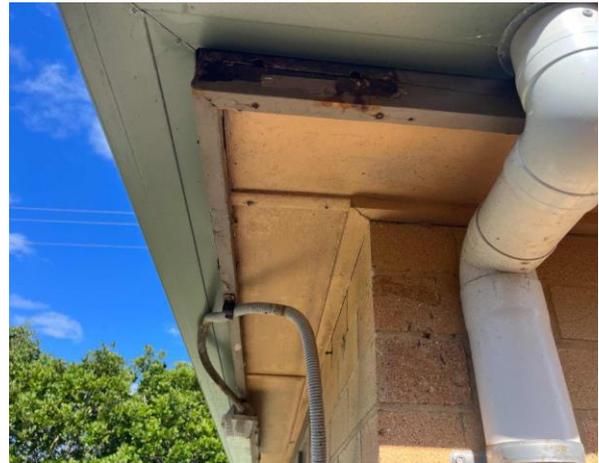
Line ID 16: External, Project Coordinators Residence, Rear Garage, Eaves, Fibre Cement Sheet - Chrysotile Asbestos Detected

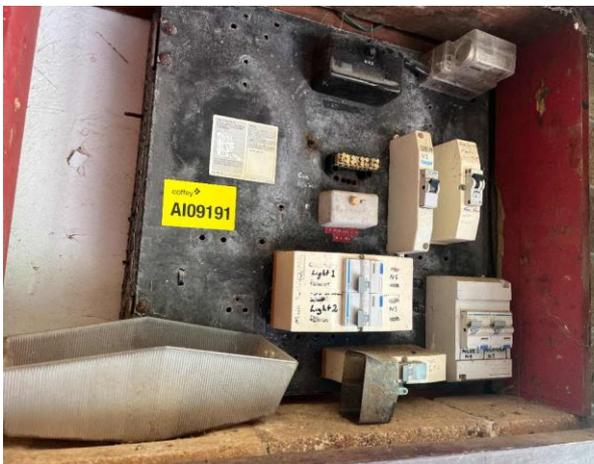
Line ID 17: External, Services Coordinator Residence, Entry And Covered Walkways, Electrical Box adjacent Entry, Bituminous Backing Board - Chrysotile Asbestos Detected

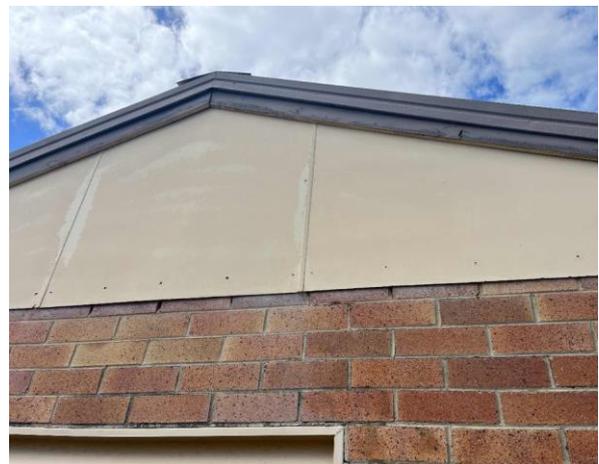
Line ID 19: External, Swimming Pool Toilets and Change, Swimming Pool Plant Room, Infill Panels above Walls, Fibre Cement Sheet - No Asbestos Detected

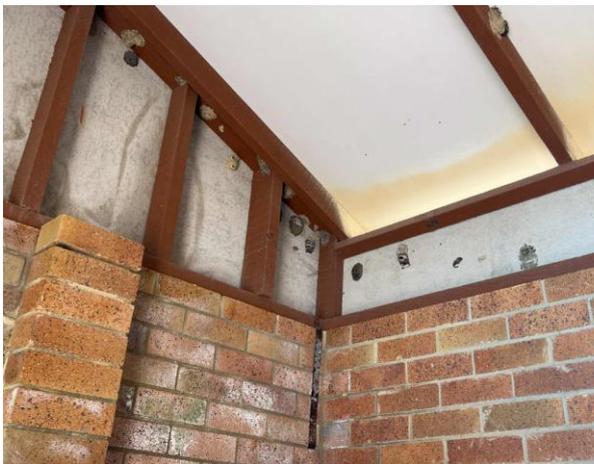
Line ID 19.1: External, Swimming Pool Plant Room, Infill Panels above Walls, Fibre Cement Sheet - No Asbestos Detected

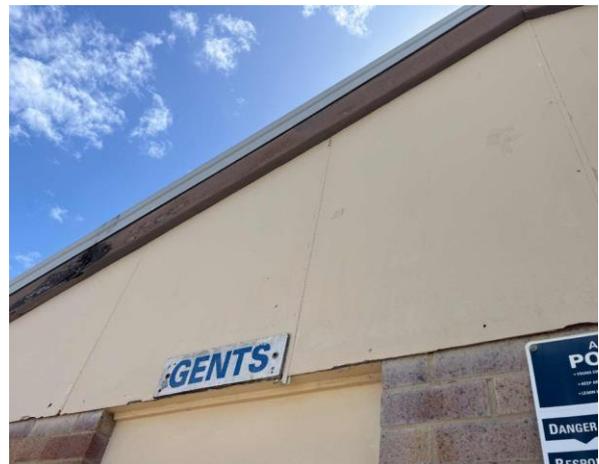
Line ID 20: External, Swimming Pool Toilets and Change, Toilet Entry Area, High Level Infill Panels Fascia, Fibre Cement Sheet - No Asbestos Detected

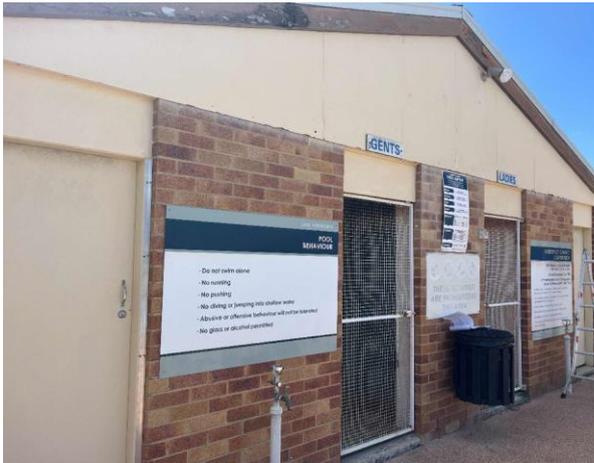
Line ID 21: External, Swimming Pool, Toilet Entry Area, Infill Panels Above Doors, Fibre Cement Sheet - Chrysotile and Amosite Asbestos Detected

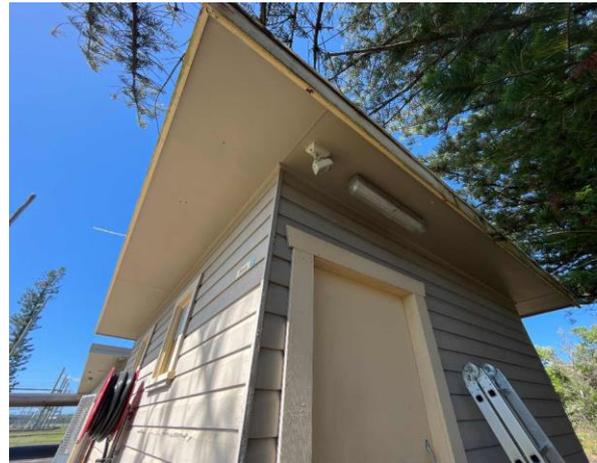
Line ID 22: External, Toilets to the North of Murph's Cottages, Entrance and Surrounds, Eaves, Fibre Cement Sheet - Chrysotile & Amosite Asbestos Detected

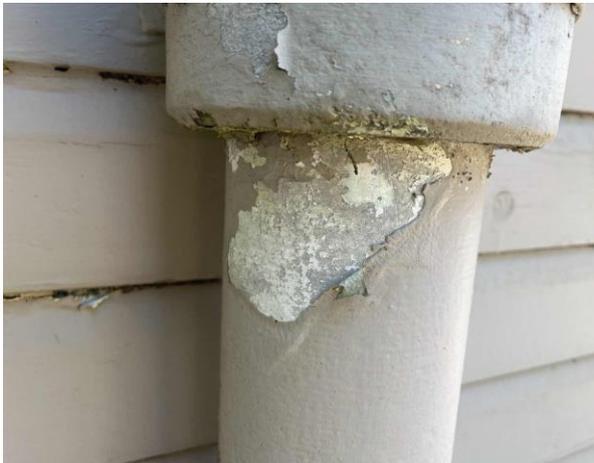
Line ID 23: External, Toilets to the North of Murph's Cottages, Entrance and Surrounds, Rear of Female Toilet, Down Pipe, Moulded Fibre Cement - Chrysotile and Amosite Asbestos Detected

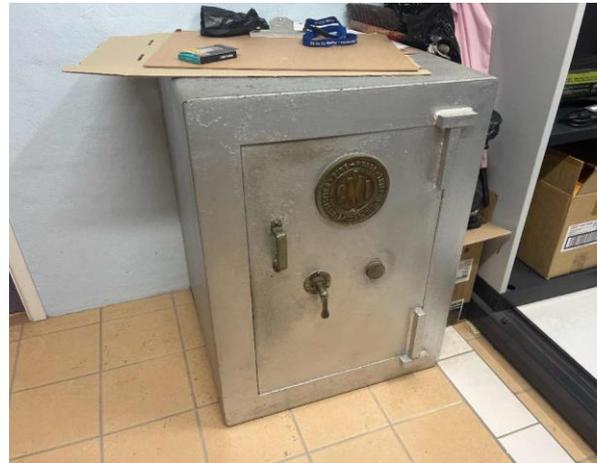
Line ID 24: Internal, Administration Building, Server Room, Safe, Internal Insulation - Suspected Asbestos

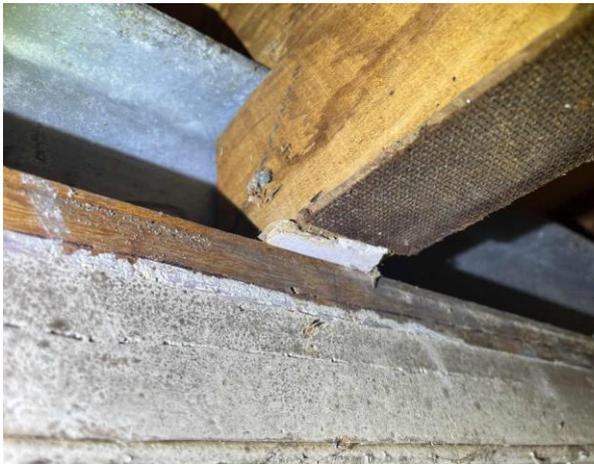
Line ID 25: Internal, Centre Managers House, Garage, Ceiling Space, Packer to Timber, Fibre Cement Sheet - Chrysotile and Amosite Asbestos Detected

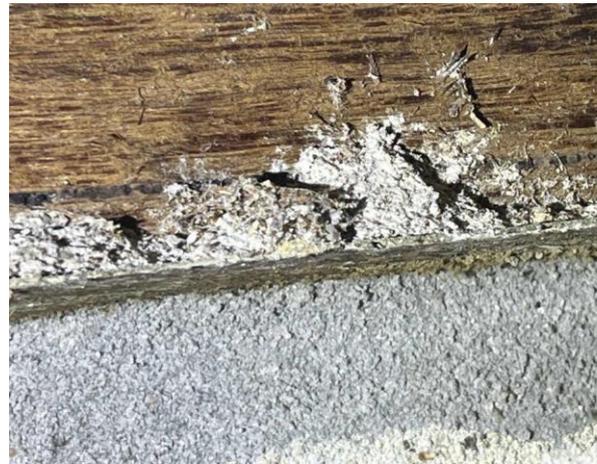
Line ID 26: Internal, Centre Managers House, Garage, Timber Beams, Fibre Cement Sheet Debris - Chrysotile Asbestos Detected

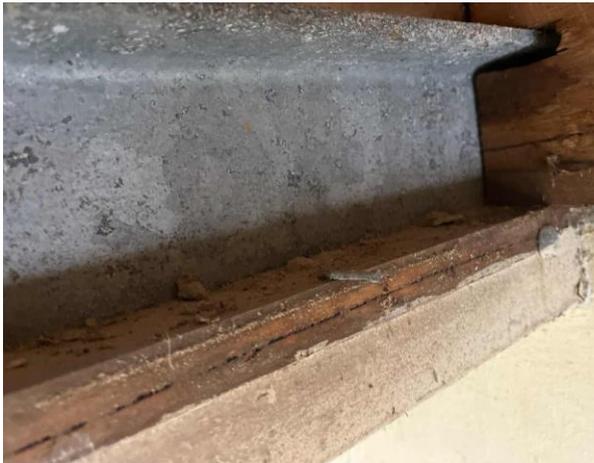
Line ID 26.1: Internal, Centre Managers House, Garage, Timber Beams, Fibre Cement Sheet Debris - Chrysotile Asbestos Detected

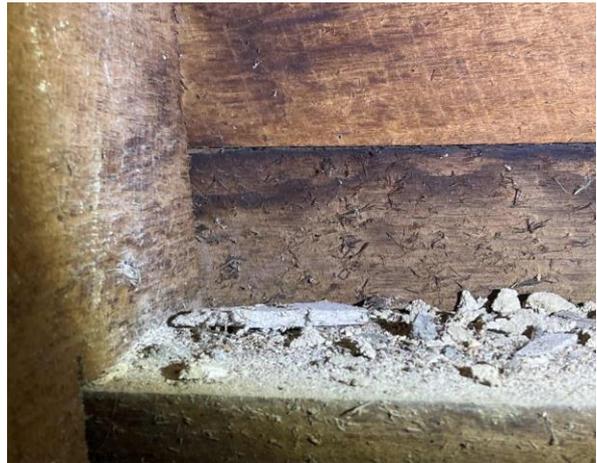
Line ID 26.2: Internal, Centre Managers House, Garage, Timber Beams, Fibre Cement Sheet Debris - Chrysotile Asbestos Detected

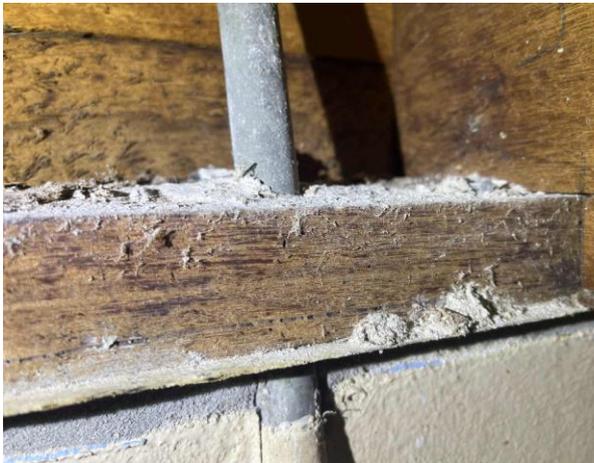
Line ID 26.3: Internal, Centre Managers House, Garage, Timber Beams, Fibre Cement Sheet Debris - Chrysotile Asbestos Detected

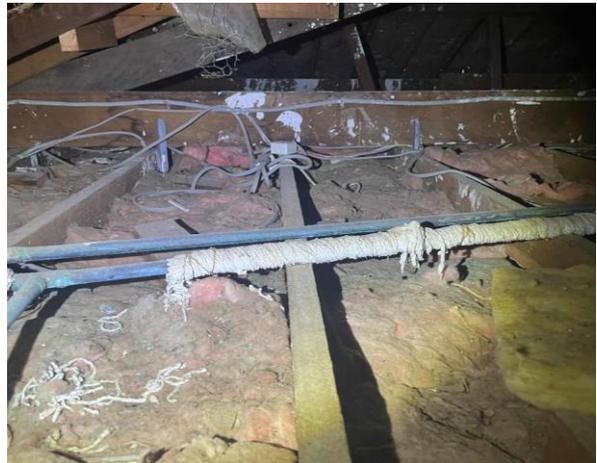
Line ID 27: Internal, Centre Managers House, Laundry, Pipework, Rope Insulation, Woven Material - Chrysotile Asbestos Detected

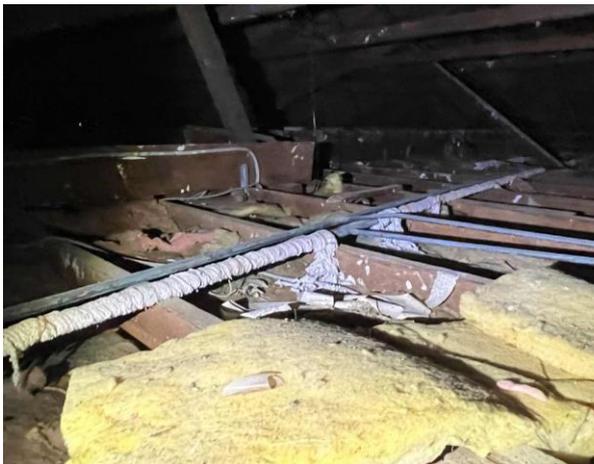
Line ID 27.1: Internal, Centre Managers House, Laundry, Pipework, Rope Insulation, Woven Material - Chrysotile Asbestos Detected

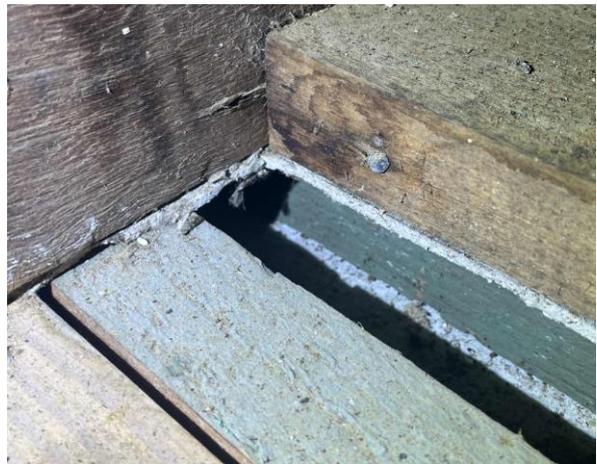
Line ID 28: Internal, Centre Managers House, Laundry, Second Skin Ceiling Lining, Fibre Cement Sheet - Chrysotile Asbestos Detected

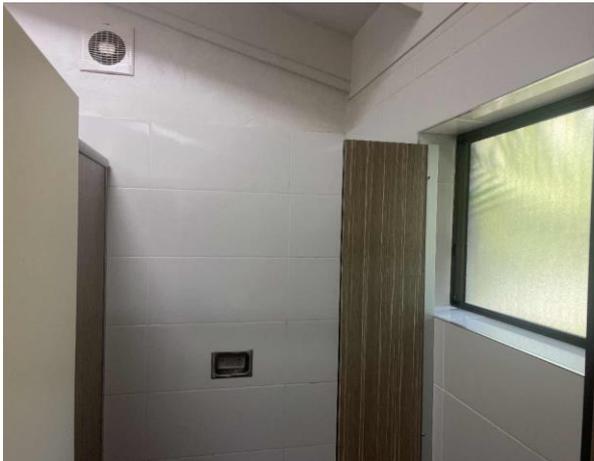
Internal	Lodge 14 / Toilet / Behind Ceramic Tiles to Walls	Fibre Cement Sheet	Asbestos	Previously Sampled: A007	Chrysotile Asbestos Detected	Non-Friable	20 m ²	Low	5 Yearly Reinspection	No access at the time of the audit but looks to be refurbished. Label as containing asbestos and maintain in current condition if to remain in-situ. Remove under controlled non-friable asbestos removal conditions prior to refurbishment or demolition works by a Class B (non-friable) licensed asbestos removal contractor in accordance with relevant State Regulations, Compliance Codes, Codes of Practice and Guidance Notes.	29

Line ID 29: Internal, Lodge 14, Toilet, Behind Ceramic Tiles to Walls, Fibre Cement Sheet - Chrysotile Asbestos Detected

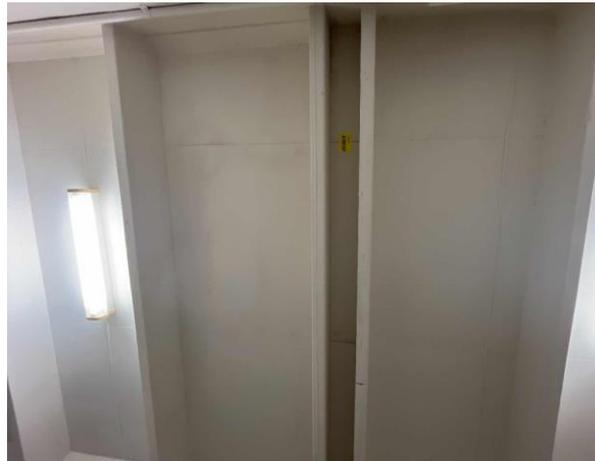
Line ID 30: Internal, Lodge 14, Toilet, Ceiling Lining, Fibre Cement Sheet - No Asbestos Detected

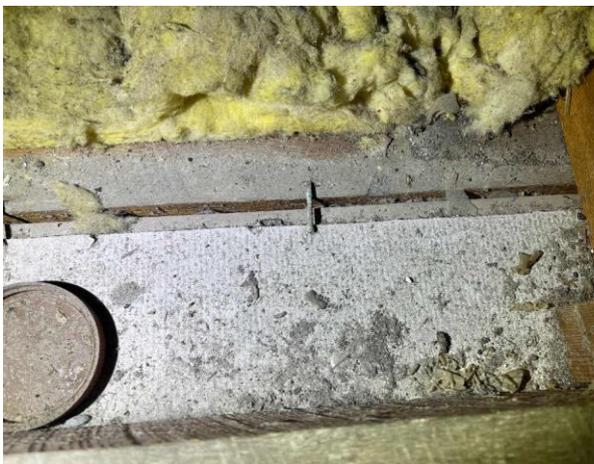
Line ID 31: Internal, Program Coordinator Residence, Laundry, Ceiling Lining, Fibre Cement Sheet - Chrysotile and Amosite Asbestos Detected

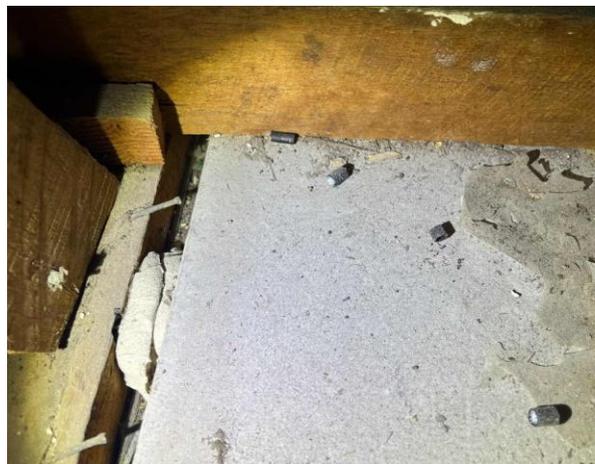
Line ID 32: Internal, Program Coordinator Residence, Laundry and Shower, Wall Lining, Fibre Cement Sheet - Chrysotile Asbestos Detected

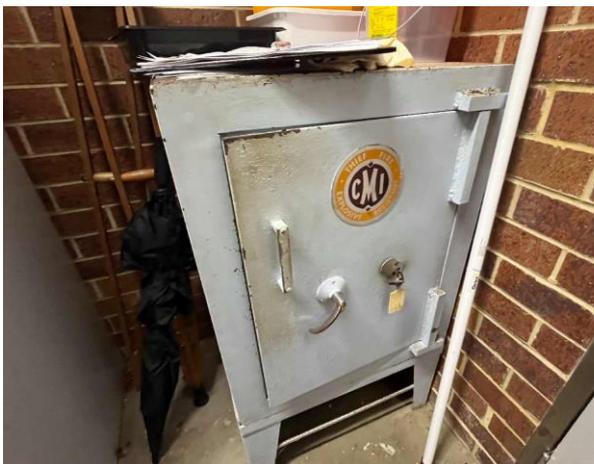
Line ID 33: Internal, Reception, Storeroom, Safe, Internal Insulation - Suspected Asbestos

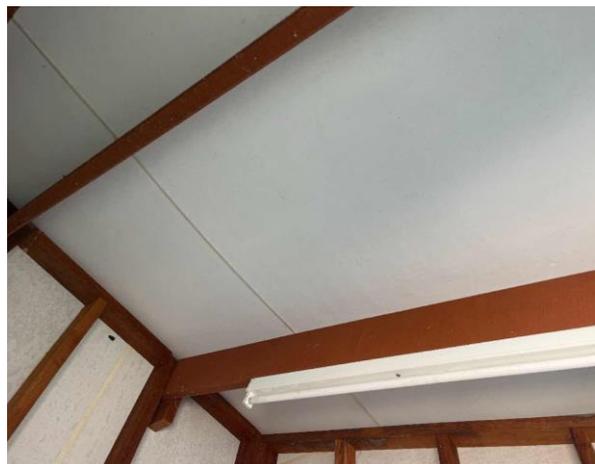
Line ID 34: Internal, Swimming Pool Change and Toilets, Storeroom Adjacent Female Change, Ceiling Linings, Fibre Cement Sheet - No Asbestos Detected

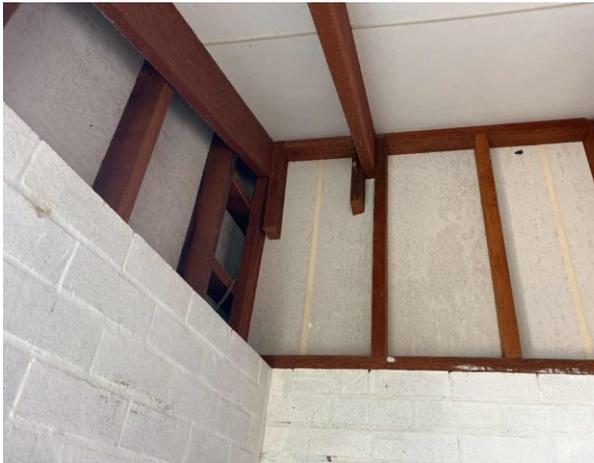
Line ID 35: Internal, Swimming Pool Change and Toilets, Storeroom Adjacent Female Change, Wall Linings, Fibre Cement Sheet - No Asbestos Detected

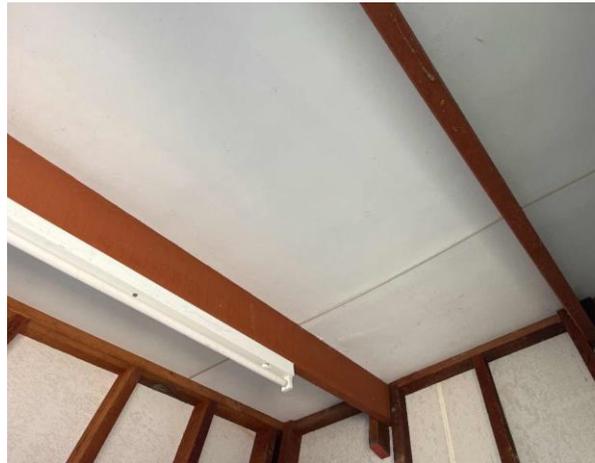
Line ID 36: Internal, Swimming Pool Change and Toilets, Storeroom Adjacent Male Toilets, Ceiling Linings, Fibre Cement Sheet - No Asbestos Detected

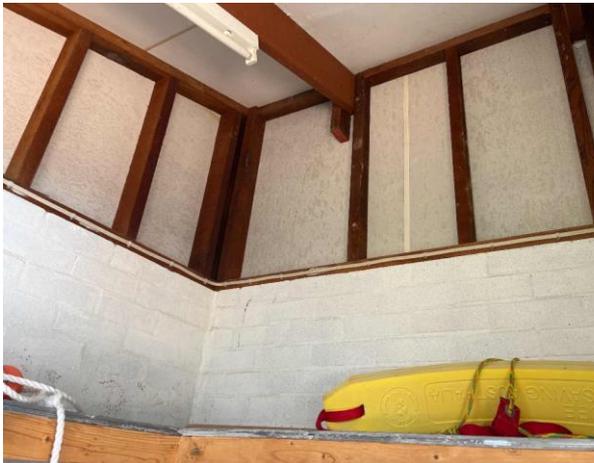
Line ID 37: Internal, Swimming Pool Change and Toilets, Storeroom Adjacent Male Toilets, Wall Linings, Fibre Cement Sheet - No Asbestos Detected

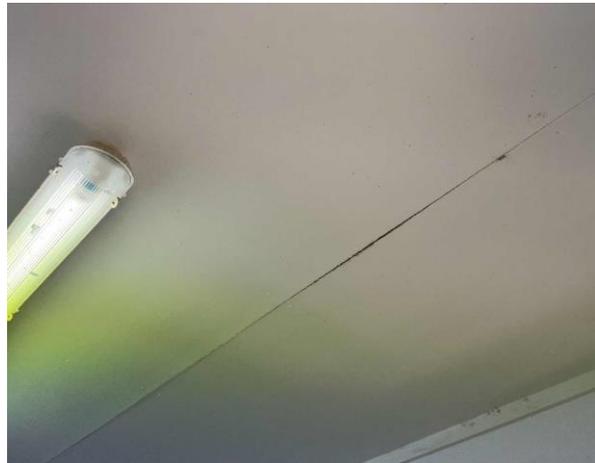
Line ID 38: Internal, Toilets North of Murph's Cottages, Throughout, Ceiling, Fibre Cement Sheet - No Asbestos Detected

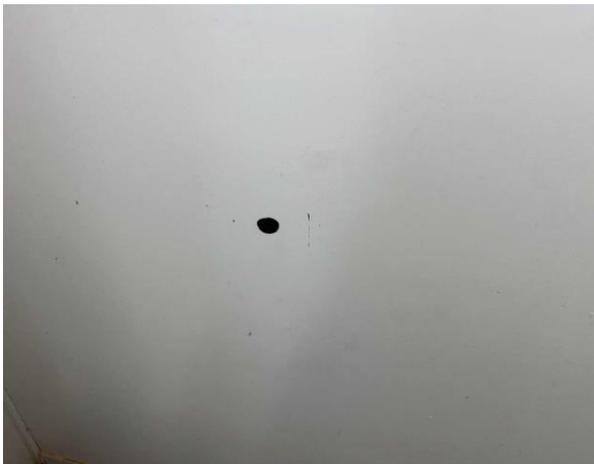
Line ID 39: Internal, Toilets North of Murph's Cottages, Throughout, Wall Lining, Fibre Cement Sheet - No Asbestos Detected

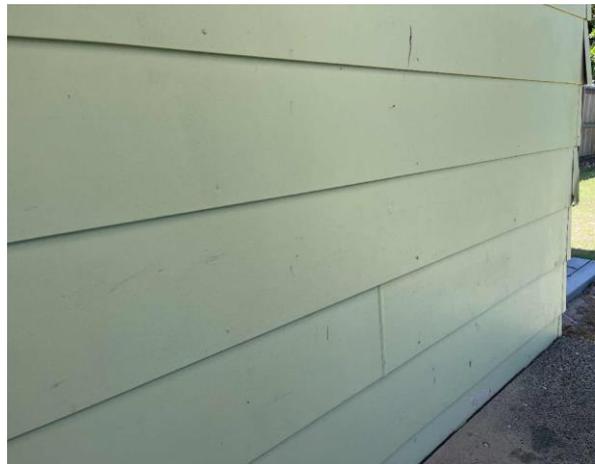
Line ID 40: External, Beachside Lodge, Veranda, Walls, Light Green Paint - Lead Detected (<0.005% w/w)

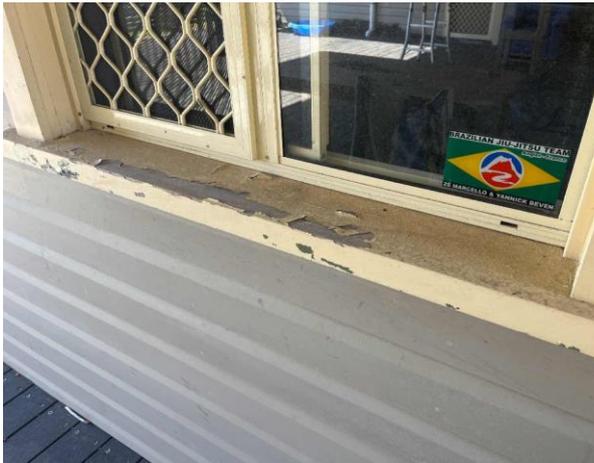
Line ID 41: External, Murphy's Cottage Block, Veranda and Undercover Area, Timber Window Frames, Cream Paint - Lead Detected (0.066% w/w)

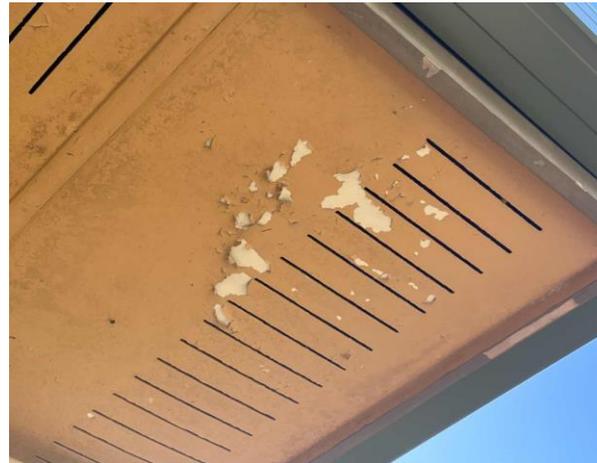
Line ID 42: External, Project Coordinators Residence, Entrance Area and Surrounds, Eave Linings, Beige Paint - Lead Detected (0.16% w/w)

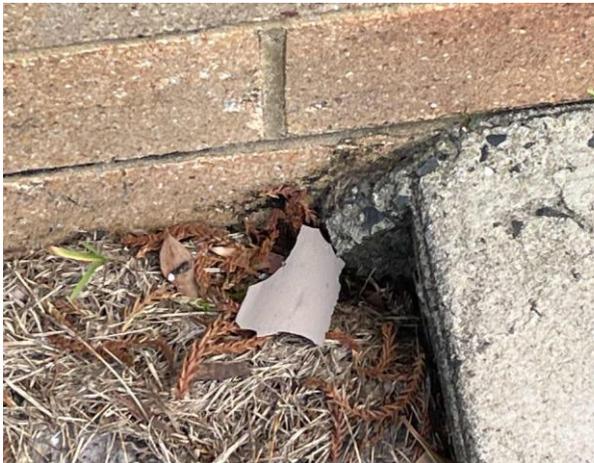
Line ID 43: External, Project Coordinators Residence, Rear Garage, Timber Window Frames, Light Brown Paint - Lead Detected (0.22% w/w)

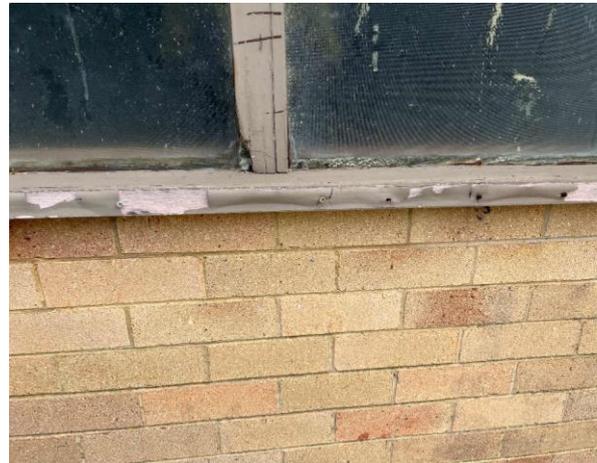
Line ID 43.1: External, Project Coordinators Residence, Rear Garage, Timber Window Frames, Light Brown Paint - Lead Detected (0.22% w/w)

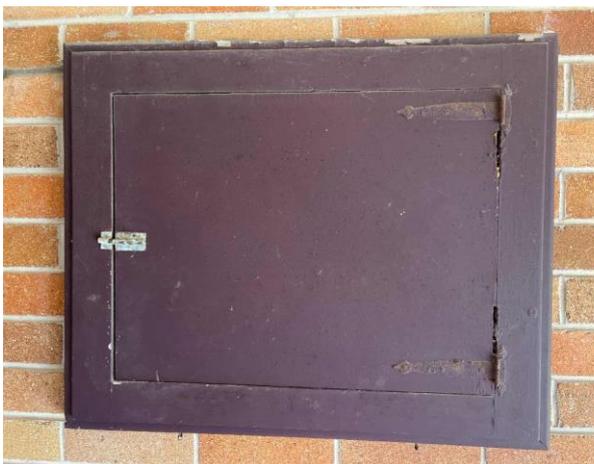
Line ID 44: External, Services Coordinator Residence, Entry And Covered Walkways, Electrical Box Adjacent Entry, Purple Paint - Lead Detected (0.18% w/w)

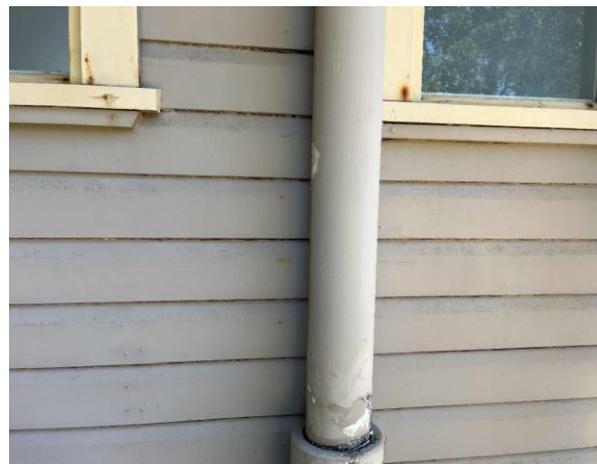
Line ID 45: External, Toilets to the North of Murph's Cottages, Entrance and Surrounds, Down Pipe and Walls, Beige Paint - Lead Detected (0.18% w/w)

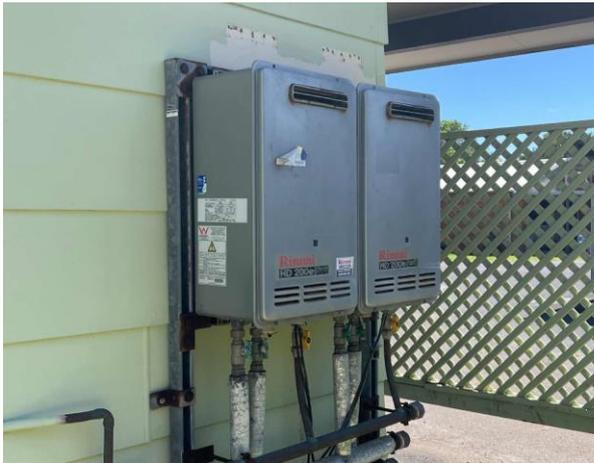
Line ID 46: External, Beachside Lodge, Veranda and Walls, Hot Water Units, Insulation Material - Suspected SMF

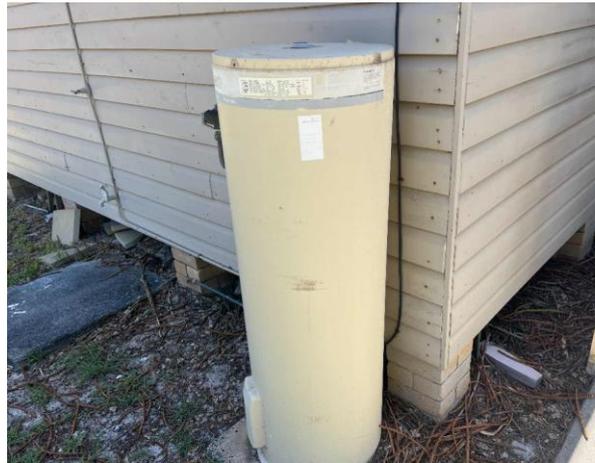
Line ID 47: External, Murphy's Cottage Block, Veranda and Undercover Area, Hot Water Unit, Insulation Material - Suspected SMF

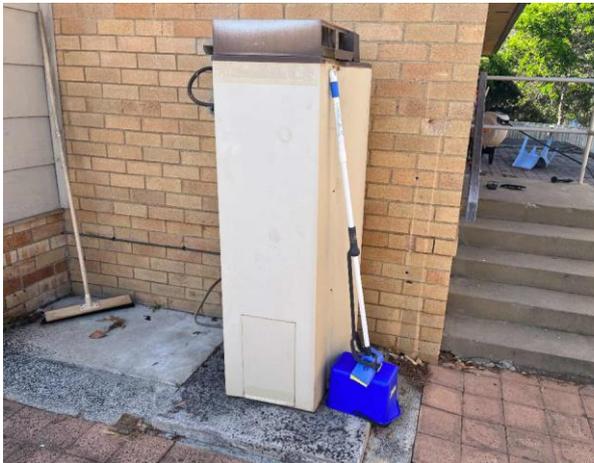
Line ID 48: External, Project Coordinators Residence, Entrance Area and Surrounds, Hot Water Unit, Insulation Material - Suspected SMF

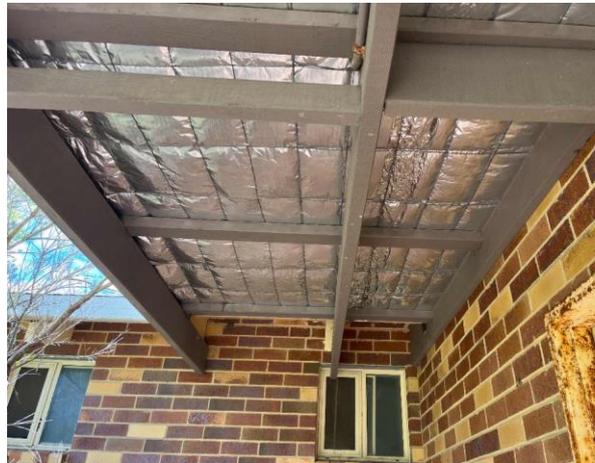
Line ID 49: External, Swimming Pool Toilets and Change, Free Play Sports Store, Roof Adjacent the Entry, Sarking Insulation - Suspected SMF

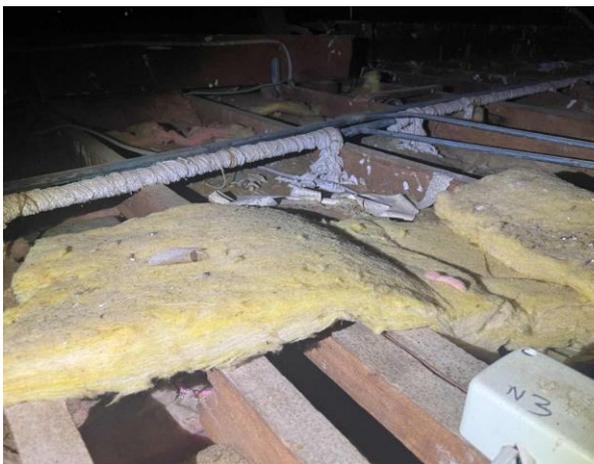
Line ID 50: Internal, Centre Managers House, Laundry, Throughout Ceiling Void, Insulation Batts - Suspected SMF

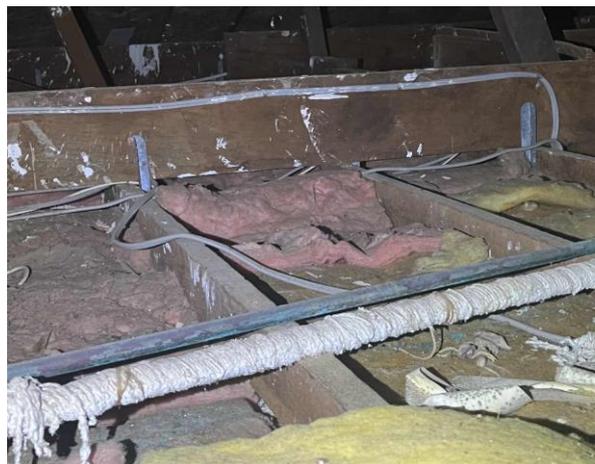
Line ID 50.1: Internal, Centre Managers House, Laundry, Throughout Ceiling Void, Insulation Batts - Suspected SMF

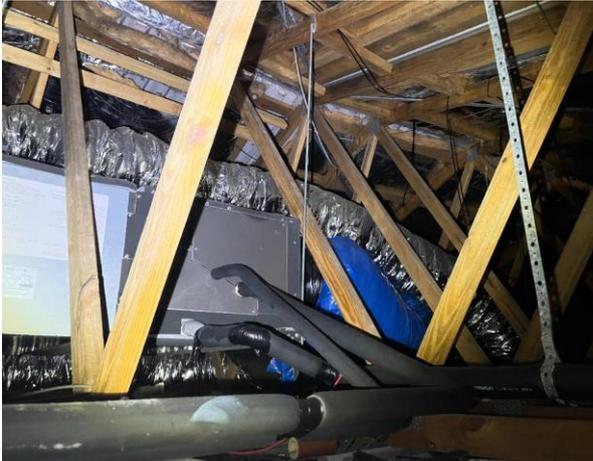
Line ID 51: Internal, Reception, Ceiling Void, Flexible Ductwork, Insulation Material - Suspected SMF

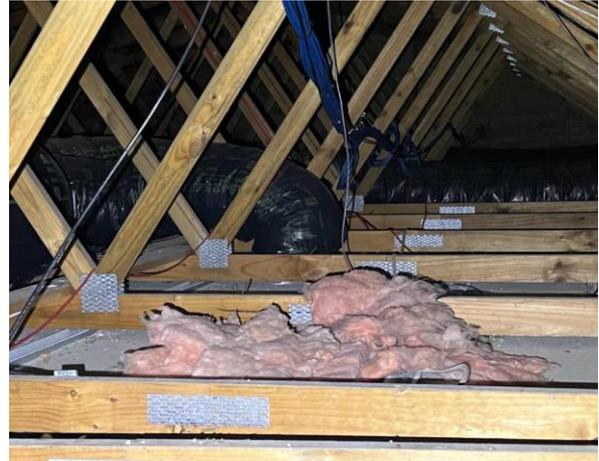
Line ID 52: Internal, Reception, Ceiling Void, Loose Insulation, Insulation Batt - Suspected SMF

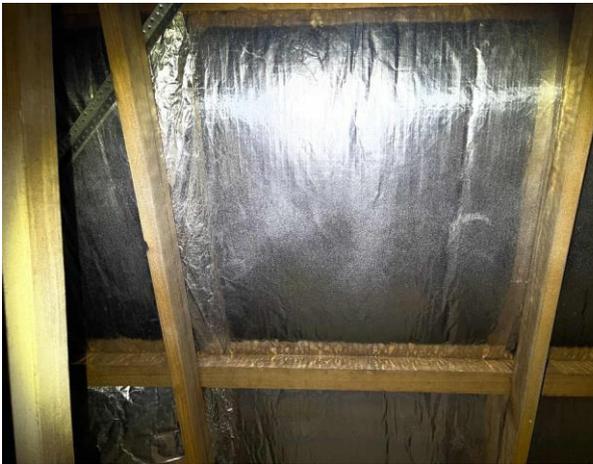
Line ID 53: Internal, Reception, Ceiling Void, Underside of Roof, Sarking Insulation - Suspected SMF

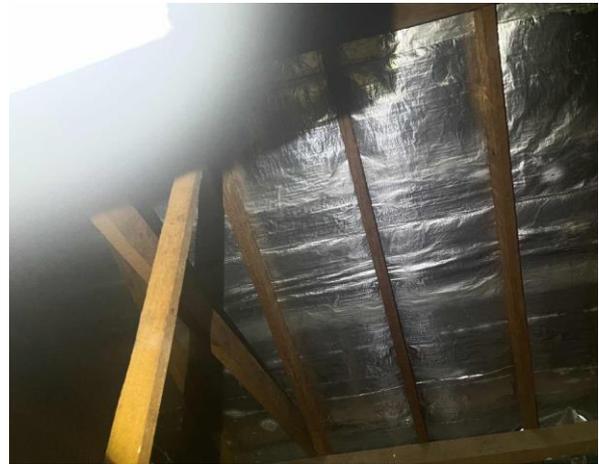
Line ID 54: Internal, Service Coordinator Residence, Ceiling Void, Underside of Roof, Sarking Insulation - Suspected SMF

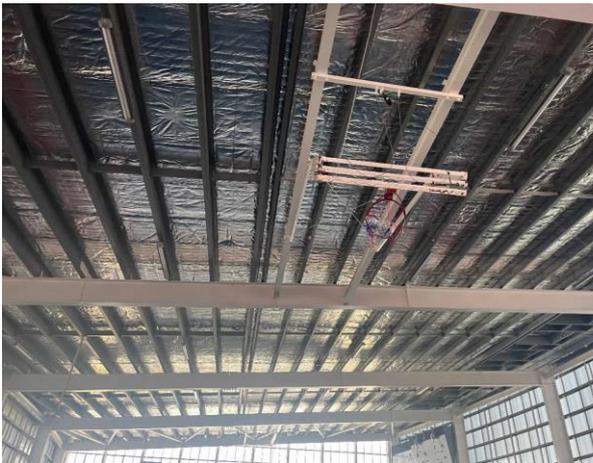
Line ID 55: Internal, Stadium, Gym, Underside of Roof, Sarking Insulation - Suspected SMF

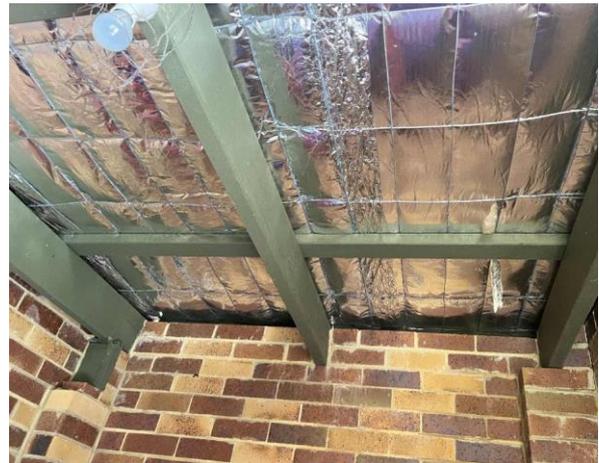
Line ID 56: Internal, Swimming Pool Change and Toilets, Free Play Ports Store, Underside of Roof, Sarking Insulation - Suspected SMF
