Asbestos and Hazardous Materials Reinspection Assessment

Point Wolstoncroft Sports and Recreational Centre

03/02/2023

754-SYDEN311850 - Point Wolstoncroft Sports and Recreational Centre - HMRR - 17012023

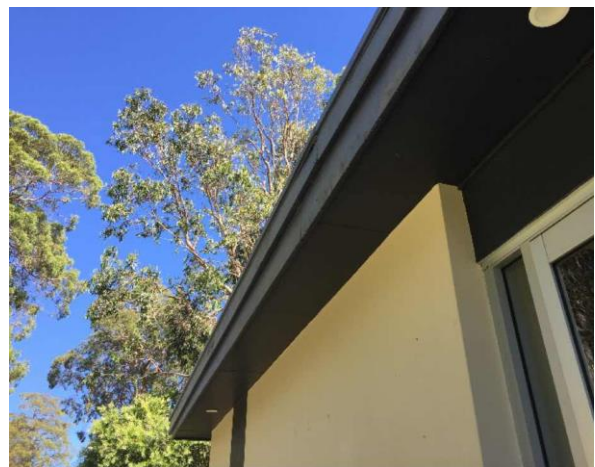
Line ID 17: External, GF, Equipment Store Building, Northern and Southern Elevations, Eaves, Fibre Cement Sheetting - Chrysotile & Amosite Asbestos Detected

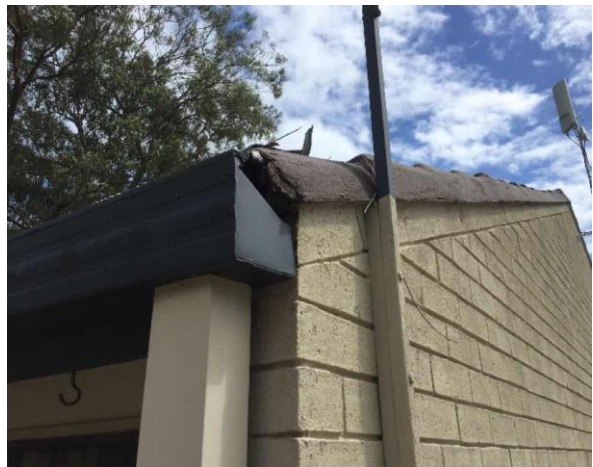
Line ID 29: External, GF, Recreational Hall, Eaves to Eastern and Western Elevations, Fibre Cement Sheetting - Chrysotile Asbestos Detected

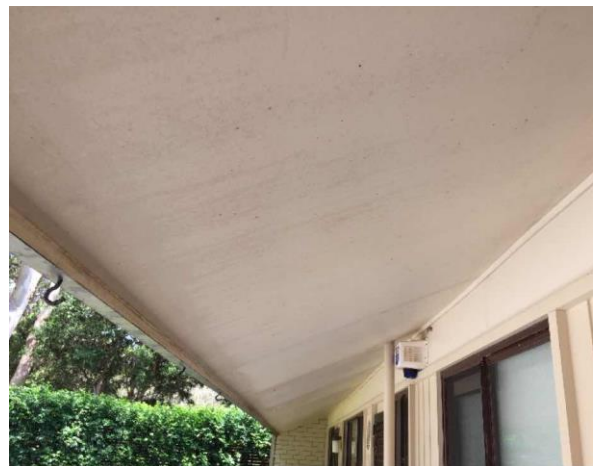
Line ID 39: External, GF, Residence 2 (Wattle House & Garage), House and Garage, Under Roof Tiles, Compressed Cement Sheetting - Chrysotile Asbestos Detected

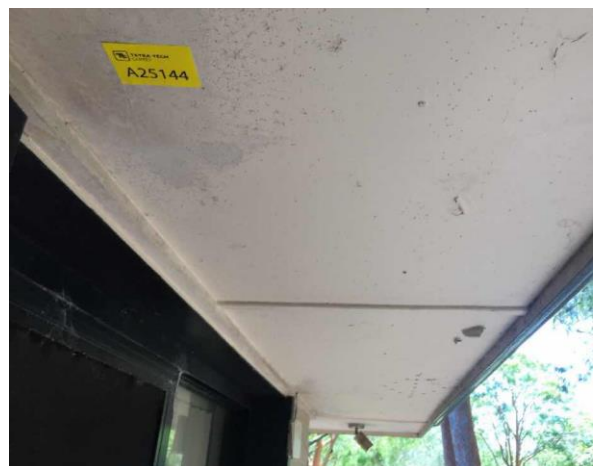
Line ID 41: External, GF, Residence, Northern and Southern Elevations, Upper 1/4 of Walls, Fibre Cement Sheetting - Chrysotile Asbestos Detected

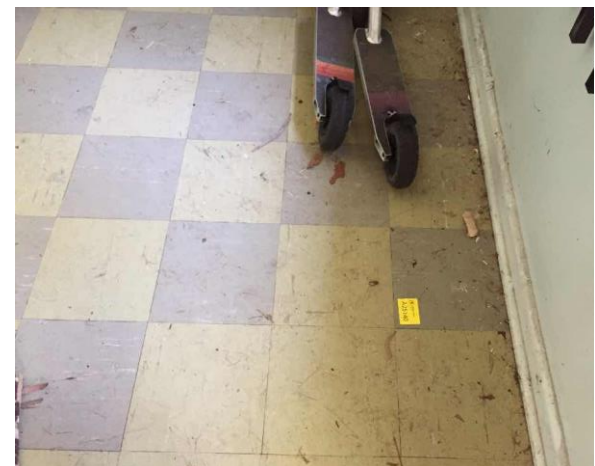
Line ID 63: Internal, GF, Bush Craft Building, Eastern and Southern Rooms, Olive Green Vinyl Floor Tiles - Chrysotile Asbestos Detected

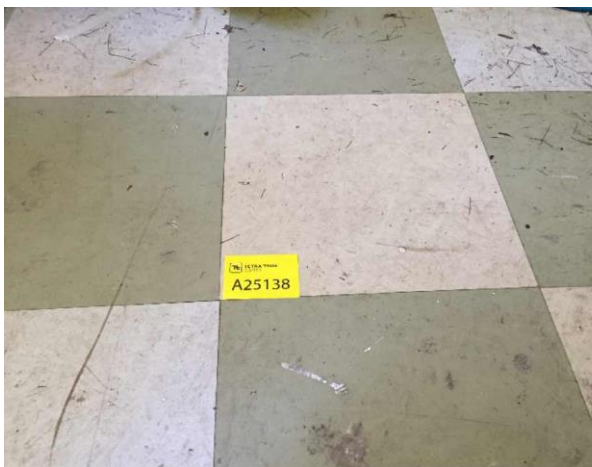
Line ID 64: Internal, GF, Bush Craft Building, Eastern and Western Rooms, Blue Vinyl Floor Tiles - Chrysotile Asbestos Detected

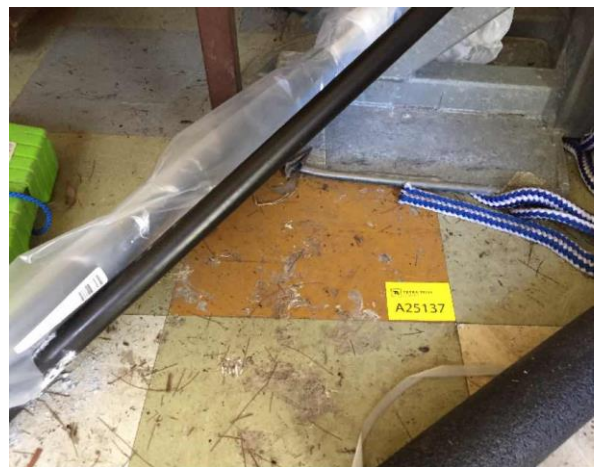
Line ID 65: Internal, GF, Bush Craft Building, Eastern Room, Cream Vinyl Floor Tiles - Chrysotile Asbestos Detected

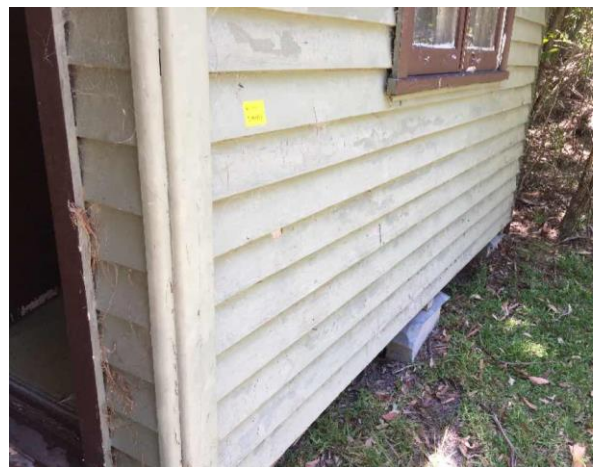
Line ID 94: External, GF, Barbeque Area, Walls Throughout, Beige Paint - Lead Detected (<0.005% w/w)

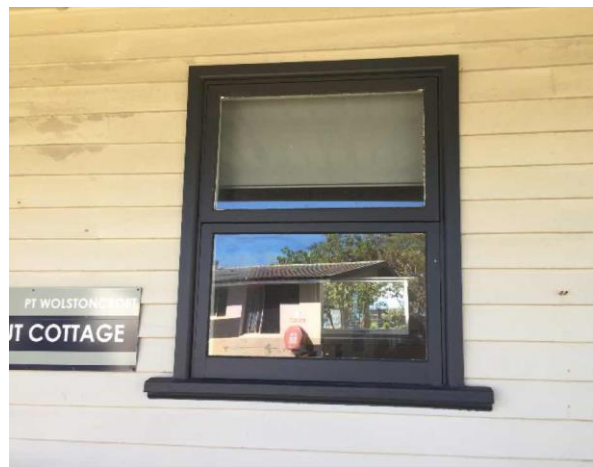
Line ID 100: External, GF, Equipment Store Building, Walls, Beige Paint - Lead Detected (7.1% w/w)

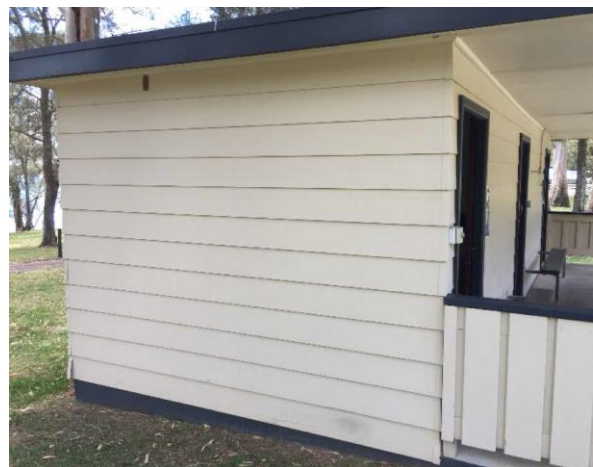
Line ID 112: External, GF, Ropes Course Store Building/Toilet, Walls, Beige Paint - Lead Detected (<0.005% w/w)

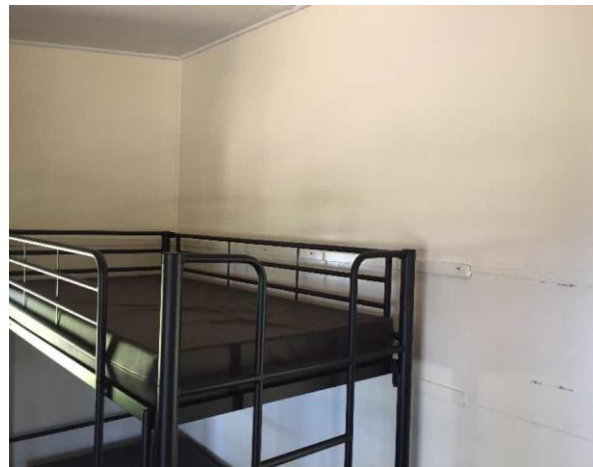
Line ID 118: Internal, GF, Bush Craft Building, Walls to Western Room, Blue Paint - Lead Detected (0.14% w/w)

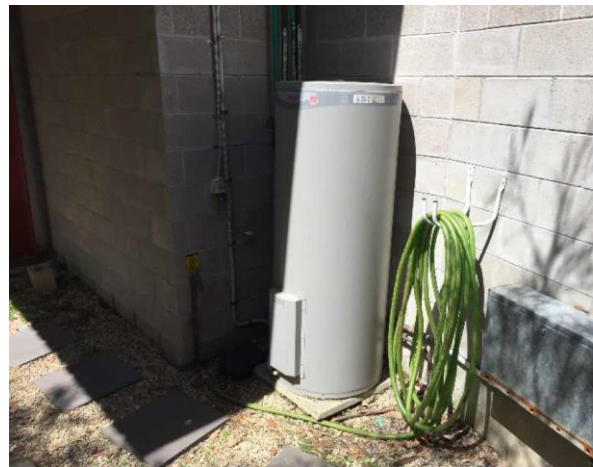
Line ID 124: External, GF, Casuarina Lodge, Western Wall, Hot Water Tank, Internal Insulation - Suspected SMF

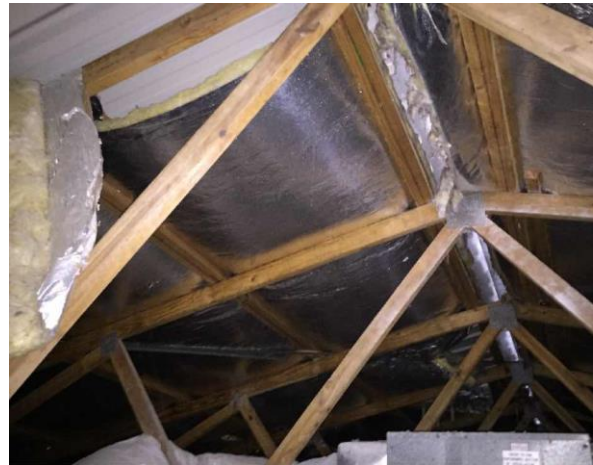
Line ID 134: Internal, GF, Administration/Office Building, Ceiling Space, Air Conditioning Ductwork, Insulation Material - Suspected SMF

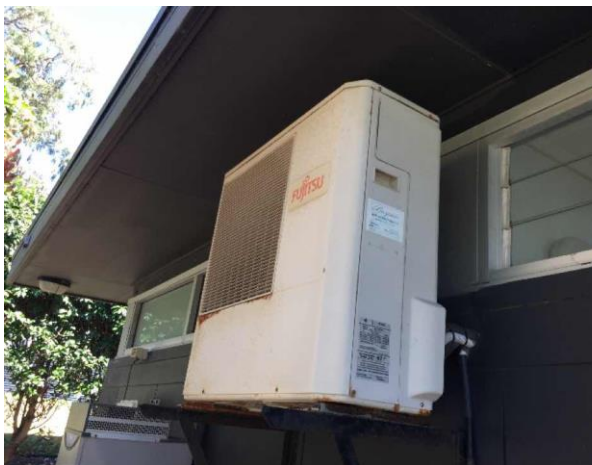
Line ID 154: External, GF, Administration/Office Building, Southern Elevation, Air Conditioning Unit, R22 Hydrochlorofluorocarbon (HCFC) - ODS Refrigerant

- Removal of refrigerants should be undertaken prior to any future demolition, partial demolition, renovation or refurbishment, where ODS's are likely to be disturbed. A licensed contractor who will recycle and reuse the refrigerant should decommission CFC and HCFC based equipment that is being disposed of in accordance with Association of Fluorocarbon Consumers and Manufacturers, The Australian Refrigeration and Air Conditioning Code of Good Practice – 1992 and the Australian Commonwealth Government Ozone Protection Act – 1989.

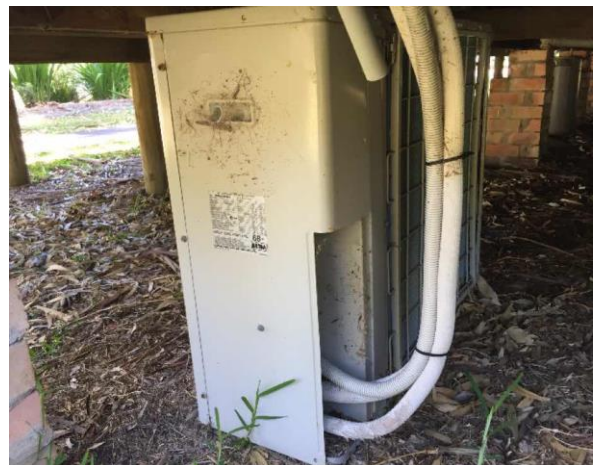
Line ID 155: External, GF, Bluegum Lodge, Southern Elevation, Air Conditioning Unit, R22 Hydrochlorofluorocarbon (HCFC) - ODS Refrigerant

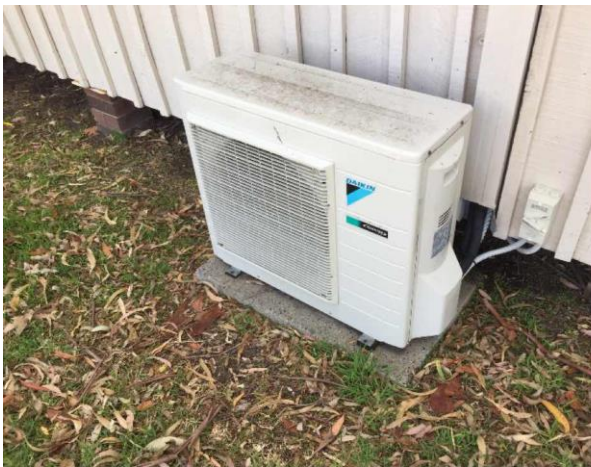
Line ID 160: External, GF, Hakea Lodges 1-3, Air Conditioning Units, R22 Hydrochlorofluorocarbon (HCFC) - ODS Refrigerant
