Asbestos and Hazardous Materials Reinspection Assessment

Sydney Academy of Sport and Recreation

Wakehurst Parkway

03/02/2023

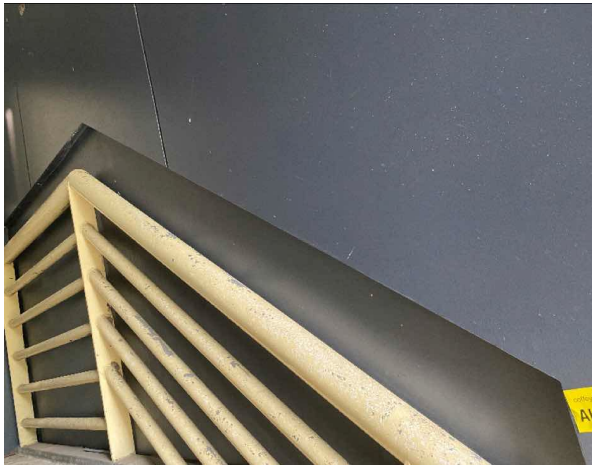
Line ID 1: External, Administration Office, Perimeter, Upper Perimeter Walls, Compressed Cement Sheet - No Asbestos Detected

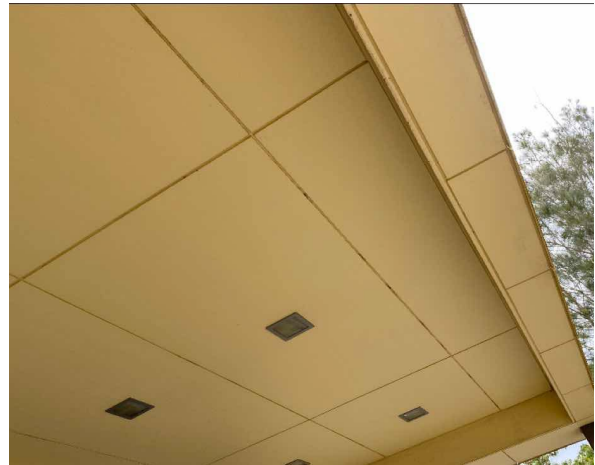
Line ID 2: External, Aquatics Facility, Entrance Foyer, Upper Walls, Compressed Cement Sheet - No Asbestos Detected

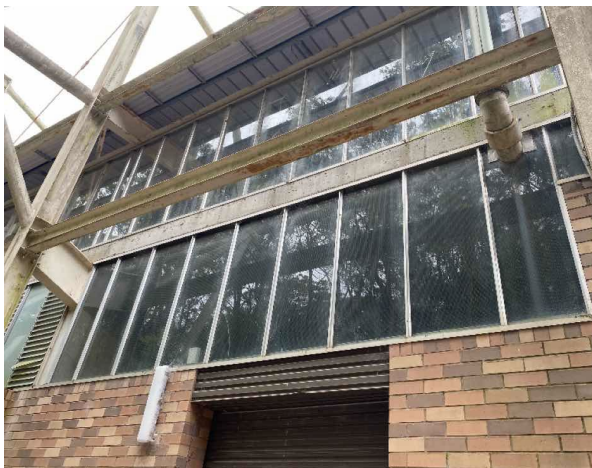
Line ID 3: External, Athletics Track Stand, Seating Area, Rear Adjacent Access Gate, Pipework, Moulded Fibre Cement - Suspected Asbestos

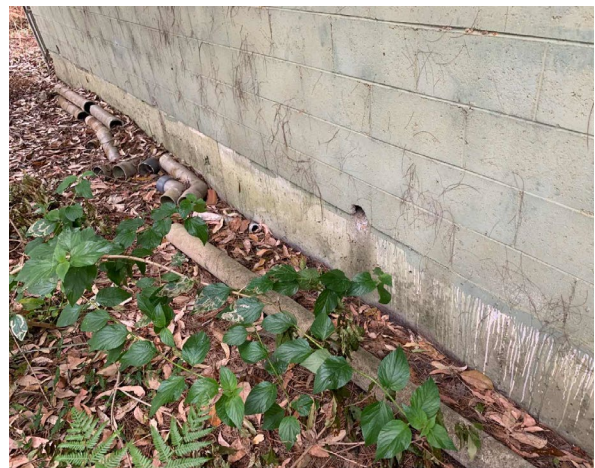
Line ID 4: External, Chemical Shed, Rear, Ground, Redundant Pipe, Moulded Cement Pipe - Chrysotile, Amosite and Crocidolite Asbestos Detected

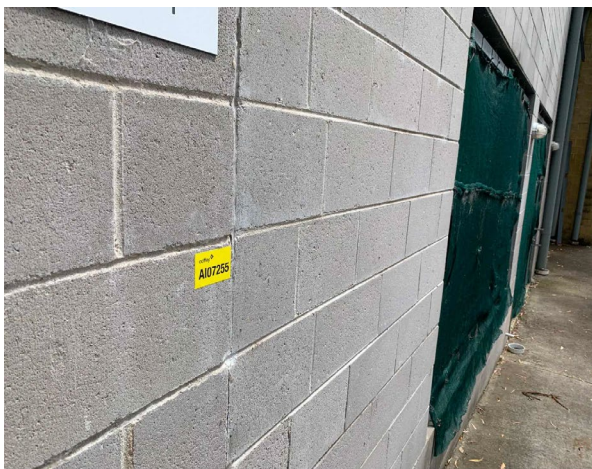
Line ID 5: External, Dining Dorm, Perimeter, Concrete Block Work, Vertical Joints Throughout, Construction Joint Mastic - Chrysotile Asbestos Detected

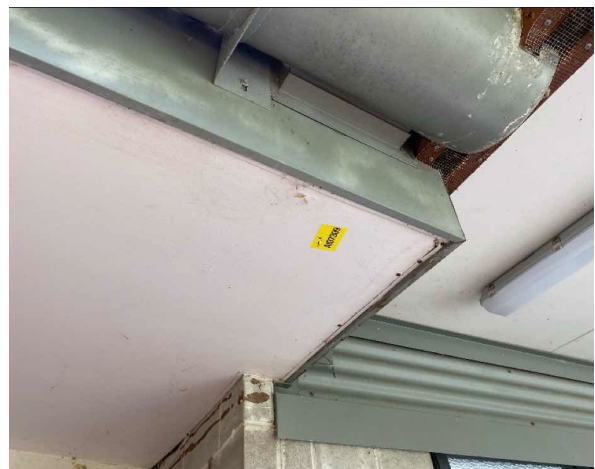
Line ID 6: External, Dining Dorm, Perimeter, Eaves, Fibre Cement Sheet - No Asbestos Detected

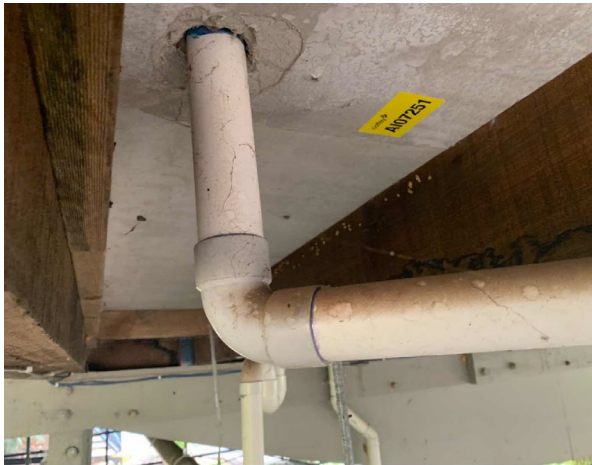
Line ID 7: External, Dorm Accommodation 1-12, Building Perimeter , All Units, Subfloor, Beneath Wet Areas, Compressed Cement Sheet - No Asbestos Detected

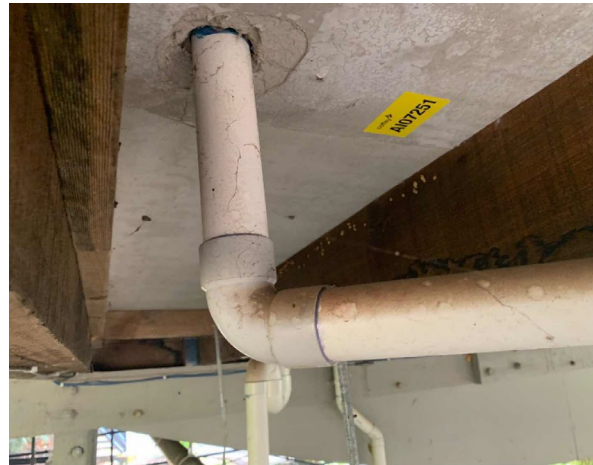
Line ID 8: External, Dorm Accommodation 1-12, Building Perimeter , Freshwater 1, Subfloor, Below Wet Areas, Compressed Cement Sheet - No Asbestos Detected

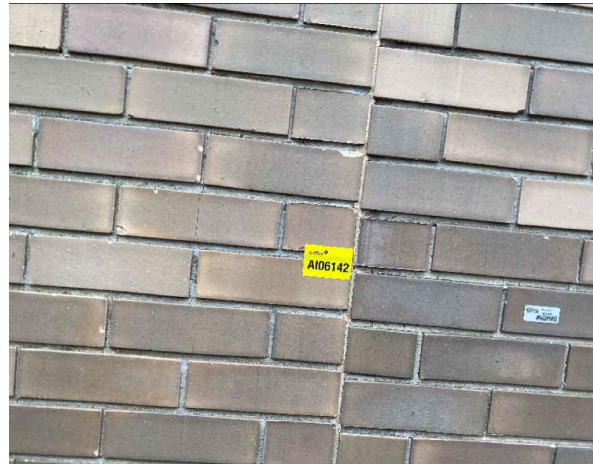
Line ID 10: External, Lecture Rooms and Accommodation, Deliveries Entrance, Brick Wall Adjacent Door, Construction Joint Mastic - No Asbestos Detected

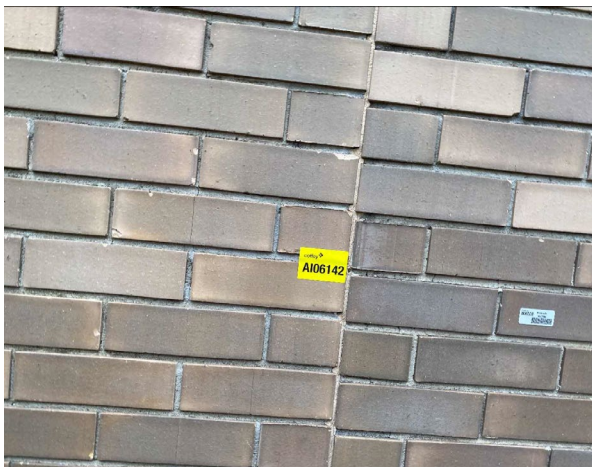
Line ID 11: External, Motel Accommodation, Elevations, Walls, Vertical Joints Throughout, Construction Joint Mastic - No Asbestos Detected

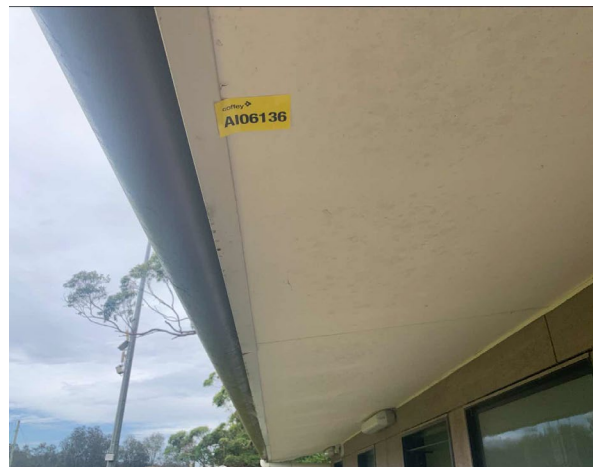
Line ID 12: External, Oval 3 Toilet Block and Change Rooms, Elevations, Eaves, Fibre Cement Sheetting - No Asbestos Detected

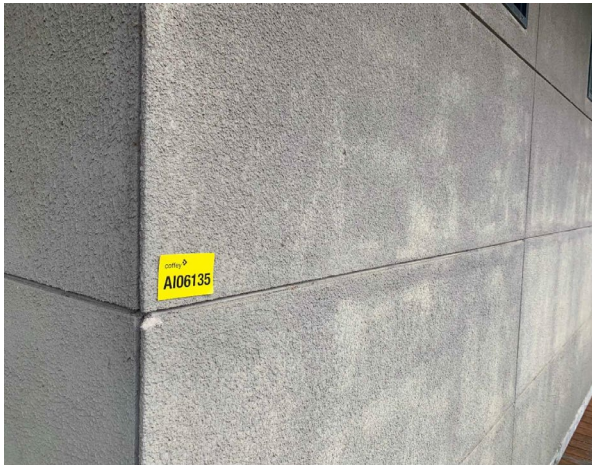
Line ID 13: External, Oval 3 Toilet Block and Change Rooms, Elevations, Facia Panels, Compressed Cement Sheet - No Asbestos Detected

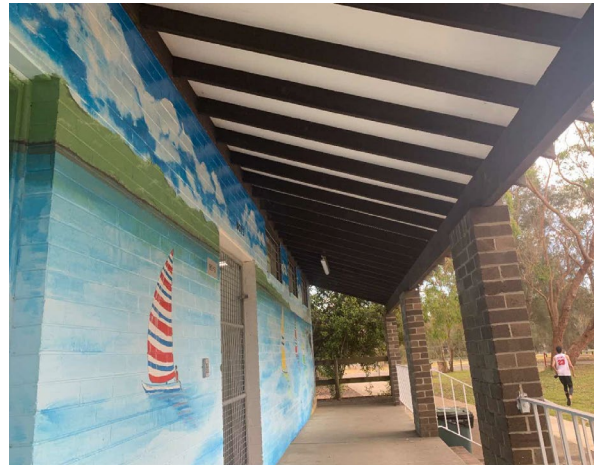
Line ID 14: External, Picnic Toilet Block, Entrance Awning, Lining, Fibre Cement Sheet - Chrysotile Asbestos Detected

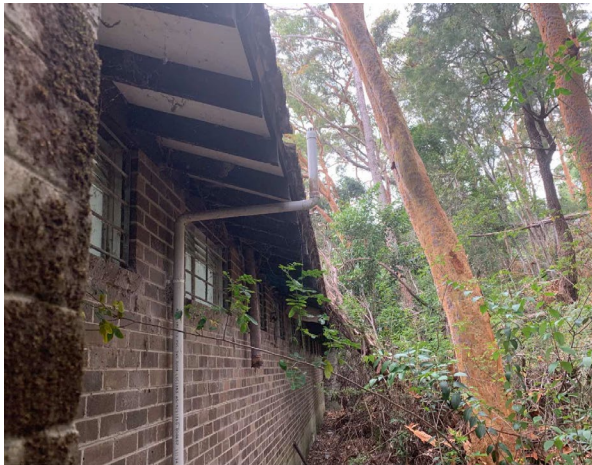
Line ID 15: External, Picnic Toilet Block, Rear, Eaves Lining, Fibre Cement Sheet - Chrysotile Asbestos Detected

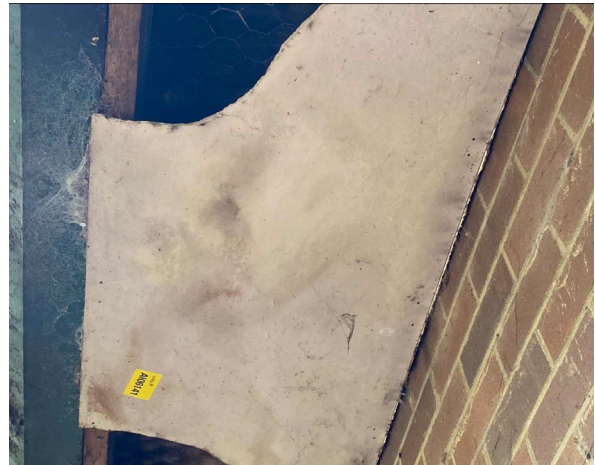
Line ID 16: External, Pump House, Elevations, Eaves, Compressed Cement Sheet - No Asbestos Detected

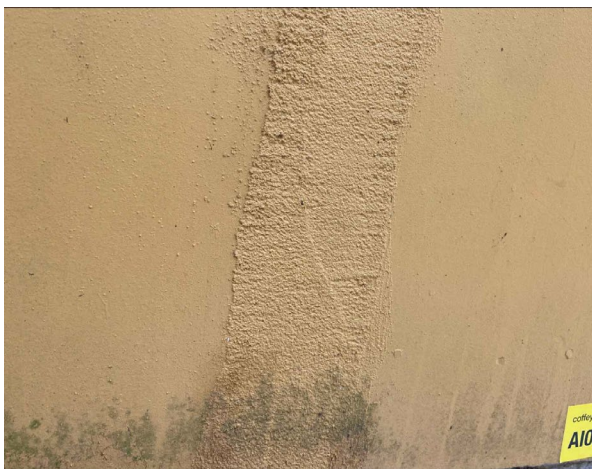
Line ID 17: External, Pump House, Elevations, Yellow Wall Panelling, Compressed Cement Sheet - No Asbestos Detected

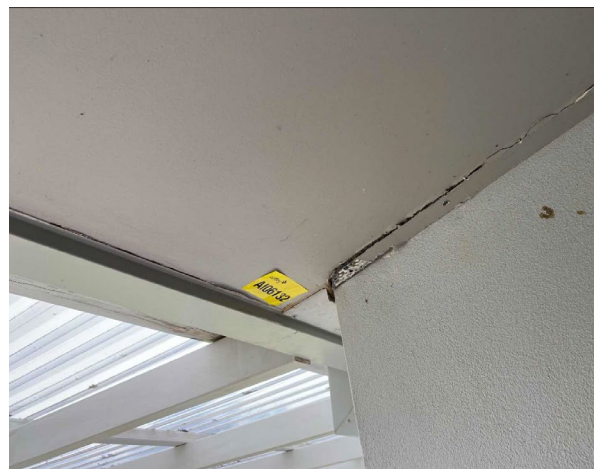
Line ID 18: External, Rugby Field Office, Perimeter, Eaves, Compressed Cement Sheet - No Asbestos Detected

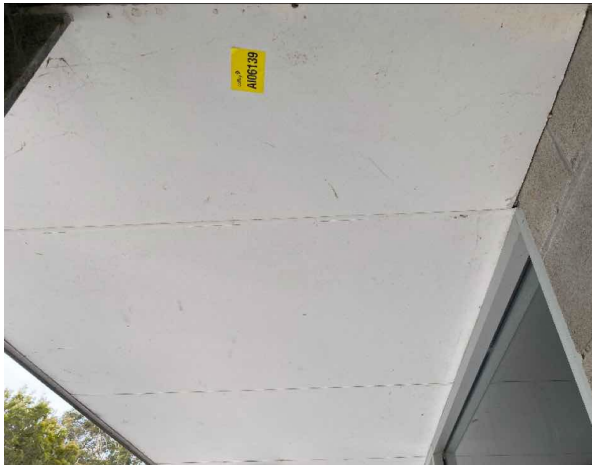
Line ID 19: External, Sea Eagles, Gym Perimeter, Eaves, Fibre Cement Sheet - No Asbestos Detected

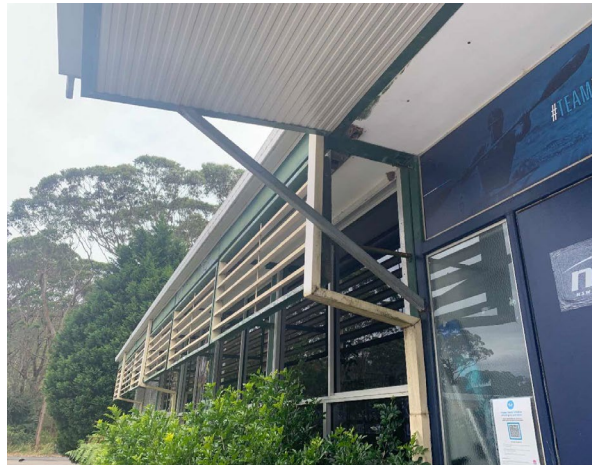
Line ID 20: External, Sea Eagles, North Side Demountable, Entrance Ceiling Lining, Fibre Cement Sheet - Chrysotile Asbestos Detected

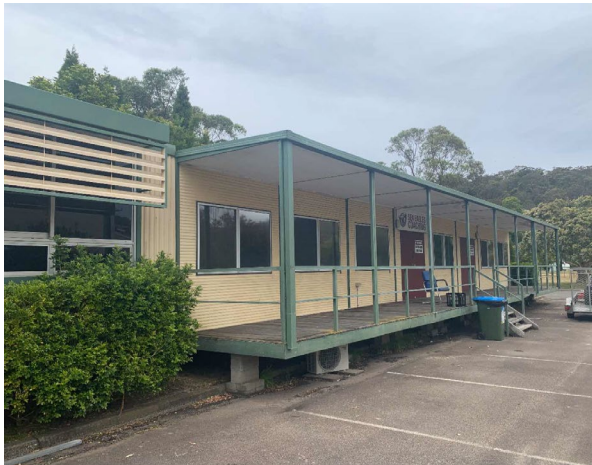
Line ID 21: External, Sea Eagles, North Side Demountable, Entrance Eaves Lining, Fibre Cement Sheet - Chrysotile Asbestos Detected

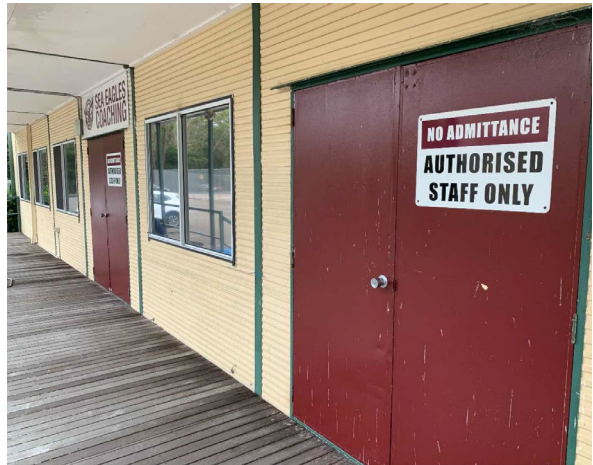
Line ID 22: External, Sea Eagles, South Side Demountable, Eaves Lining, Fibre Cement Sheet - No Asbestos Detected

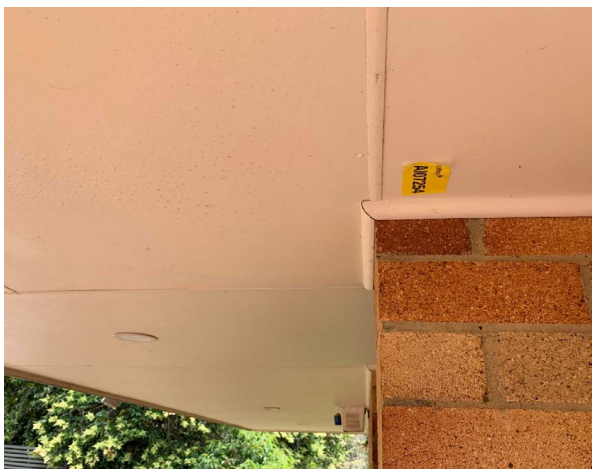
Line ID 23: External, Staff Residence #1 (South of Dining Dorm), Building Perimeter, Eaves and Awnings, Fibre Cement Sheet - No Asbestos Detected

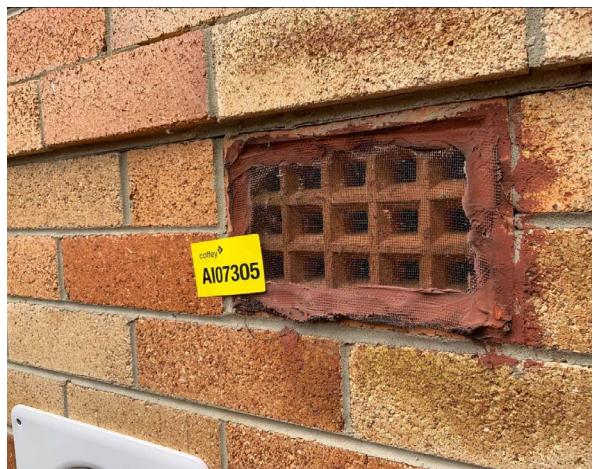
Line ID 24: External, Staff Residence #1 (South of Dining Dorm), Building Perimeter, Ventilation Grate, Mastic Sealant, Mastic Sealant - No Asbestos Detected

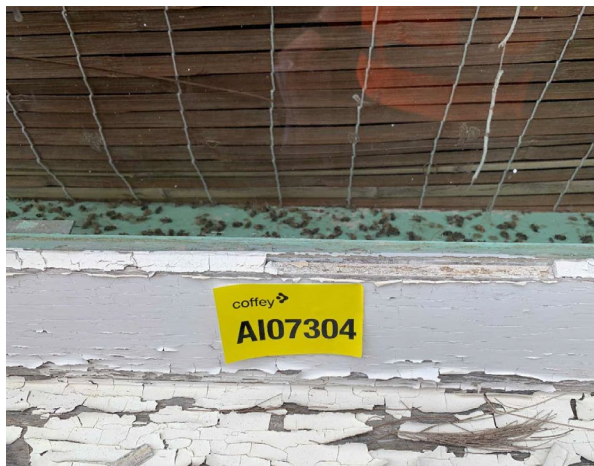
Line ID 25: External, Staff Residence #1 (South of Dining Dorm), Building Perimeter, Window Frames, Pane to Timber Joint, Window Caulking - No Asbestos Detected

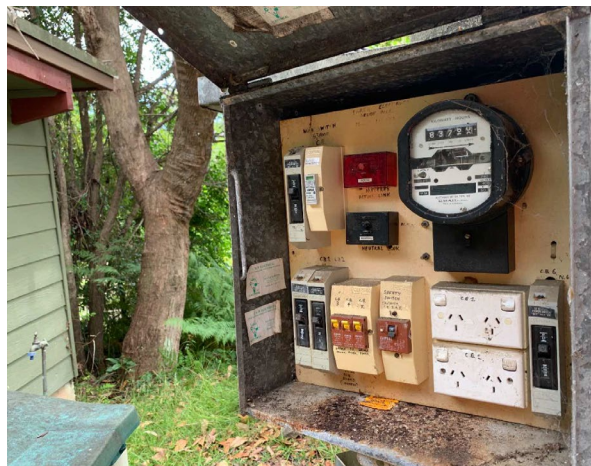
Line ID 26: External, Staff Residence #1 (South of Dining Dorm), North Side of House, Electrical Switchboard, Bituminous Backing Board - Chrysotile Asbestos Detected

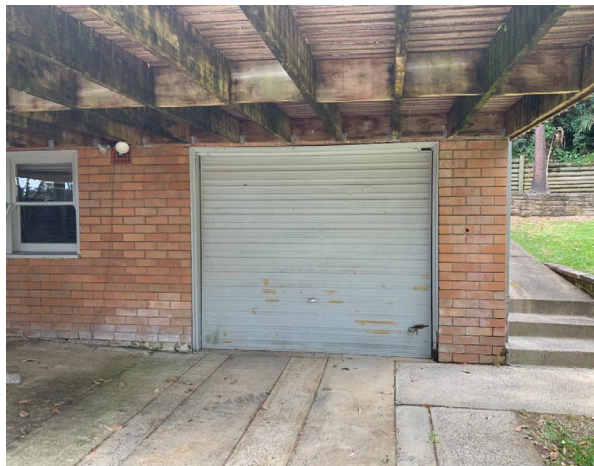
Line ID 27: External, Staff Residence #3 (West of Dining Dorm), Carport, Communications Pit Lid, Compressed Cement - Chrysotile Asbestos Detected

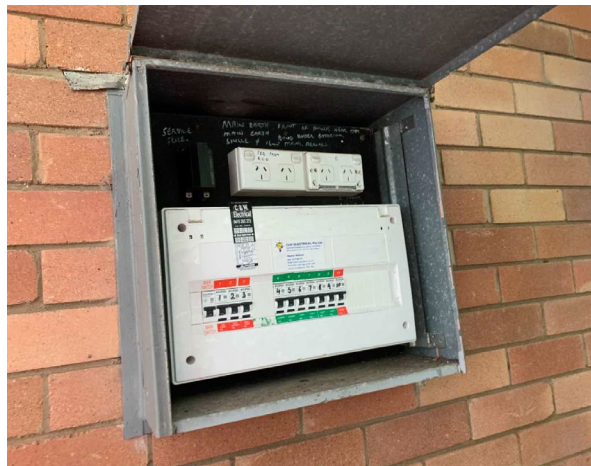
Line ID 28: External, Staff Residence #3 (West of Dining Dorm), Carport, Front of House, Electrical Switchboard, Bituminous Backing Board - Chrysotile Asbestos Detected

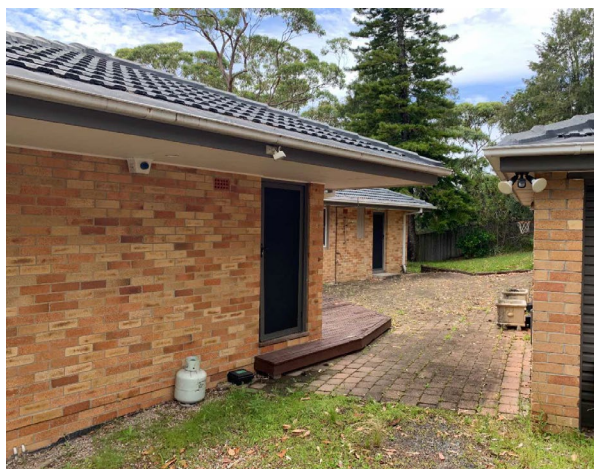
Line ID 29: External, Staff Residence 3 (West of Picnic Area), Building Perimeter, Eaves, Fibre Cement Sheet - Chrysotile Asbestos Detected

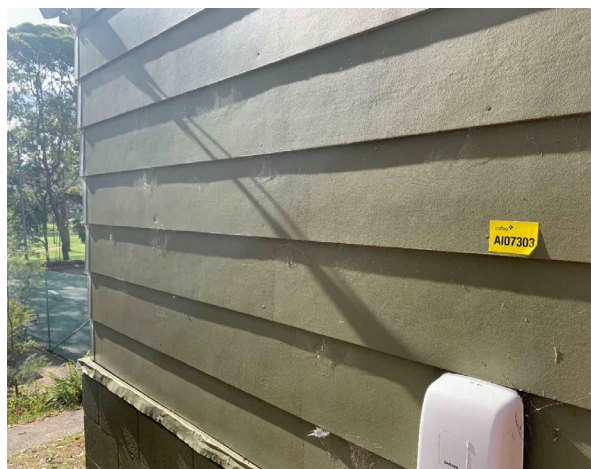
Line ID 30: External, Tennis Court Building, Perimeter, Facia Panelling, Compressed Cement Sheet - No Asbestos Detected

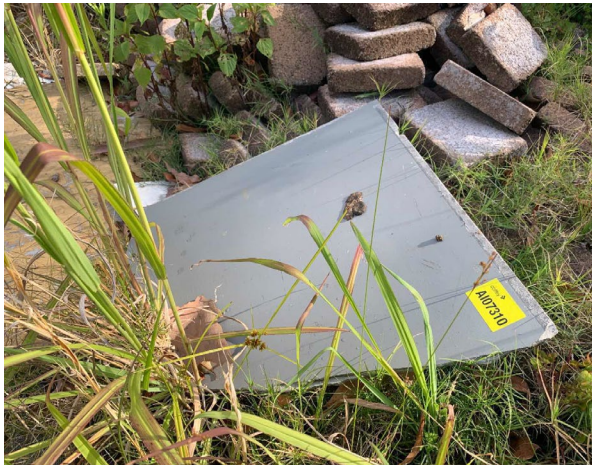
Line ID 31: External, The Compound, Throughout, South of Concrete Stockpile, Debris, Compressed Cement Sheet - No Asbestos Detected

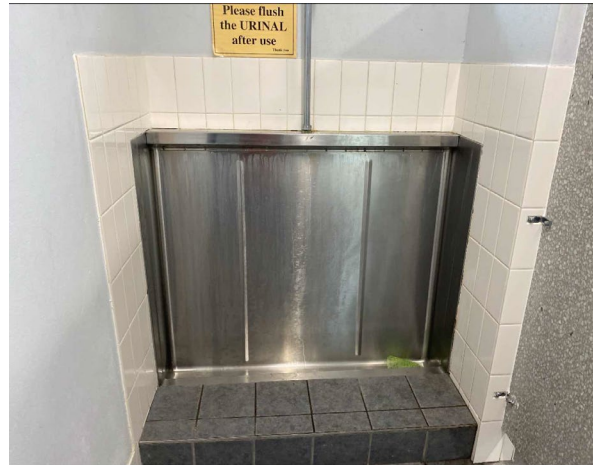
Line ID 32: Internal, Athletics Track Stand, Toilet Block, Behind Male Urinal, Bituminous Membrane - Suspected Asbestos

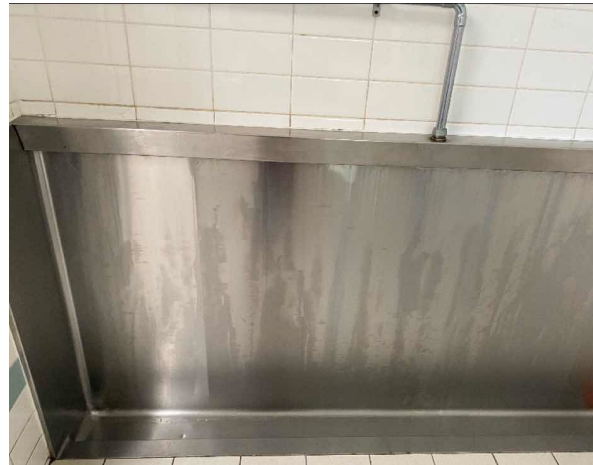
Line ID 34: Internal, Dining Dorm, Entrance Foyer Male Toilet, Behind Urinal, Bituminous Membrane - Suspected Asbestos

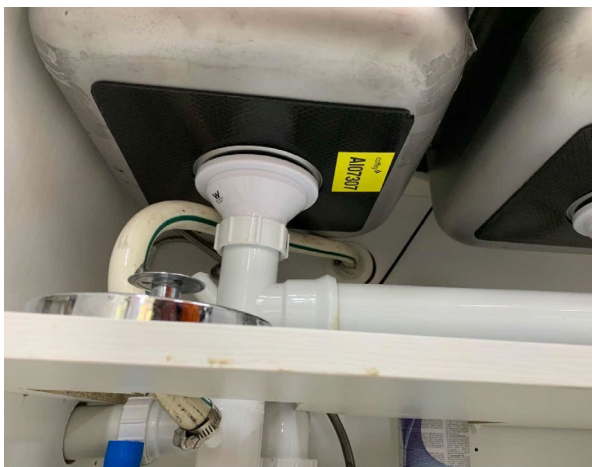
Line ID 35: Internal, Dining Dorm, Level 1, Kitchenette, Beneath Sink, Bituminous Sink Pad - No Asbestos Detected

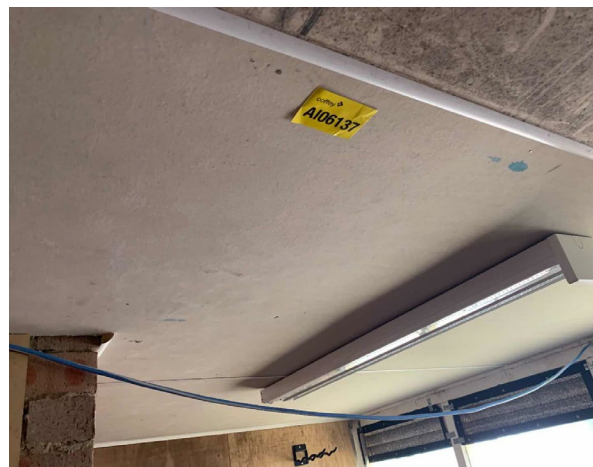
Line ID 36: Internal, Gymnasium, Cleaners Rooms, Ceiling Lining, Fibre Cement Sheet - No Asbestos Detected

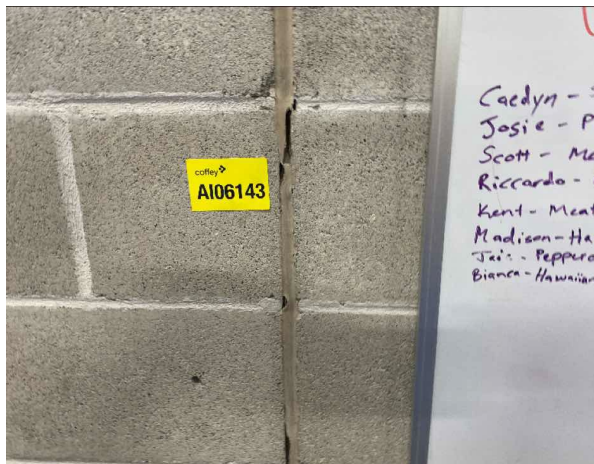
Line ID 38: Internal, Gymnastics, Training Area, Perimeter Walls, Construction Joint Mastic - No Asbestos Detected

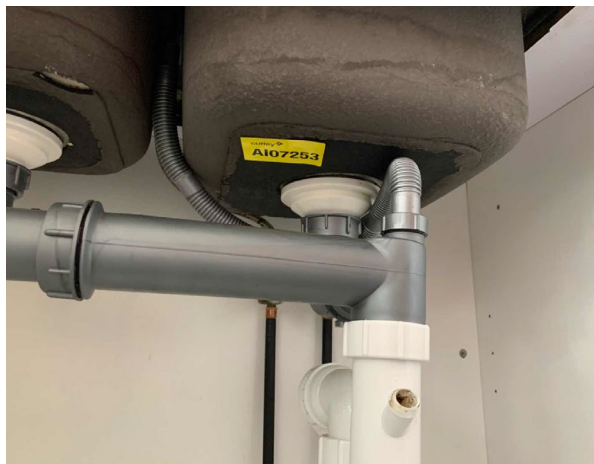
Line ID 40: Internal, Sea Eagles Coaching Offices, Kitchenette, Beneath Sink, Bituminous Sink Pad - No Asbestos Detected

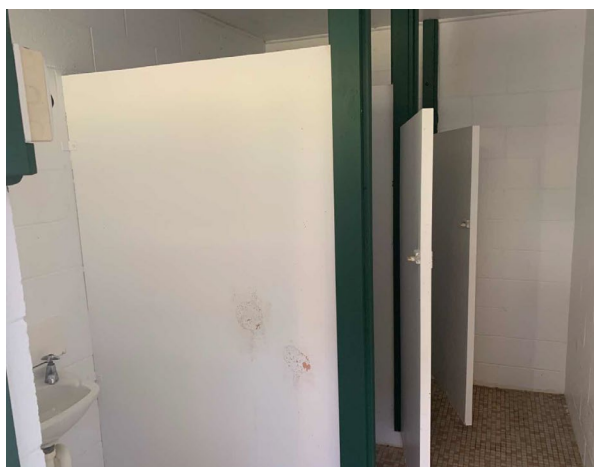
Line ID 44: Internal, Tennis Court Building, Male & Female Toilets, Toilet Partitions, Fibre Cement Sheet - Chrysotile Asbestos Detected

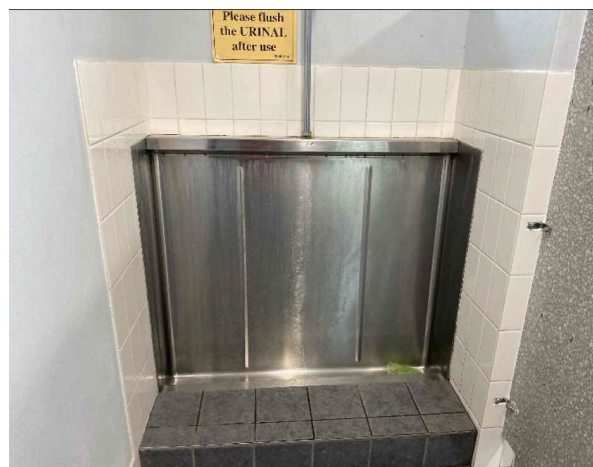
Line ID 45: Internal, Weights Room, Male Toilets, Behind Urinal, Bituminous Membrane - Suspected Asbestos

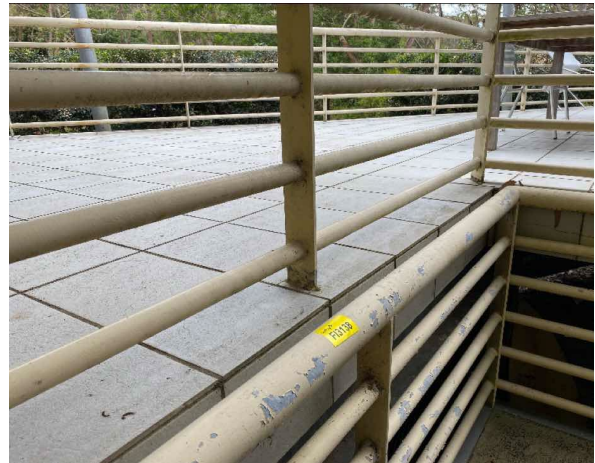
Line ID 47: External, Administration Office, Perimeter, Handrails Throughout, Cream Paint - Lead Detected (0.01% w/w)

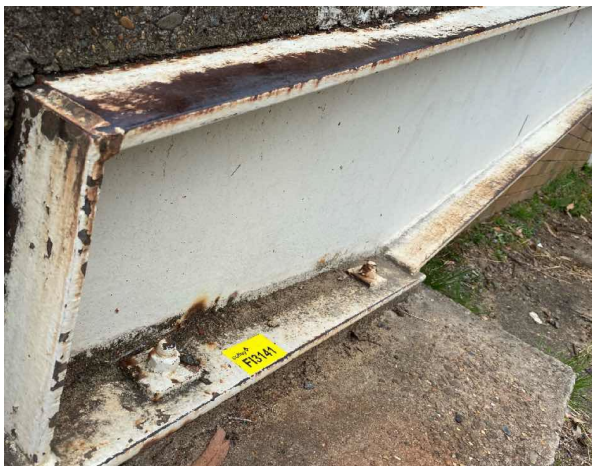
Line ID 48: External, Athletics Track Stand, Seating Area, Metal Beams, Cream Paint - Lead Detected (0.008% w/w)

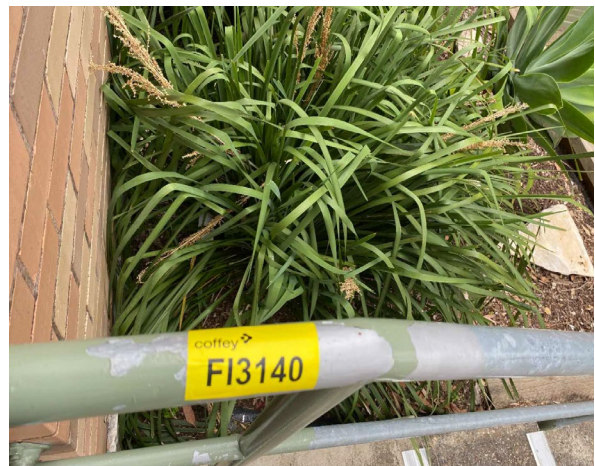
Line ID 49: External, Athletics Track Stand, Toilet Block, Adjacent Entry, Handrail, Green (Light) Paint - Lead Detected (0.005% w/w)

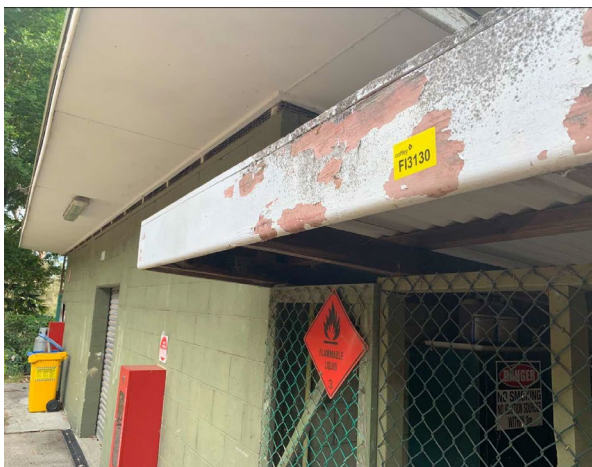
Line ID 50: External, Chemical Shed, Throughout, Trimwork, White Paint - Lead Detected (0.12% w/w)

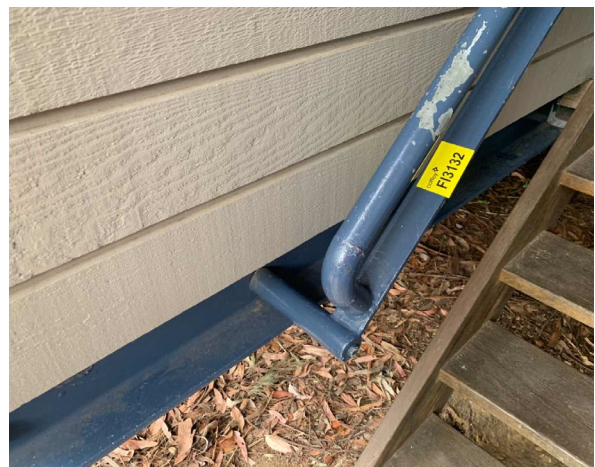
Line ID 51: External, Dorm Accommodation 1-12, Elevations, Metal, Support Structures, Trimwork and Handrails, Blue Paint - Lead Detected (0.01% w/w)

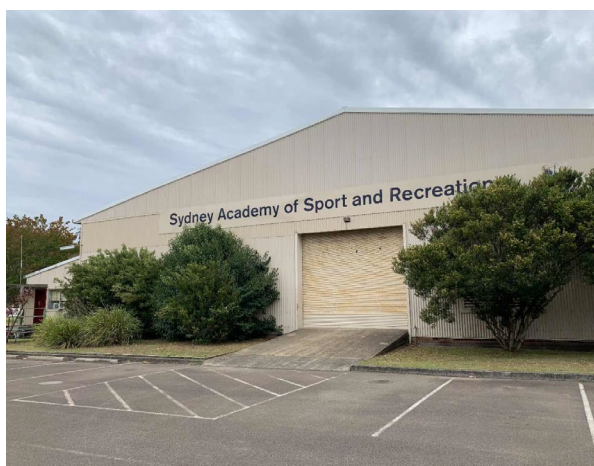
Line ID 52: External, Gymnasium, Building Perimeter, Guttering, Green Paint - Lead Detected (0.2% w/w)

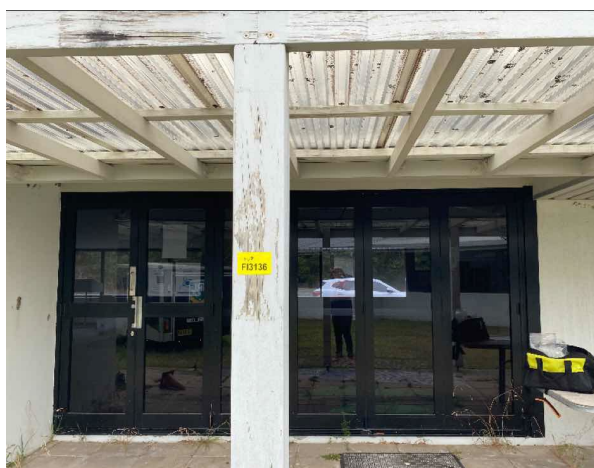
Line ID 56: External, Rugby Field Office, Perimeter, Timberwork, White Paint - Lead Detected (<0.005% w/w)

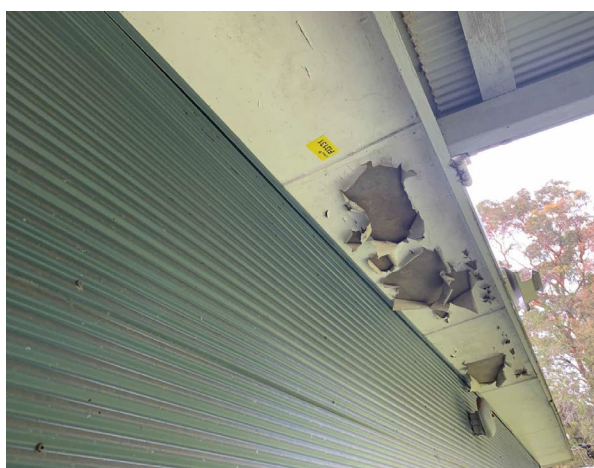
Line ID 58: External, Staff Accommodations (Five Domiciles), Elevations, Bilgoa, Eaves, White Paint - Lead Detected (0.41% w/w)

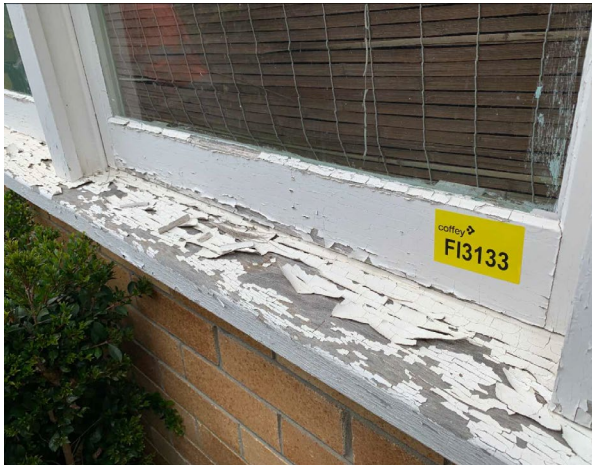
Line ID 60: External, Staff Residence #1 (South of Dining Dorm), Building Perimeter, Window Frames and Trimwork, White Paint - Lead Detected (0.72% w/w)

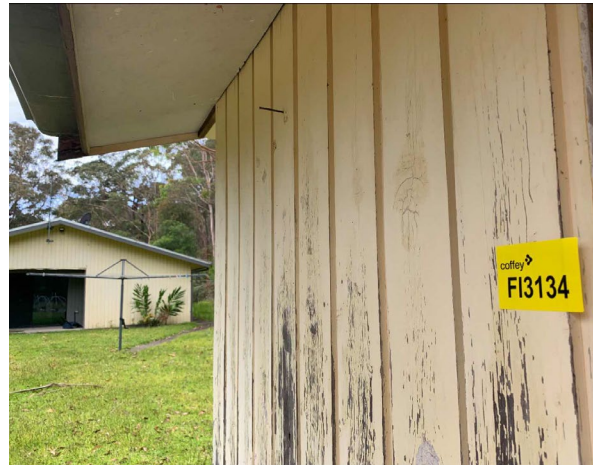
Line ID 61: External, Staff Residence #2 (West of Dining Room), Shed, Throughout, Yellow (Light) Paint - Lead Detected (<0.005% w/w)

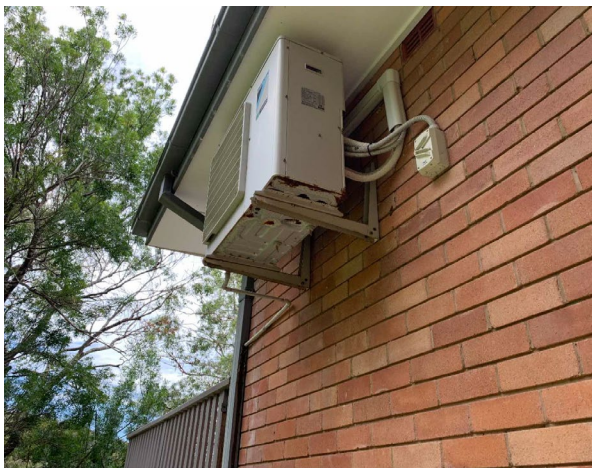
Line ID 62: External, Staff Residence #3 (West of Dining Dorm), Building Perimeter, Eaves, White Paint - Lead Detected (0.2% w/w)

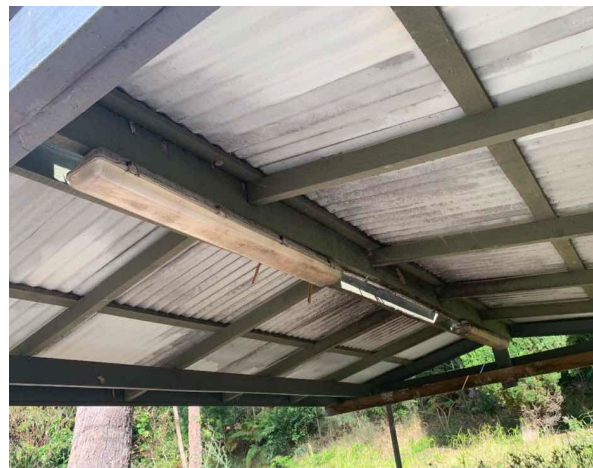
Line ID 64: External, The Compound, Gardeners Shed, Timber Framework, Brown Paint - Lead Detected (0.3% w/w)

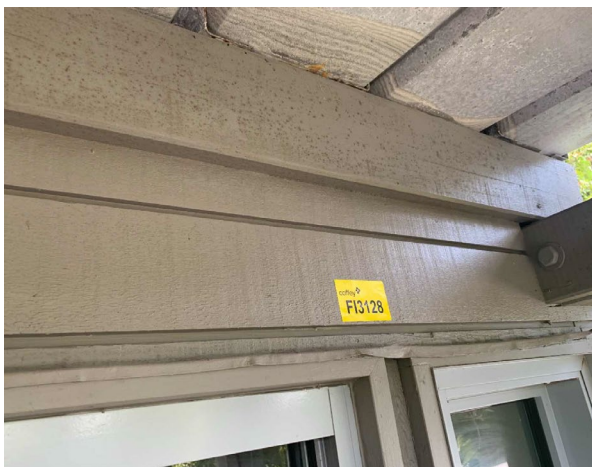
Line ID 65: Internal, Dorm Accommodation 1-12 (Former Staff Accom), Throughout, All Dorms, Fascia, Dark Green/Grey Paint - Lead Detected (0.02% w/w)

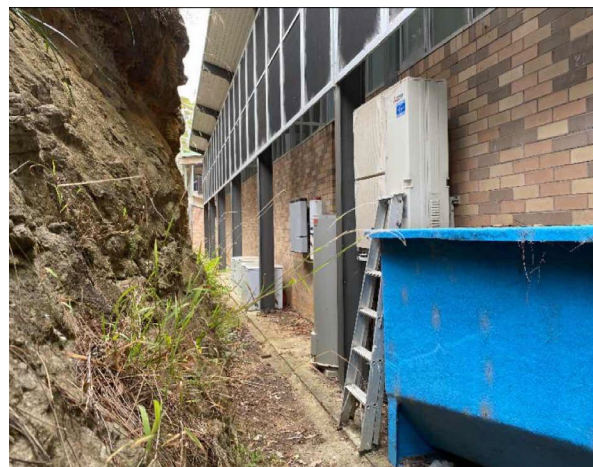
Line ID 68: External, Athletics Track Stand, South Wall, Hot Water Heater, Internal Insulation - Suspected SMF

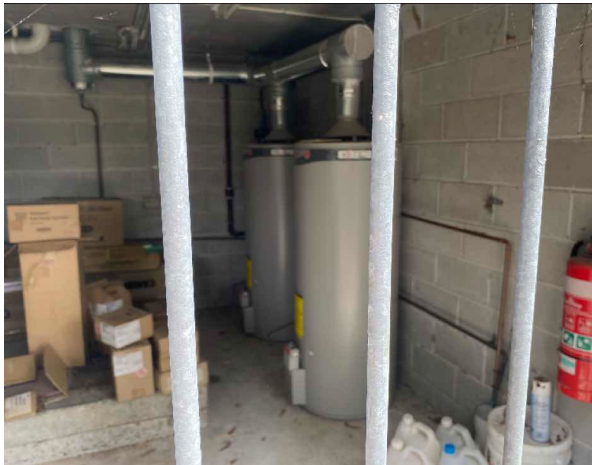
Line ID 69: External, Dining Dorm, Plant Rooms
Adjacent Car Park, Hot Water Heater, Internal
Insulation - Suspected SMF

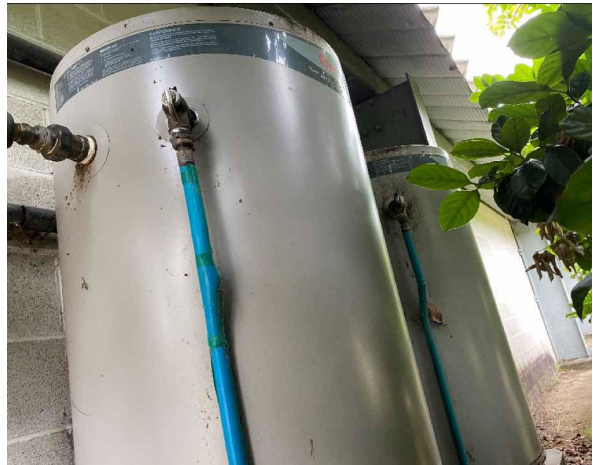
Line ID 70: External, Sea Eagles, Gym West Face, Hot
Water Units, Internal Insulation - Suspected SMF

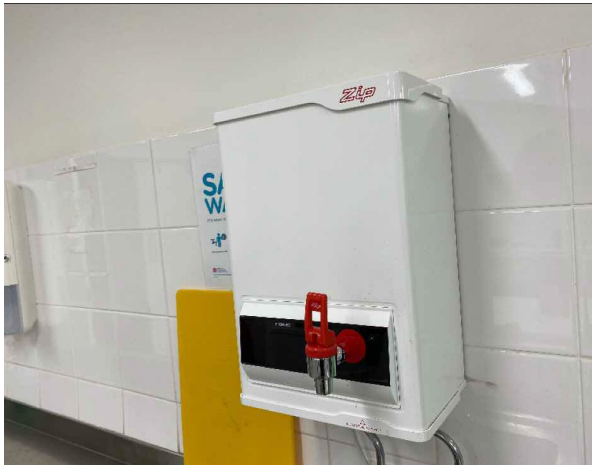
Line ID 71: Internal, Administration Building, Kitchen,
Zip Hot Water Unit, Internal Insulation - Suspected SMF

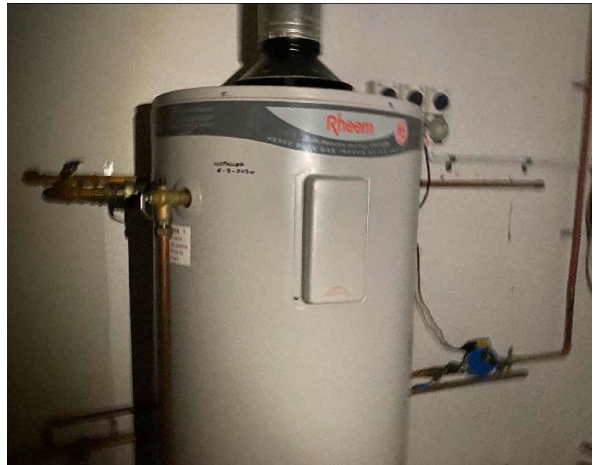
Line ID 72: Internal, Aquatics Facility, Plant Room, Rheem
Hot Water Unit, Internal Insulation - Suspected SMF

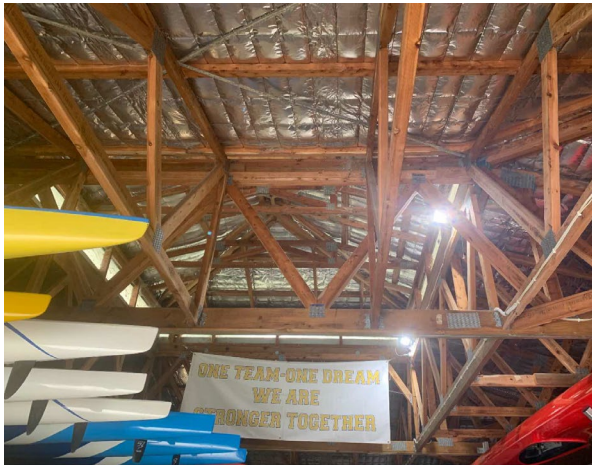
Line ID 75: Internal, Boat Shed, Throughout, Underside of Roof, Sarking Insulation - Suspected SMF

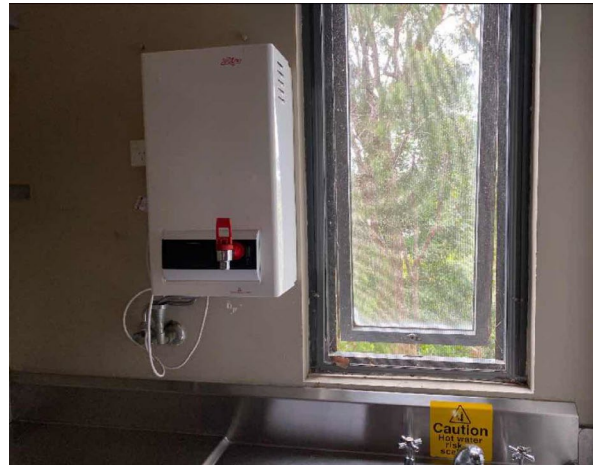
Line ID 76: Internal, Dining Dorm, Wash Area, Hot Water Heater, Internal Insulation - Suspected SMF

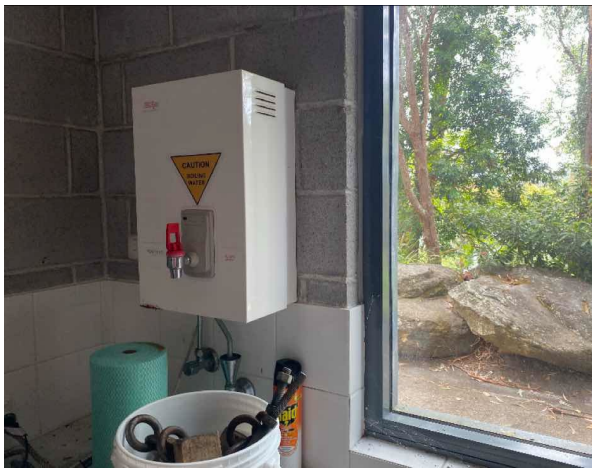
Line ID 77: Internal, Dining Dorm, Storeroom, Boiler, Internal Insulation - Suspected SMF

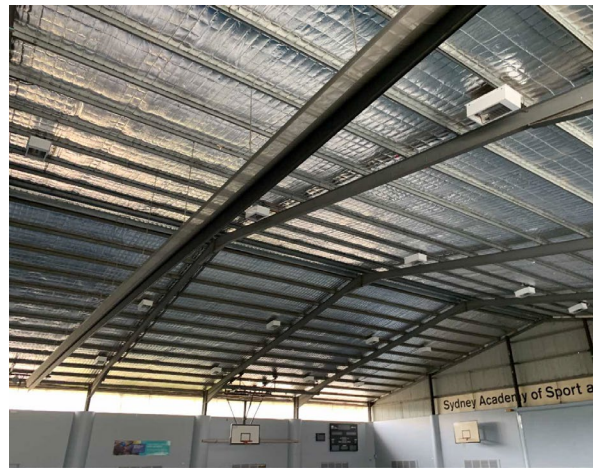
Line ID 78: Internal, Gymnasium, Basketball Court, Roof Lining, Sarking Insulation - Suspected SMF

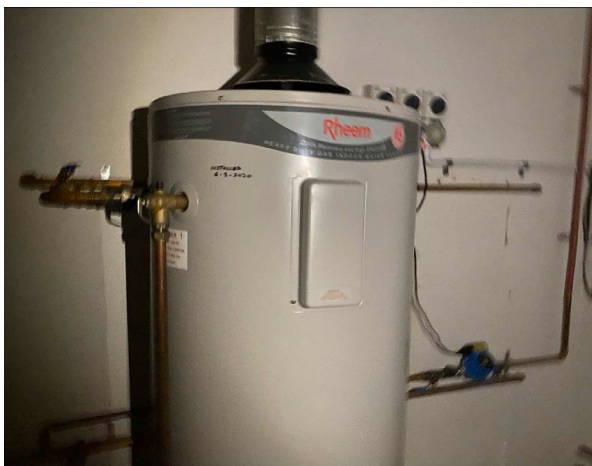
Line ID 79: Internal, Lecture Rooms and Motel Accommodation, Cleaners Storage Room, Hot Water Heater, Internal Insulation - Suspected SMF

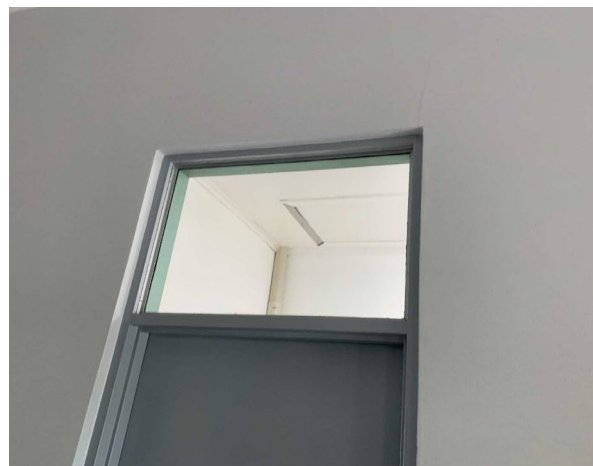
Line ID 80: Internal, Lecture Rooms and Motel Accommodation, Lecture Room, Ceiling Space, Insulation Material - Suspected SMF

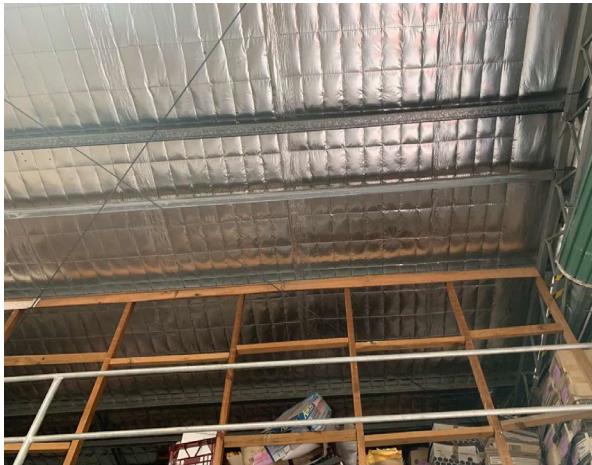
Line ID 81: Internal, Mower Room, Throughout, Underside of Roof, Sarking Insulation - Suspected SMF

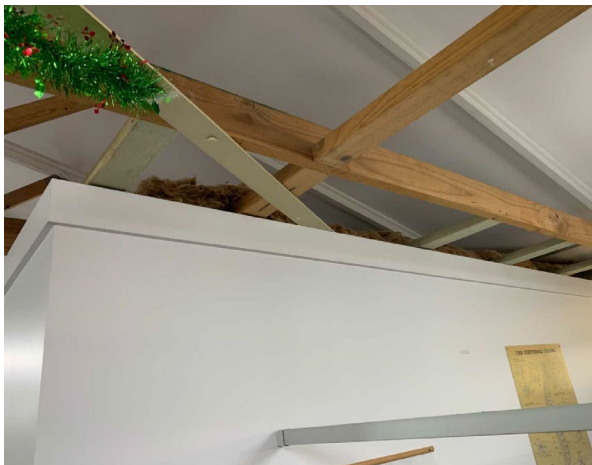
Line ID 83: Internal, Sports Science & Sports Medicine, Throughout, Underside of Roof, Sarking Insulation - None Suspected

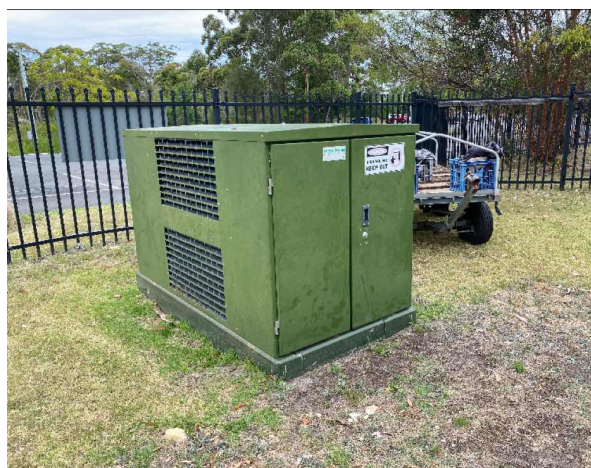
Line ID 87: External, Athletics Track Stand, Adjacent Toilet Side Entry Gate, Green Transformer, Ballast(s) - Suspected PCB

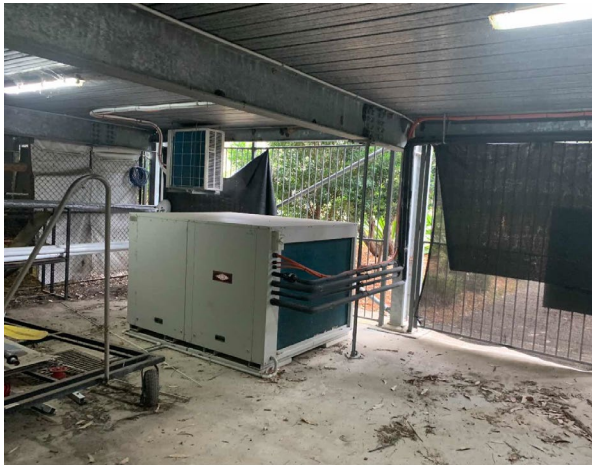
Line ID 88: External, Administration Office, Basement Carpark, Air Conditioning Unit, R22 Hydrochlorofluorocarbon (HCFC) - ODS Refrigerant

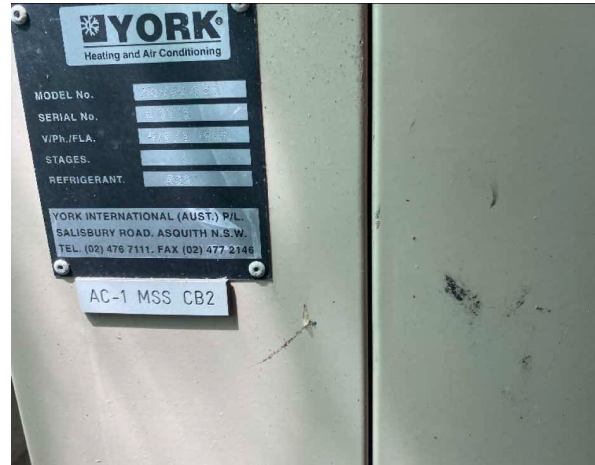
Line ID 89: External, Dining Dorm, Plant Rooms Adjacent Car Park, HVAC Units, R22 Hydrochlorofluorocarbon (HCFC) - ODS Refrigerant

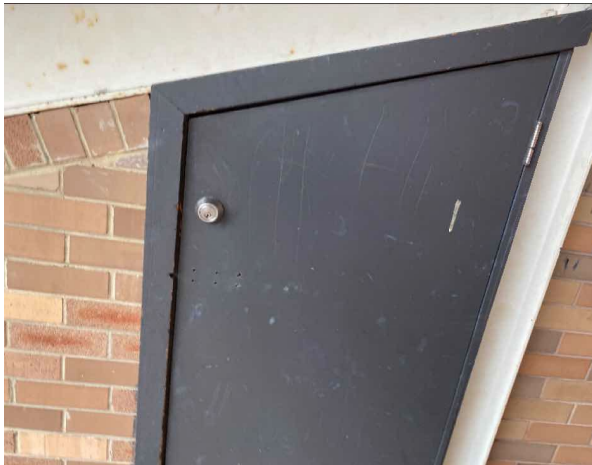
Line ID 90: External, Athletics Track Stand, Toilet Block, Sub-floor Entry Adjacent Toilets - Presumed to contain asbestos or hazardous materials
