Asbestos and Hazardous Materials Reinspection Assessment

Sydney International Equestrian Centre

28/03/2023

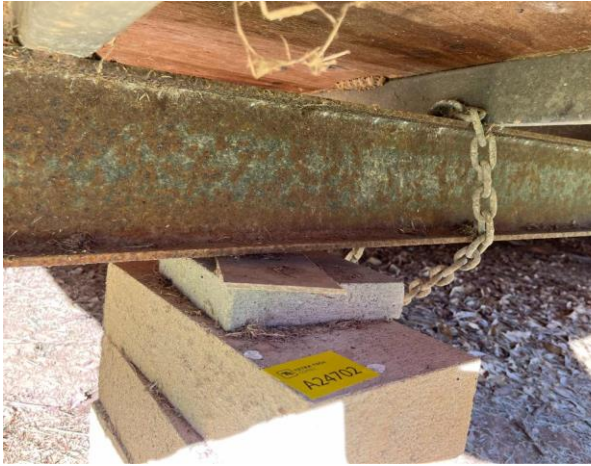
Line ID 1: External, Cabins, Throughout, Packers Under House, Fibre Cement Sheet - No Asbestos Detected

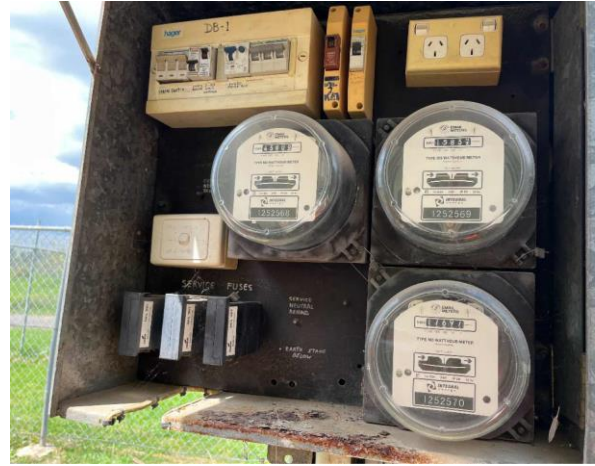
Line ID 2: External, Gardeners Shed, Electrical Box, Switchboard, HRC Fuses - Suspected Asbestos

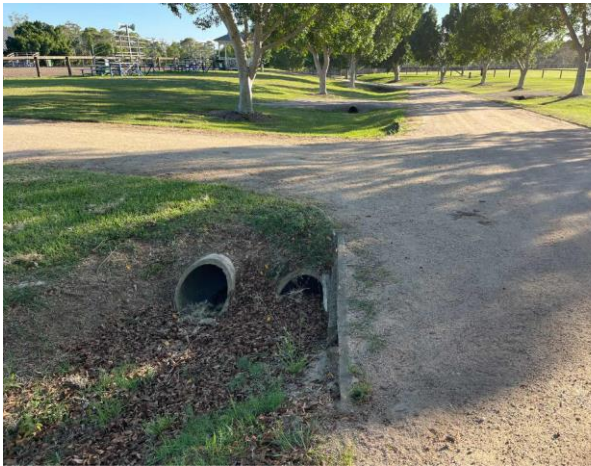
Line ID 3: External, Grounds Throughout, East of Arena 2, Drainage Pipes, Moulded Fibre Cement - No Asbestos Detected

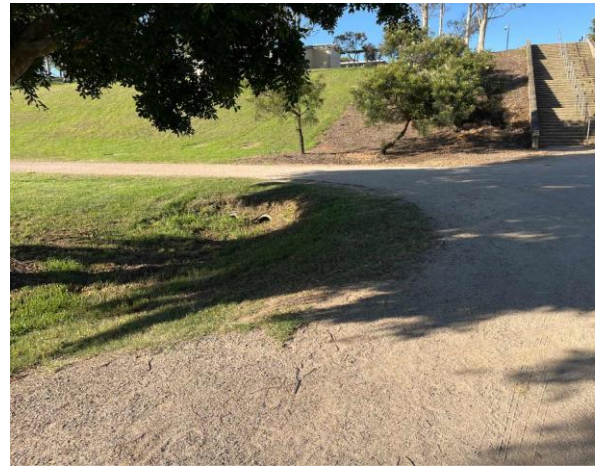
Line ID 3.1: External, Grounds Throughout, East of Arena 2, Drainage Pipes, Moulded Fibre Cement - No Asbestos Detected

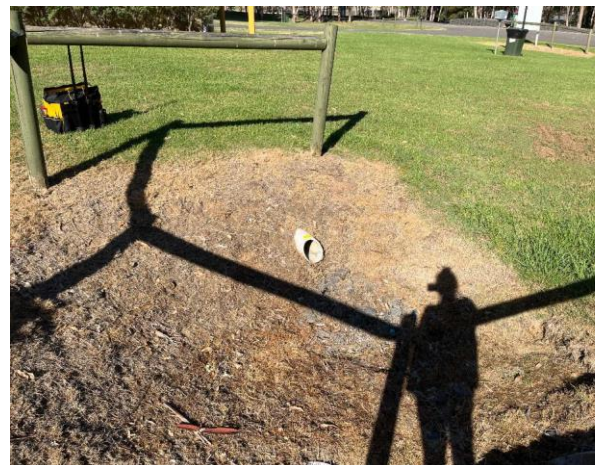
Line ID 5: External, Grounds Throughout, North Side of Cabins, Small Drainage Pipes, Compressed Cement Sheet - No Asbestos Detected

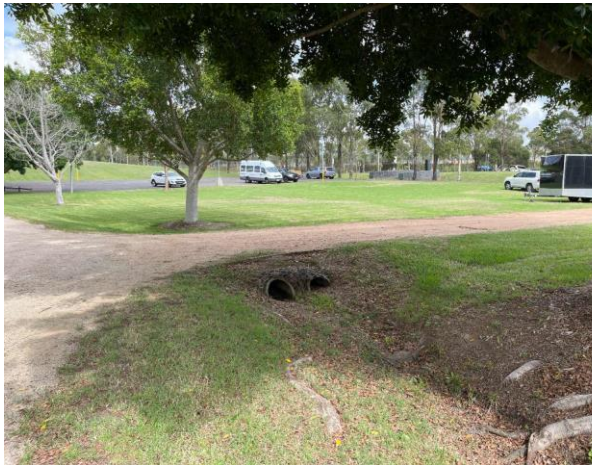
Line ID 6: External, Grounds Throughout, South of Indoor Arena, Drainage Pipes, Moulded Fibre Cement - No Asbestos Detected

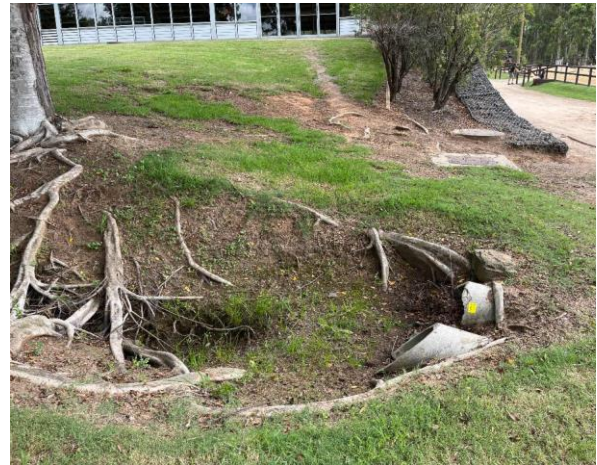
Line ID 6.1: External, Grounds Throughout, South of Indoor Arena, Drainage Pipes, Moulded Fibre Cement - No Asbestos Detected

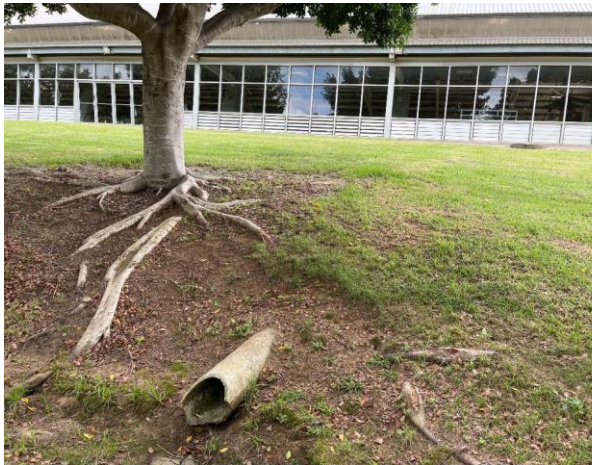
Line ID 7: External, Grounds Throughout, South of Indoor Arena, Smaller Drainage Pipe, Fibre Cement Sheet - No Asbestos Detected

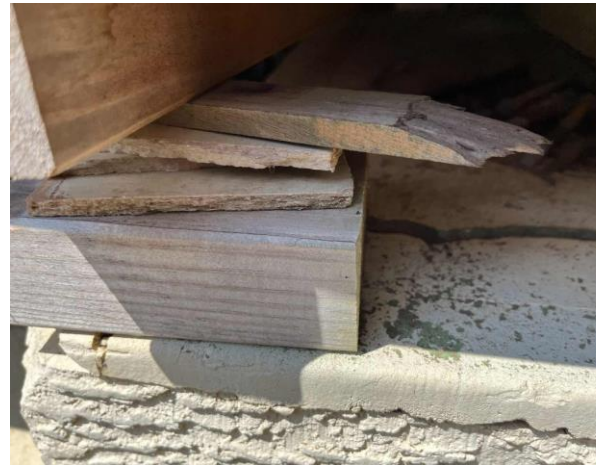
Line ID 8: External, House, Backyard, Packers Under Deck, Fibre Cement Sheet - No Asbestos Detected

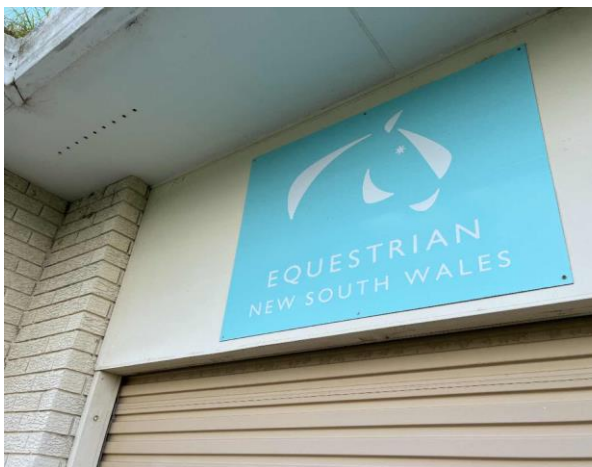
Line ID 9: External, House, Front of House, Above Garage Door, Infill Panel, Fibre Cement Sheet - No Asbestos Detected

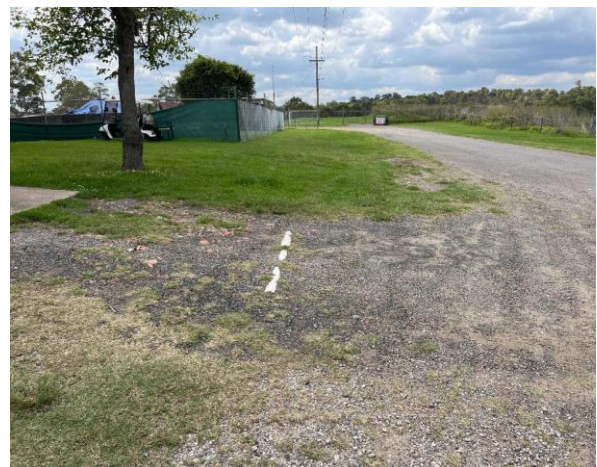
Line ID 10: External, House, Front of House, Driveway, Pipework, Fibre Cement Sheet - Chrysotile, Amosite and Crocidolite Asbestos Detected

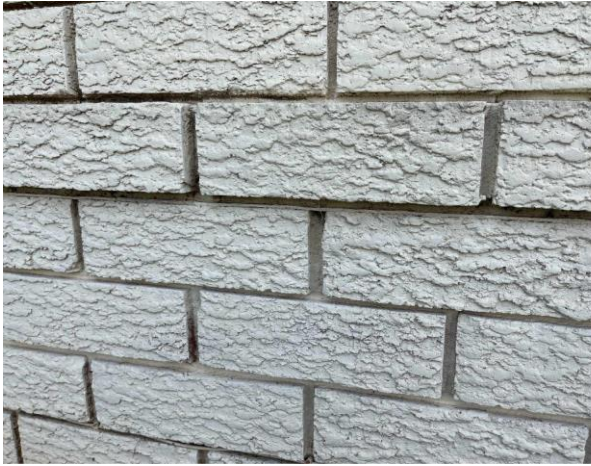
Line ID 11: External, House, Perimeter, Damp Proof Course to Brickwork, Waterproof Membrane - No Asbestos Detected

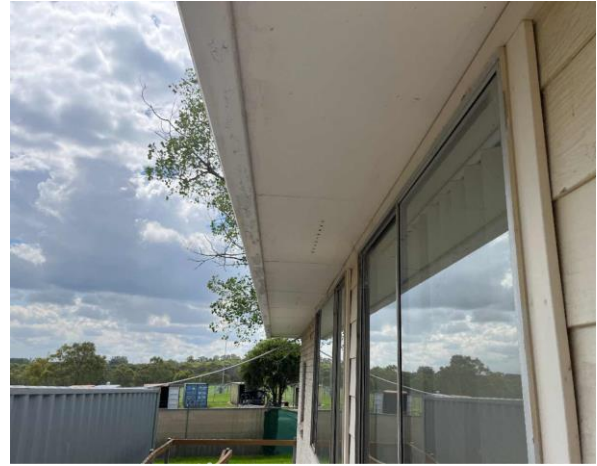
External	House / Perimeter / Damp Proof Course to Brickwork	Waterproof Membrane	Asbestos	A24674	No Asbestos Detected	-	50 m	-	-	-	11
External	House / Perimeter / Eaves	Fibre Cement Sheet	Asbestos	A24668	Chrysotile Asbestos Detected	Non-Friable	40 m	Low	5 Yearly Reinspection	Label as containing asbestos and maintain in current condition if to remain in-situ. Remove under controlled non-friable asbestos removal conditions prior to refurbishment or demolition works by a Class B	12

Line ID 12: External, House, Perimeter, Eaves, Fibre Cement Sheet - Chrysotile Asbestos Detected

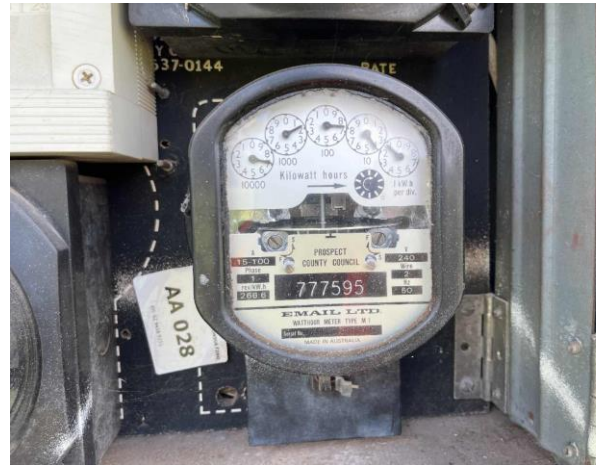
Line ID 14: External, House, Perimeter, Meter Box, Mastic Sealant to Meter - Suspected Asbestos

External	House / Perimeter / Meter Box	Mastic Sealant to Meter	Asbestos	754-SYDEN311850 Equestrian Centre168A8	Suspected Asbestos	Non-Friable	3 Units	Low	5 Yearly Reinspection	Confirm status, label as containing asbestos and maintain in current condition if to remain in-sit in accordance with relevant State Regulations, Compliance Codes, Codes of Practice and Guidance Notes. Remove under controlled non-friable asbestos removal conditions prior to refurbishment or demolition works by a Class B (non-friable) licensed asbestos removal contractor in accordance with relevant State Regulations, Compliance Codes, Codes of Practice and Guidance Notes.	14
External	House / Perimeter / South Corner, on Floor	Debris	Asbestos	A24673	No Asbestos Detected	-	1 m ²	-	-	-	15

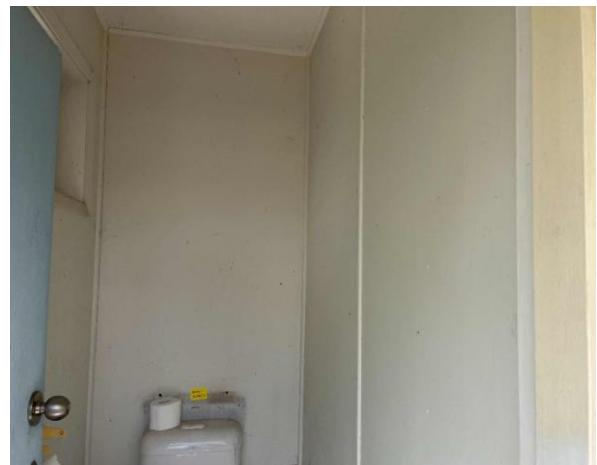
Line ID 17: External, House, Perimeter, Toilets, Walls and Ceilings, Fibre Cement Sheet - Chrysotile Asbestos Detected

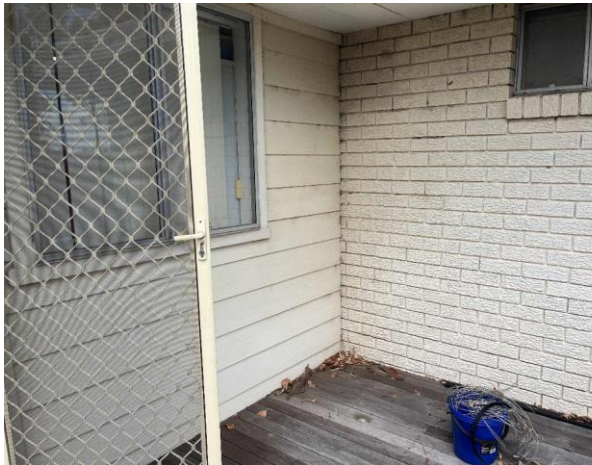
Line ID 18: External, House, Perimeter, Walls, Weatherboard Cladding, Fibre Cement Sheet - No Asbestos Detected

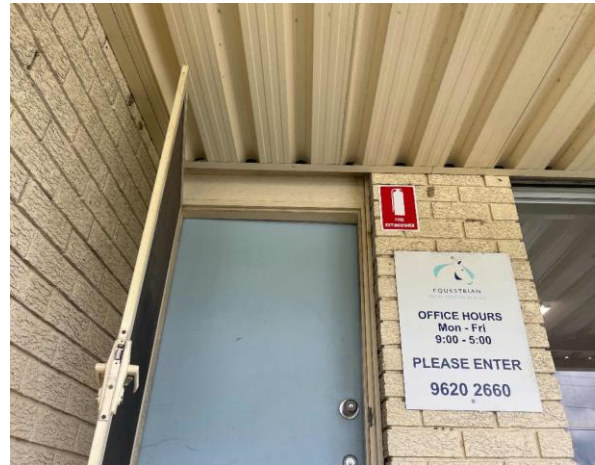
Line ID 18.1: External, House, Perimeter, Walls, Weatherboard Cladding, Fibre Cement Sheet - No Asbestos Detected

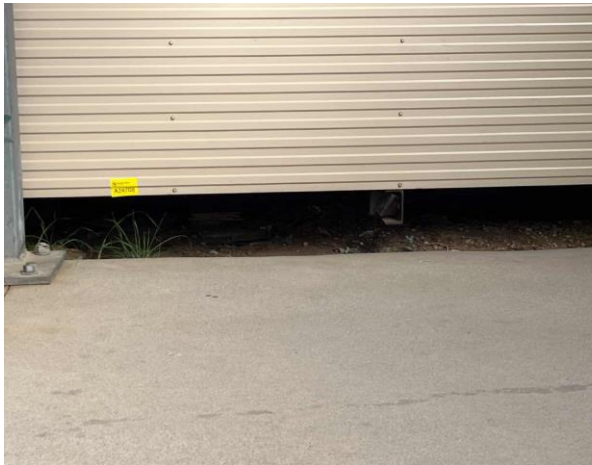
Line ID 19: External, Riders Retreat, First Aid Room, Packers Under Floor, Fibre Cement Sheet - No Asbestos Detected

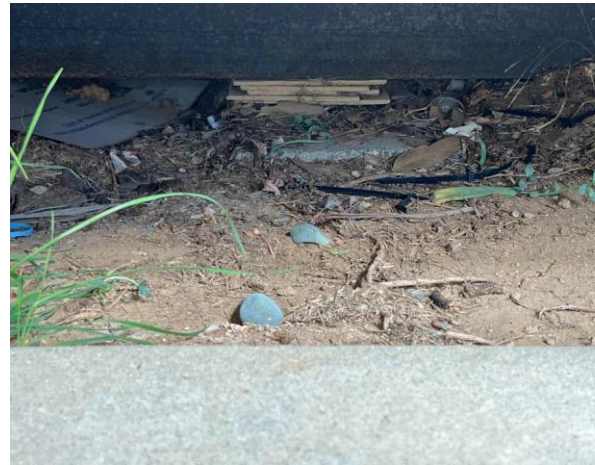
Line ID 19.1: External, Riders Retreat, First Aid Room, Packers Under Floor, Fibre Cement Sheet - No Asbestos Detected

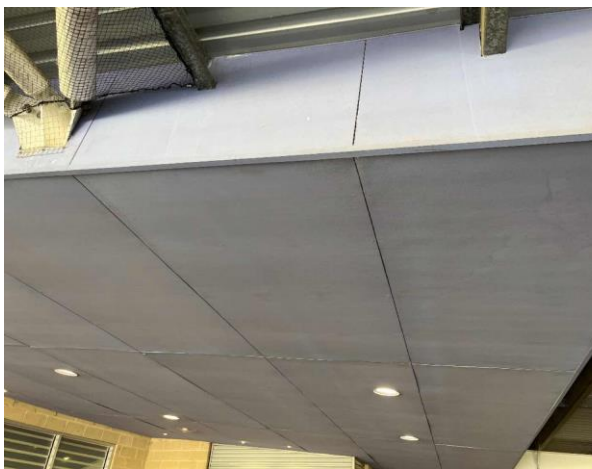
Line ID 20: External, Venue Office, Throughout, Fascia and Ceiling, Fibre Cement Sheet - No Asbestos Detected

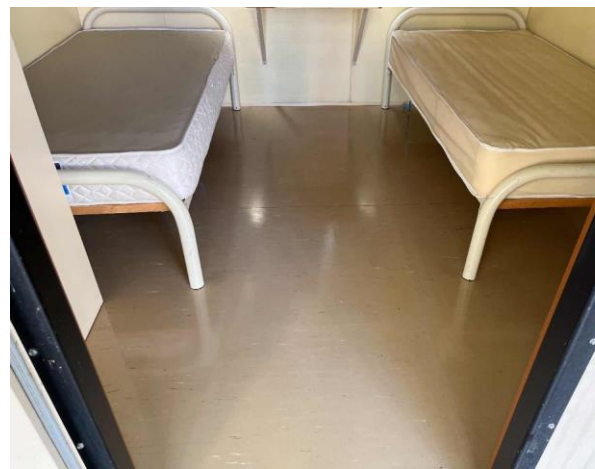
Line ID 21: Internal, Cabins, Bedrooms, Floor Covering Throughout, Beige Vinyl Sheet - No Asbestos Detected

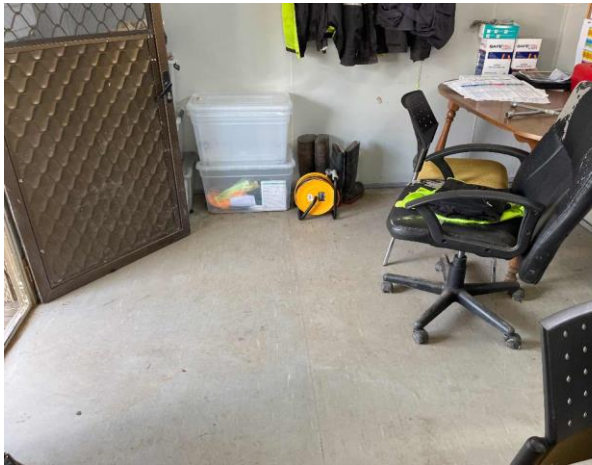
Line ID 23: Internal, Gardener's Shed, Lunch Shed, Floor Covering, Blue Vinyl Sheet - No Asbestos Detected

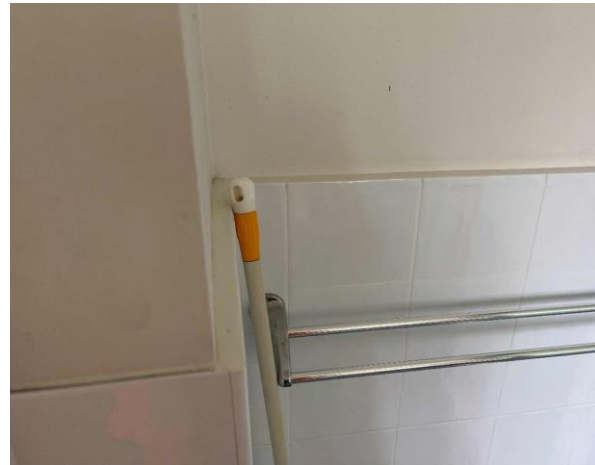
Line ID 24: Internal, House, Bathroom, Walls Behind Tiles, Fibre Cement Sheet - Suspected Asbestos

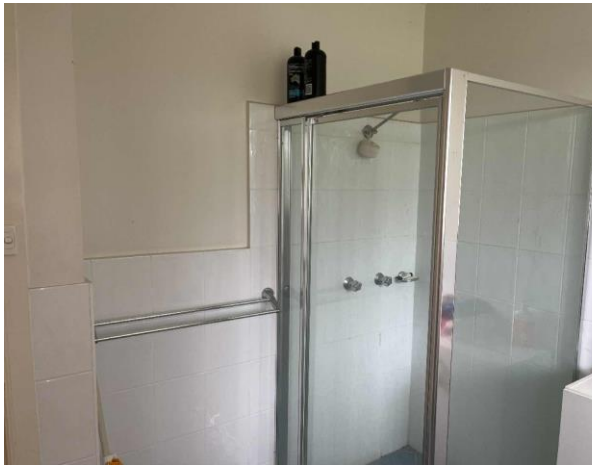
Line ID 24.1: Internal, House, Bathroom, Walls Behind Tiles, Fibre Cement Sheet - Suspected Asbestos

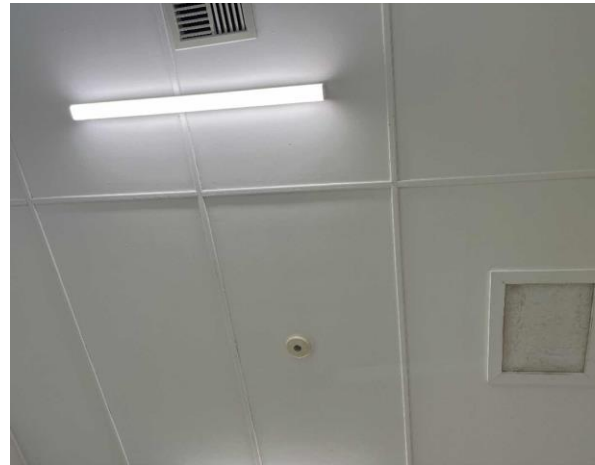
Internal	House / Board Room / Ceiling	Fibre Cement Sheet	Asbestos	A24664	Chrysotile Asbestos Detected	Non-Friable	15 m ²	Low	5 Yearly Reinspection	Label as containing asbestos and maintain in current condition if to remain in-situ. Remove under controlled non-friable asbestos removal conditions prior to refurbishment or demolition works by a Class B (non-friable) licensed asbestos removal contractor in accordance with relevant State Regulations, Compliance Codes, Codes of Practice and Guidance Notes.	25
Internal	House / Board Room / Ceiling Space	Dust	Asbestos	A24666	No Asbestos Detected	-	100 m ²	-	-	-	26

Line ID 25: Internal, House, Board Room, Ceiling, Fibre Cement Sheet - Chrysotile Asbestos Detected

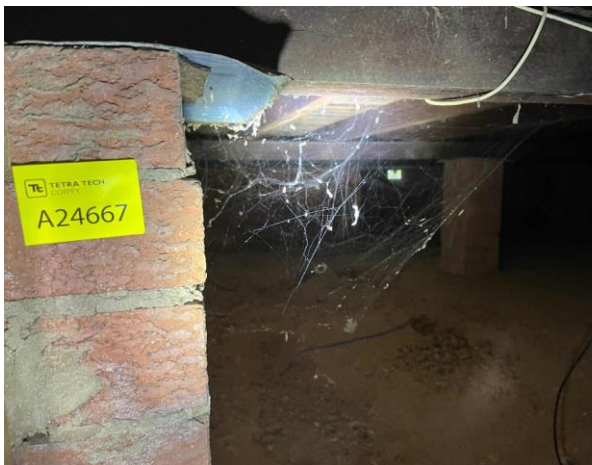
Line ID 27: Internal, House, Board Room, Sub Floor, Bituminous Packers - No Asbestos Detected

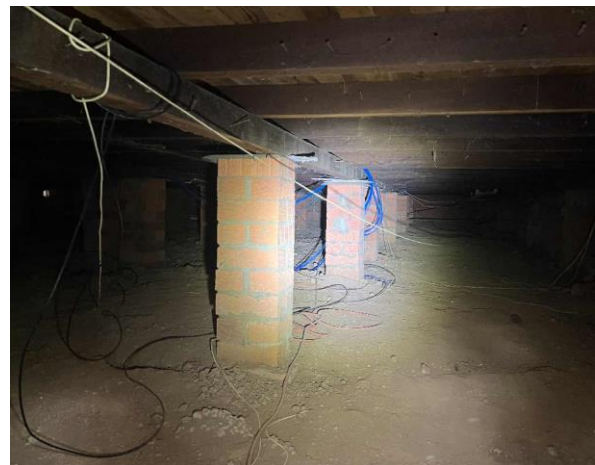
Line ID 28: Internal, House, Board Room, Sub Floor Packers, Fibre Cement Sheet - Suspected Asbestos

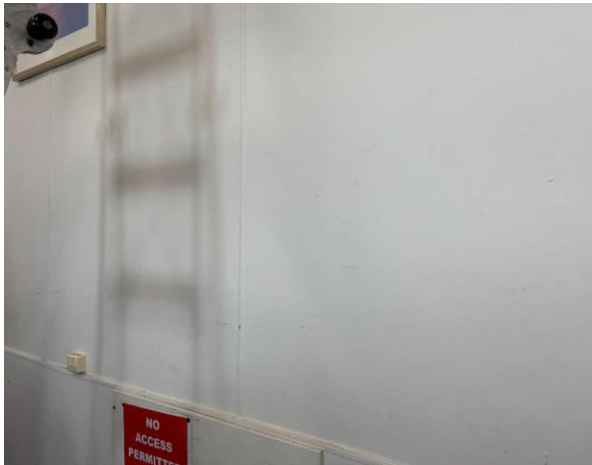
Line ID 29: Internal, House, Board Room, Western Wall, Fibre Cement Sheeting - No Asbestos Detected

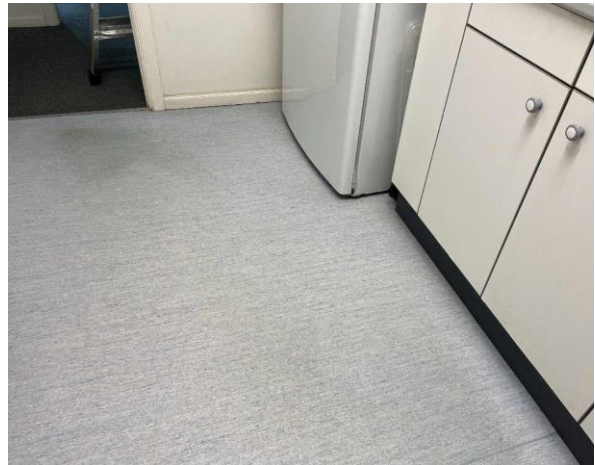
Line ID 30: Internal, House, Kitchen, Floor Covering, Blue Vinyl Sheet - No Asbestos Detected

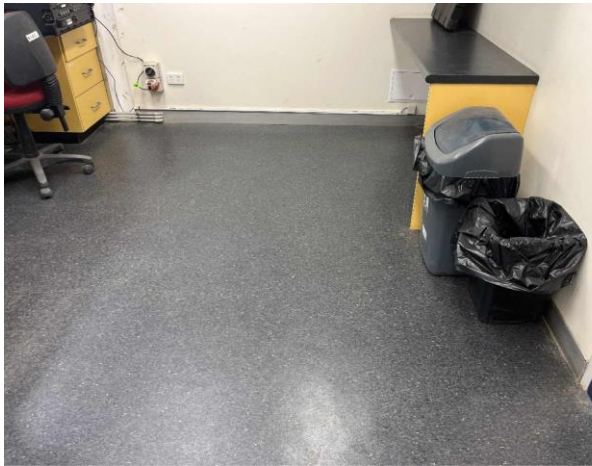
Line ID 31: Internal, Indoor Arena, Judges Office, Floor Covering, Grey Vinyl Sheet - No Asbestos Detected

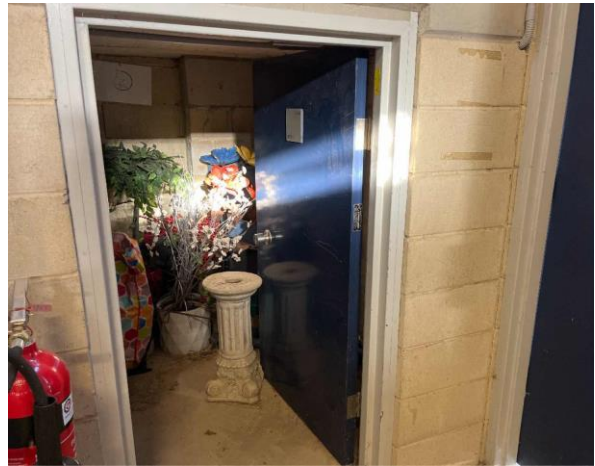
Line ID 32: Internal, Main Arena 1, Eastern Storage Area, Door to E.05, E.04 and E.03, Fire Door Core - Suspected Asbestos

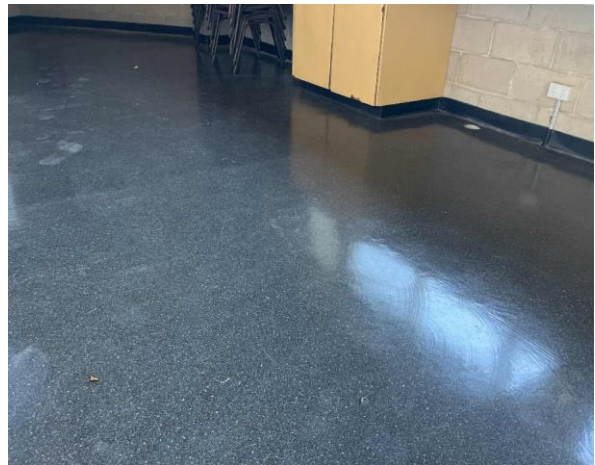
Line ID 33: Internal, Main Arena 1, Eastern Storage Area, E.03 Floor Covering, Black Vinyl Sheet - No Asbestos Detected

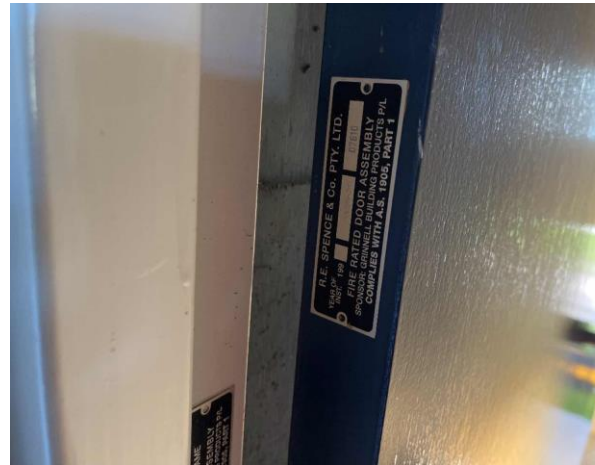
Line ID 36: Internal, Main Arena 1, Western Storage Area, Door to F.06, F.03 and F.05, Fire Door Core - Suspected Asbestos

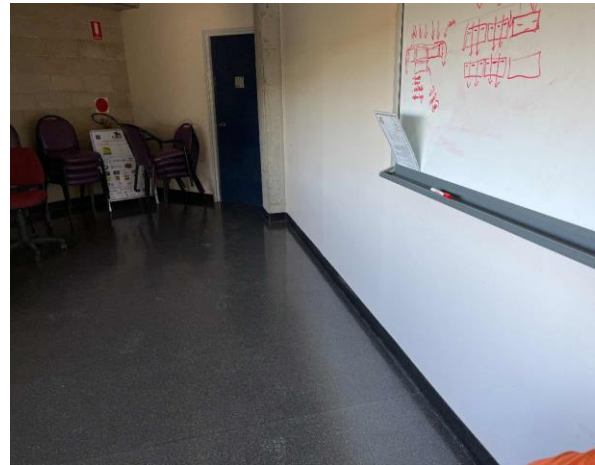
Line ID 38: Internal, Main Arena 1, Western Storage Area, F.03 Skirting, Black Vinyl Sheet - No Asbestos Detected

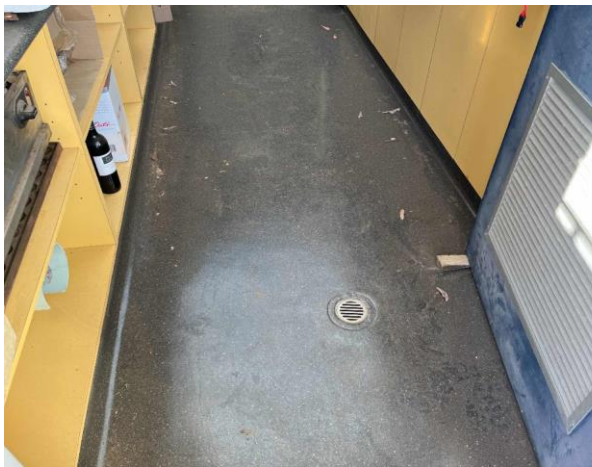
Line ID 39: Internal, Main Arena 1 West Amenities, C.06 Canteen, Floor Covering, Black Vinyl Sheet - No Asbestos Detected

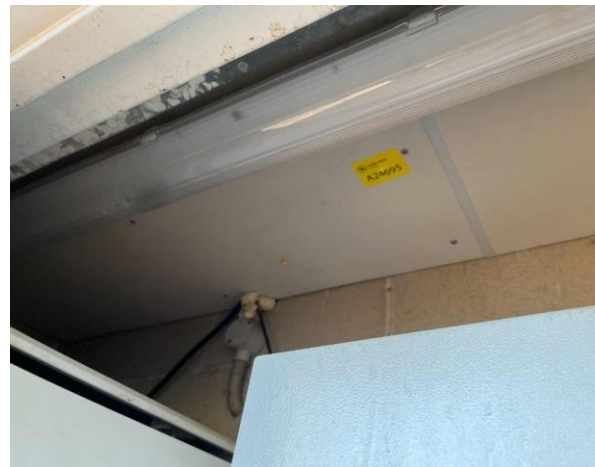
Line ID 40: Internal, Main Arena 1 West Amenities, C.08 Store, Ceiling, Fibre Cement Sheetting - No Asbestos Detected

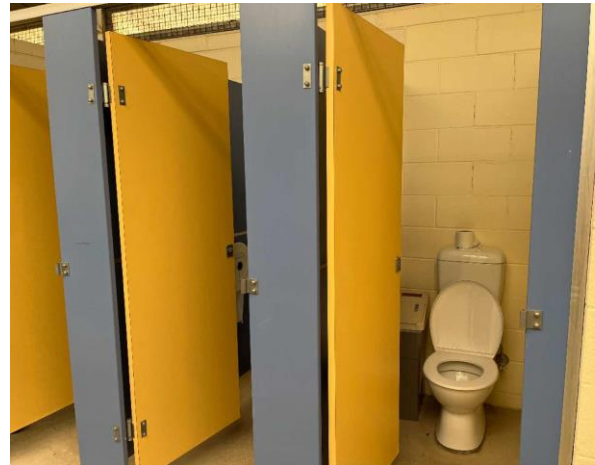
Line ID 42: Internal, Main Arena 1 West Amenities, Female Toilets, Partition Walls, Fibre Cement Sheet - No Asbestos Detected

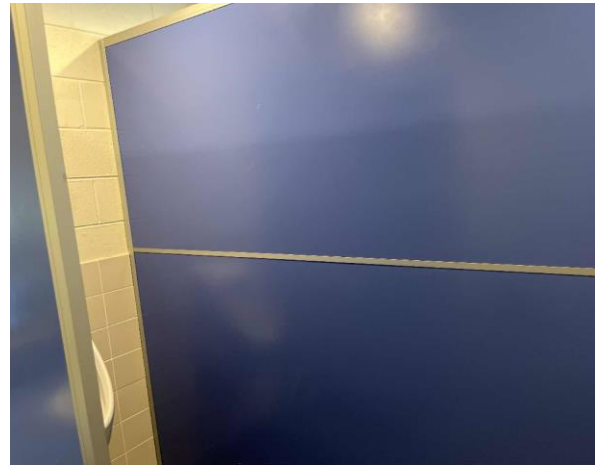
Line ID 44: Internal, Riders Retreat, Bathrooms, Cubicle Partition Walls, Fibre Cement Sheet - No Asbestos Detected

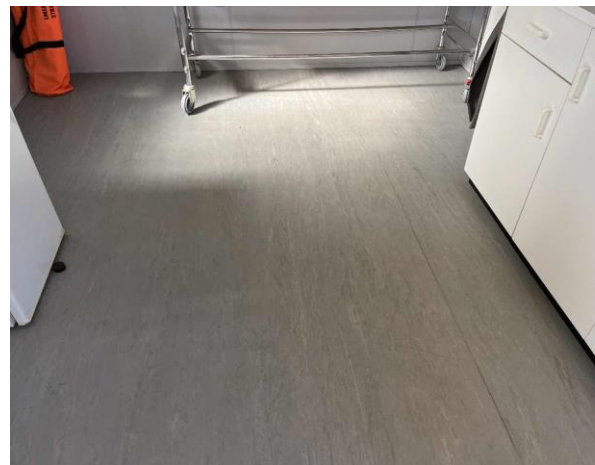
Line ID 46: Internal, Riders Retreat, First Aid Room, Floor Covering, Blue Vinyl Sheet - No Asbestos Detected

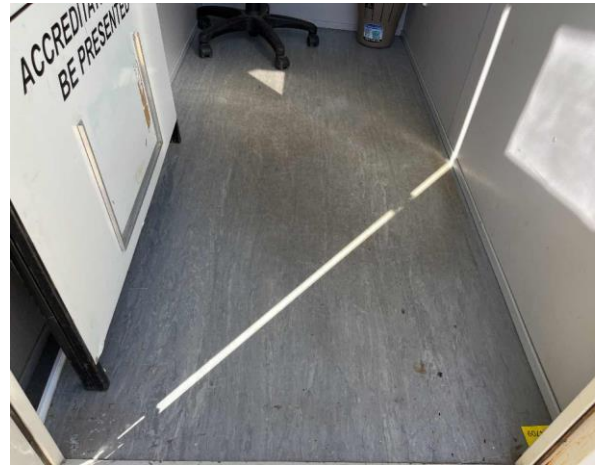
Line ID 48: Internal, Security Hunts on Road, Throughout, Floor Covering, Grey Vinyl Sheet - No Asbestos Detected

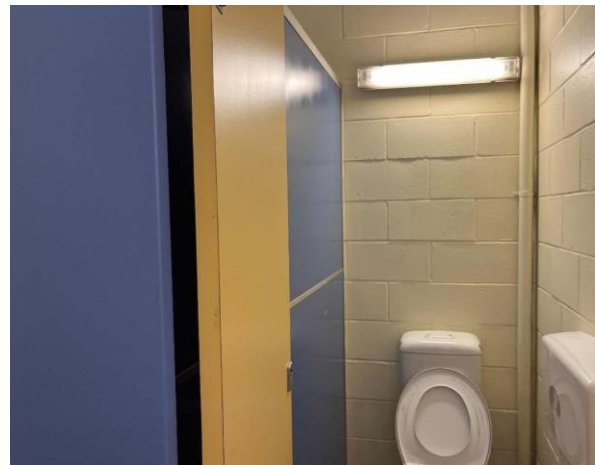
Line ID 50: Internal, Stables, Amenities, Cubicle Partition Walls, Fibre Cement Sheet - No Asbestos Detected

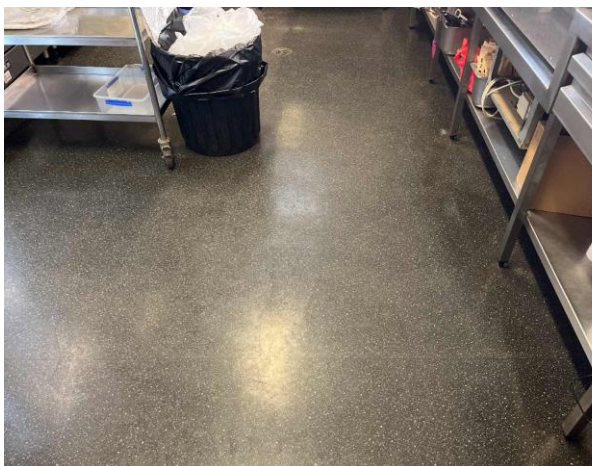
Line ID 51: Internal, Venue Office, Canteen, Floor Covering, Grey Vinyl Sheet - No Asbestos Detected

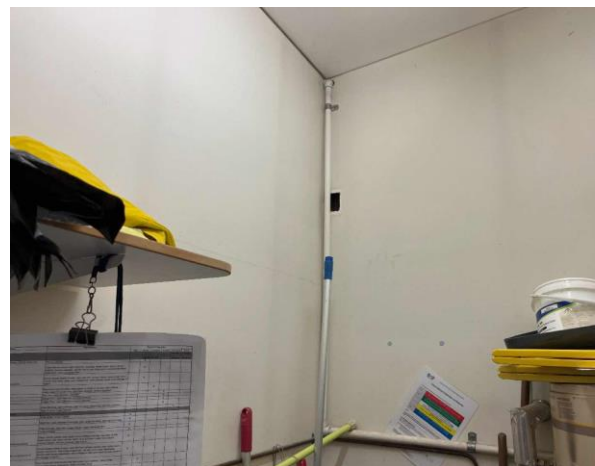
Line ID 52: Internal, Venue Office, Cleaners Store A.10, Walls, Fibre Cement Sheeting - No Asbestos Detected

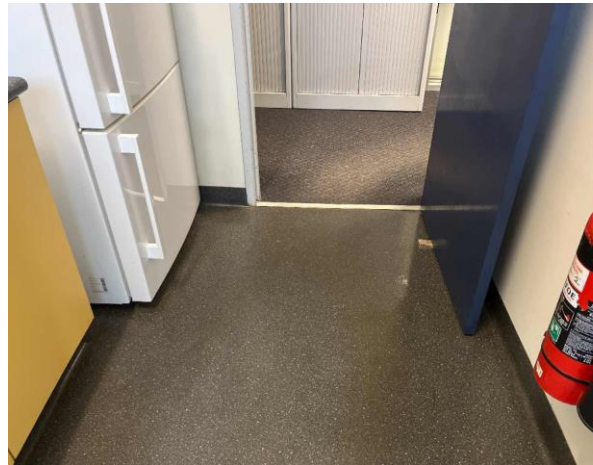
Line ID 54: Internal, Venue Office, Kitchen, Floor Covering, Grey Vinyl Sheet - No Asbestos Detected

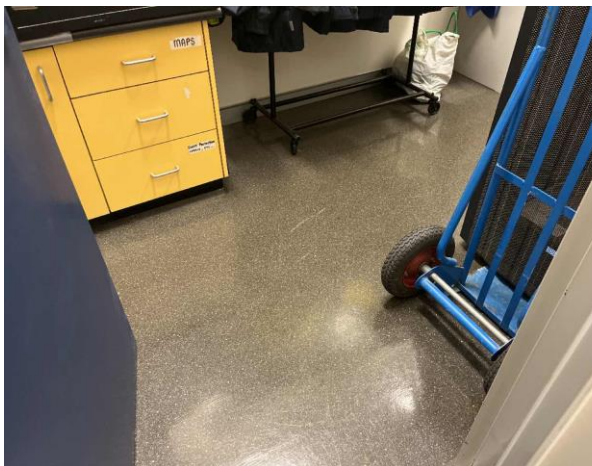
Line ID 55: Internal, Venue Office, Office A.02, Floor Covering, Grey Vinyl Sheet - No Asbestos Detected

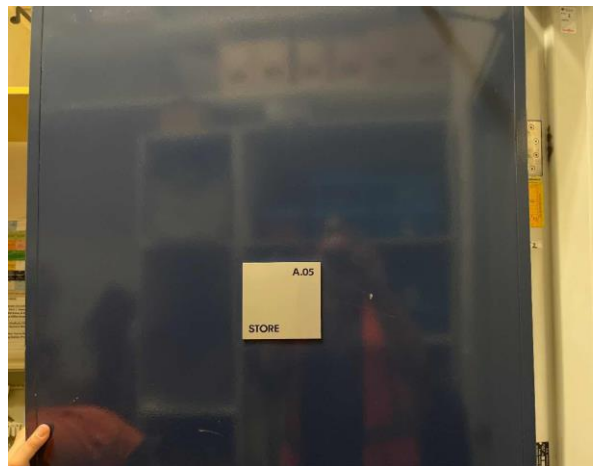
Line ID 56: Internal, Venue Office, Office A.05, Fire Door, Fire Door Core - Suspected Asbestos

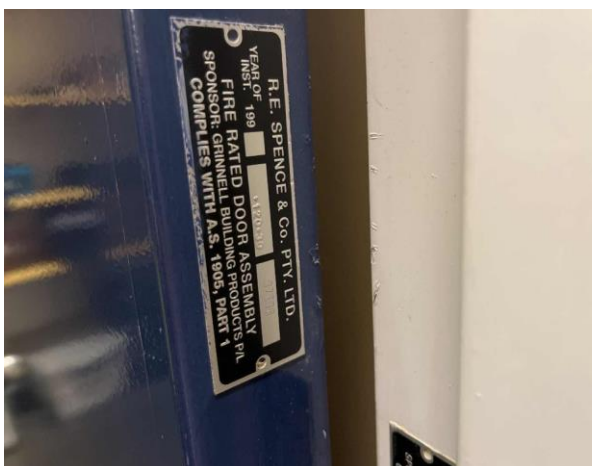
Line ID 56.1: Internal, Venue Office, Office A.05, Fire Door, Fire Door Core - Suspected Asbestos

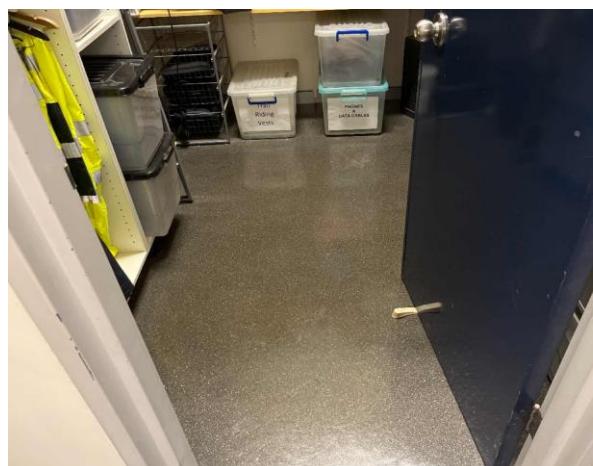
Line ID 57: Internal, Venue Office, Office A.05, Floor Covering, Grey Vinyl Sheet - No Asbestos Detected

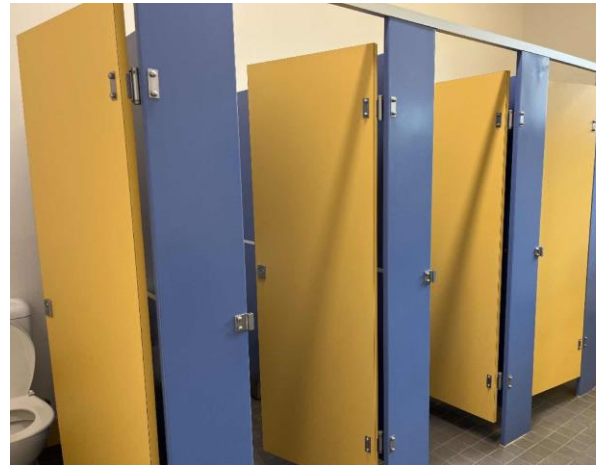
Line ID 59: Internal, Venue Office, Toilets, Cubicle Walls, Compressed Cement Sheeting - No Asbestos Detected

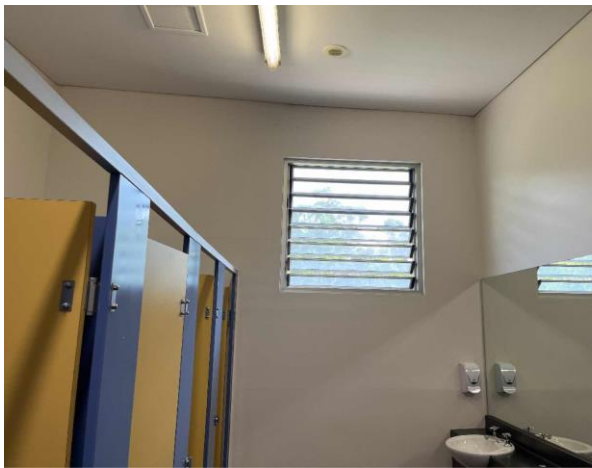
Line ID 60: Internal, Venue Office, Toilets, Walls, Fibre Cement Sheeting - No Asbestos Detected

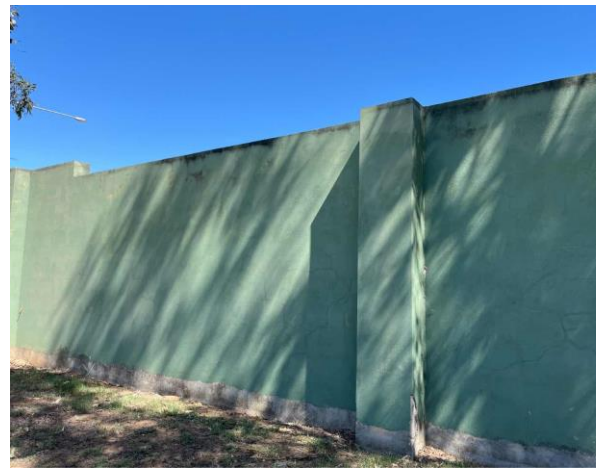
Line ID 61: External, Grounds Throughout, Perimeter, North and West Walls, Green Paint - Lead Detected (<0.005% w/w)

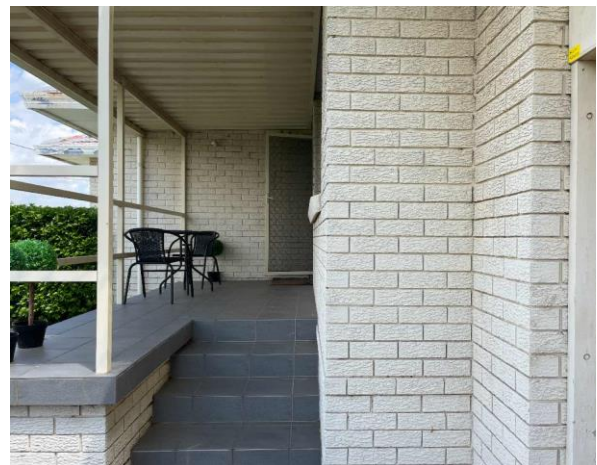
Line ID 64: External, House, Perimeter, Walls and Old Stairs, Cream Paint - Lead Detected (<0.005% w/w)

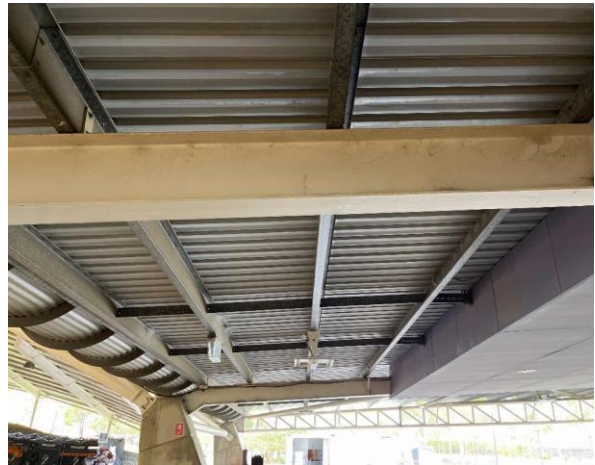
Line ID 65: External, Indoor Arena, Throughout, Beams, White Paint - Lead Detected (<0.005% w/w)

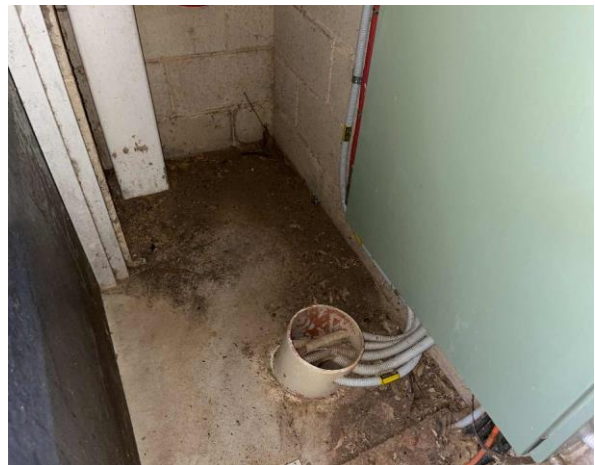
Line ID 68: Internal, Stables, Amenities, EB.05, Floor, Dust - Lead Detected (8 mg/kg)

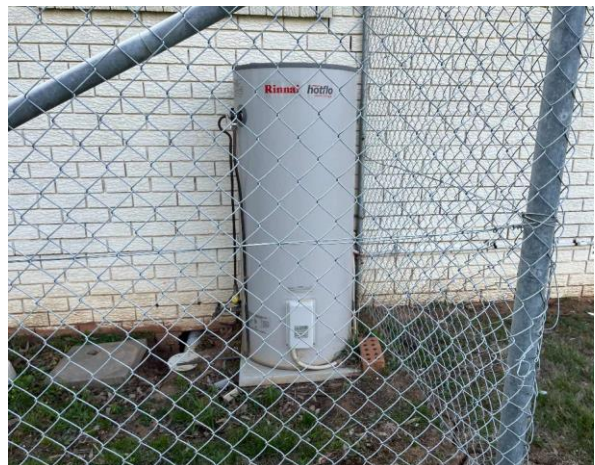
Line ID 70: External, House, Perimeter, Hot Water Heater, Insulation Material - Suspected SMF

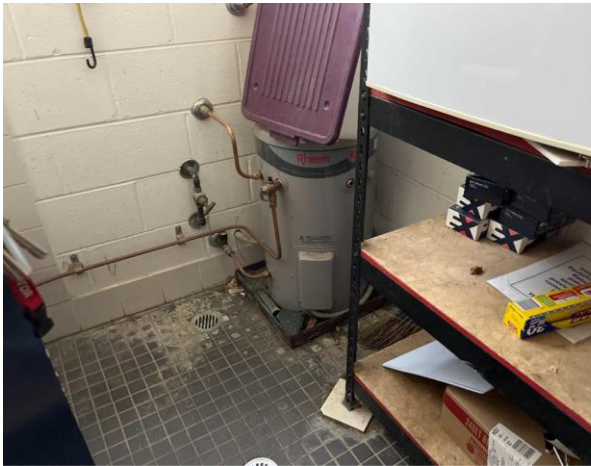
Line ID 75: Internal, Riders Retreat, Bathrooms, Cleaners Store, Hot Water Heater, Internal Insulation - Suspected SMF

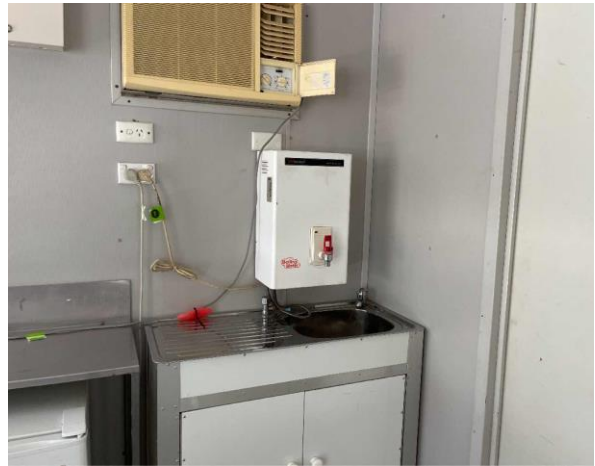
Line ID 76: Internal, Riders Retreat, Event Office, Above Sink, Hot Water Boiler, Internal Insulation - Suspected SMF

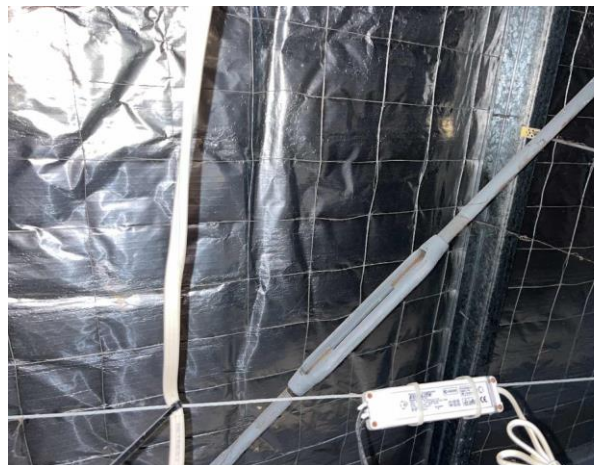
Line ID 78: Internal, Riders Retreat, Throughout, Ceiling Space, Sarking Insulation - Suspected SMF

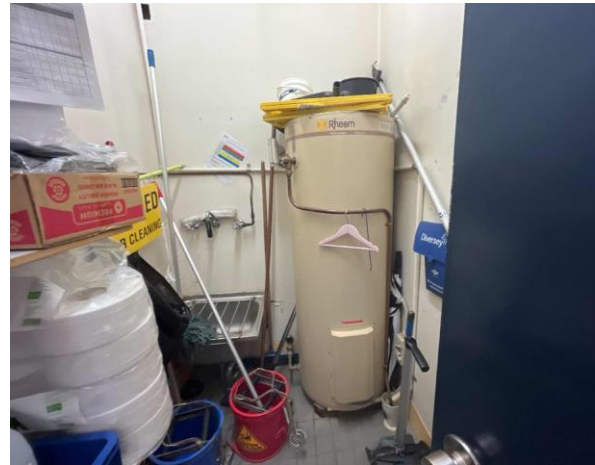
Line ID 81: Internal, Venue Office, Cleaners Store A.10, Hot Water Heater, Internal Insulation - Suspected SMF

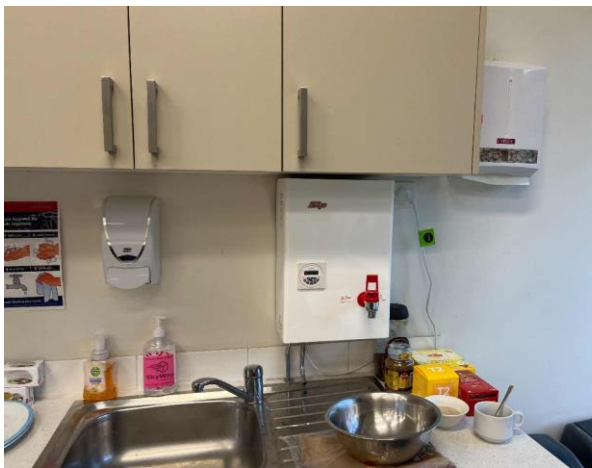
Line ID 82: Internal, Venue Office, Conference Room, Hot Water Boiler, Internal Insulation - Suspected SMF

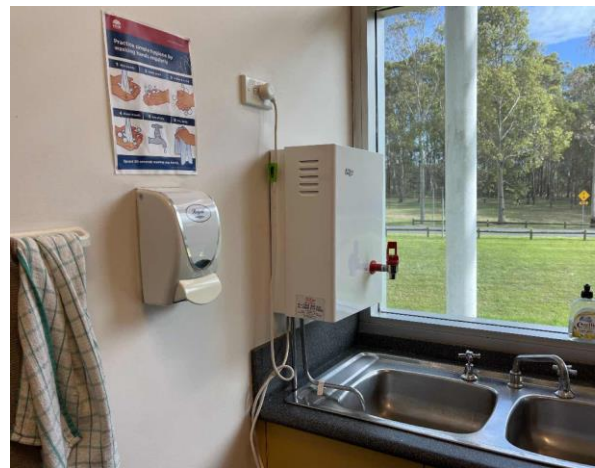
Line ID 84: Internal, Venue Office, Kitchen, Above Sink, Boiler, Internal Insulation - Suspected SMF

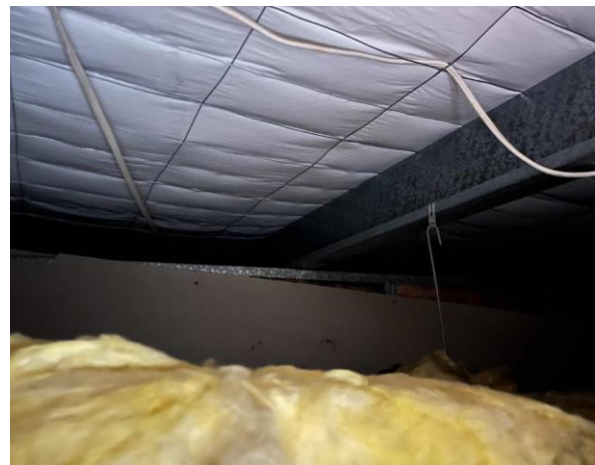
Line ID 86: Internal, Venue Office, Throughout, Ceiling, Insulation Batts - Suspected SMF

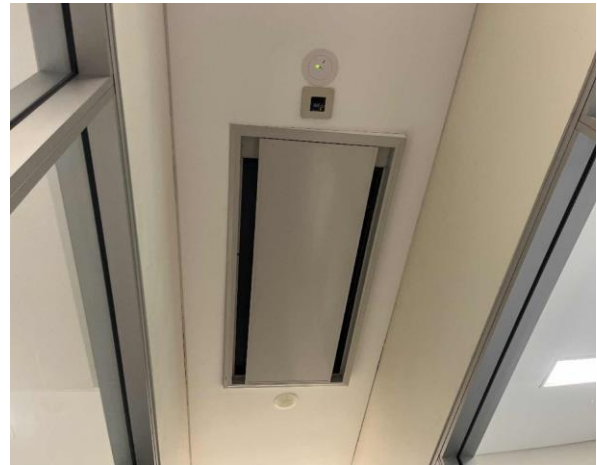
Line ID 88: Internal, Venue Office, Throughout, Ceiling Space, Air Conditioning Ductwork - Suspected SMF

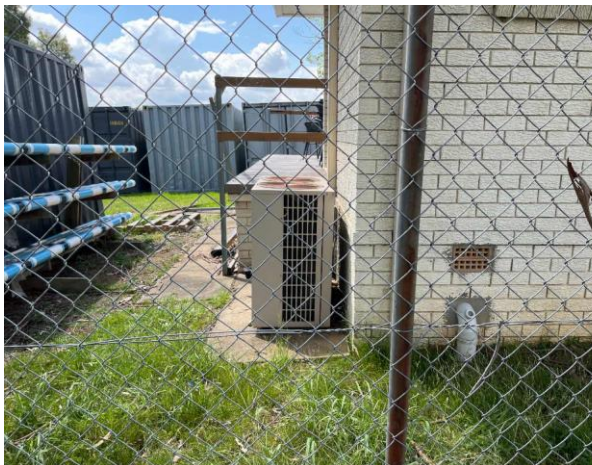
Line ID 90: External, House, Backyard, AC Unit, Unknown Refrigerant - Suspected ODS

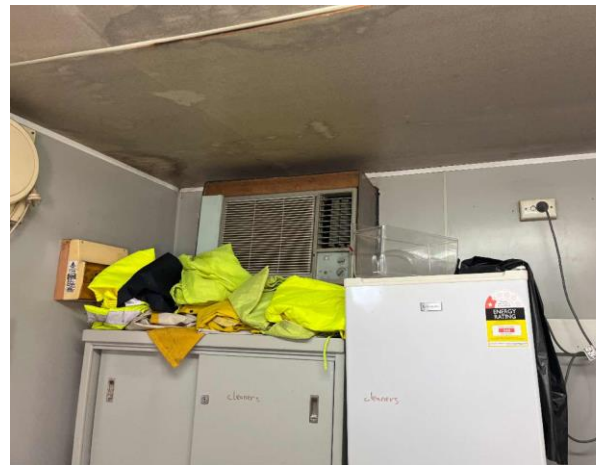
Line ID 91: Internal, Gardener's Shed, Lunch Shed, Lunch Room, AC Unit, Unknown Refrigerant - Suspected ODS

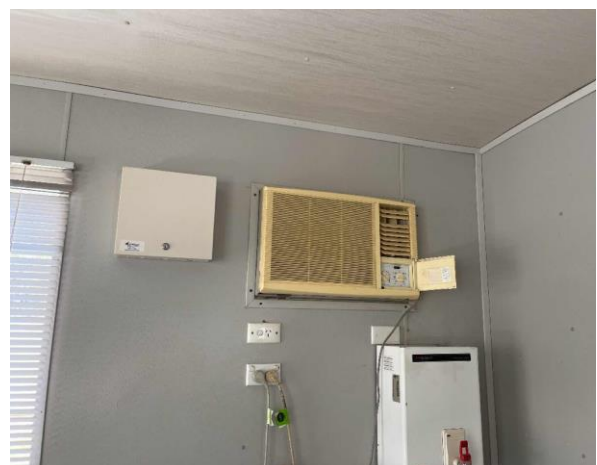
Line ID 92.1: Internal, Riders Retreat, Event Office, TECO AC Unit, Unknown Refrigerant - Suspected ODS

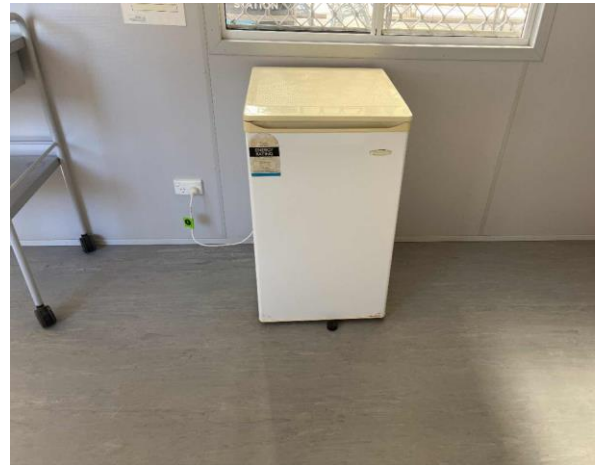
Line ID 94: Internal, Riders Retreat, First Aid Room, Wanbao Fridge, R134a Refrigerant - Non ODS Refrigerant

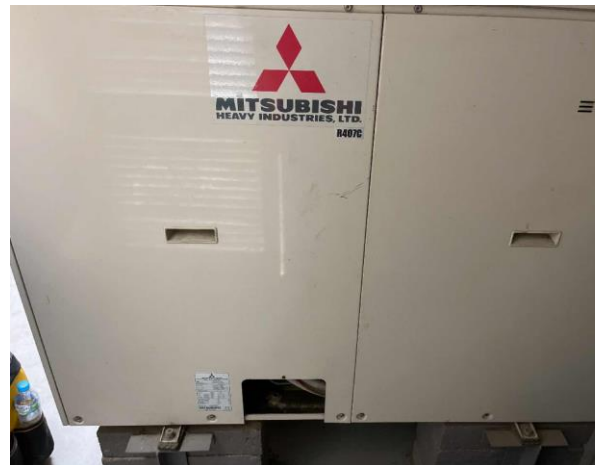
Line ID 96: Internal, Venue Office, Electrical Comms A.15, Mitsubishi AC Unit, R407c Refrigerant - Non ODS Refrigerant
