# Asbestos and Hazardous Materials Reinspection Assessment

Sydney International Regatta Centre

28/03/2023

754-SYDEN311850 - Sydney International Regatta Centre - HMRR - 01032023

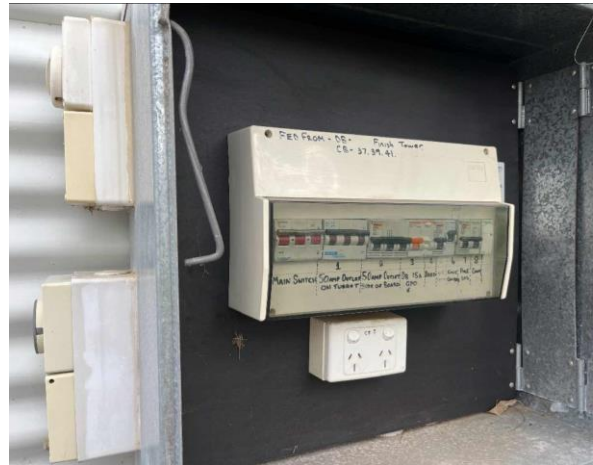
Line ID 3: External, Finish Tower, L3, Balcony, Switchboard, Bituminous Backing Board - No Asbestos Suspected

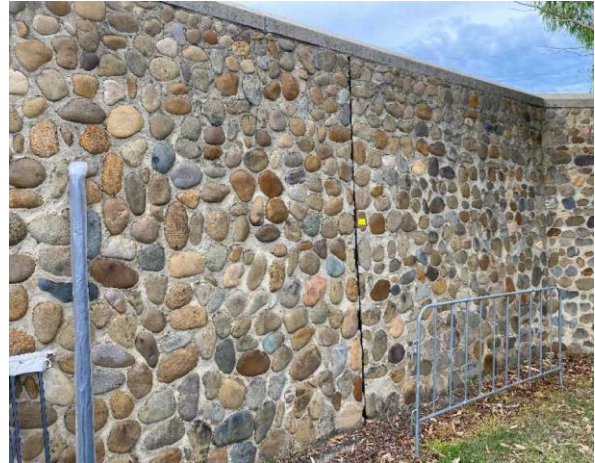
Line ID 7: External, Grounds, Entrance Wall, Expansion Gap, Bituminous Membrane - No Asbestos Detected

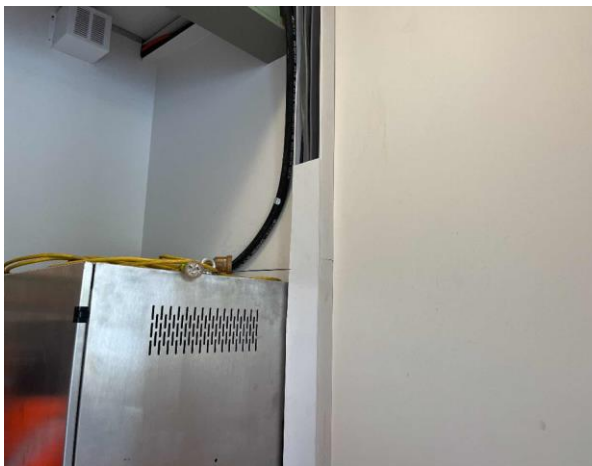
Line ID 29: Internal, Finish Tower, GF, Electrical and MDF Room, Electrical Meter, Mastic and Glazing - Suspected Asbestos

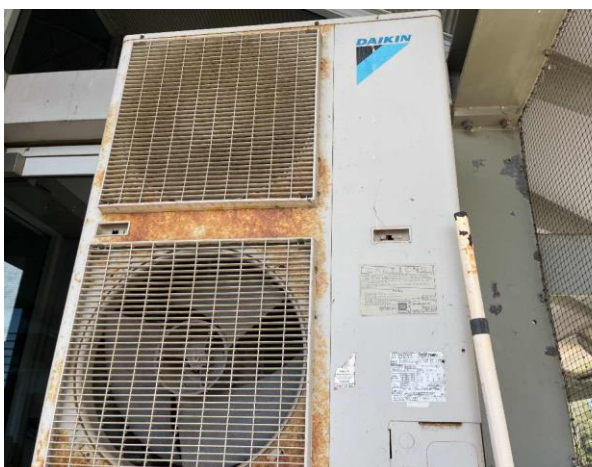
Line ID 106: External, Finish Tower, L2, Balcony, Daikin AC Units, R22 Hydrochlorofluorocarbon (HCFC) - ODS Refrigerant

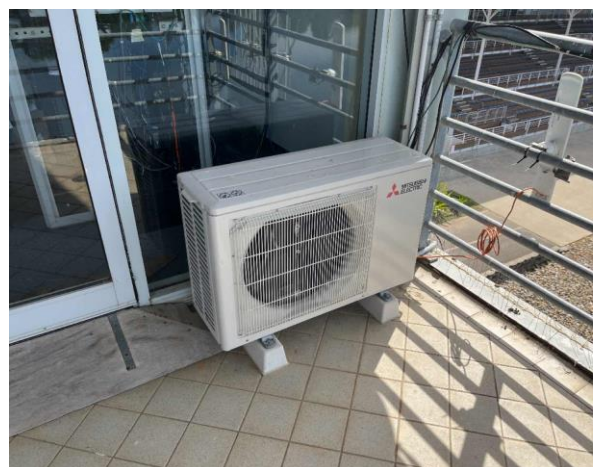
Line ID 106.1: External, Finish Tower, L2, Balcony, Daikin AC Units, R22 Hydrochlorofluorocarbon (HCFC) - ODS Refrigerant

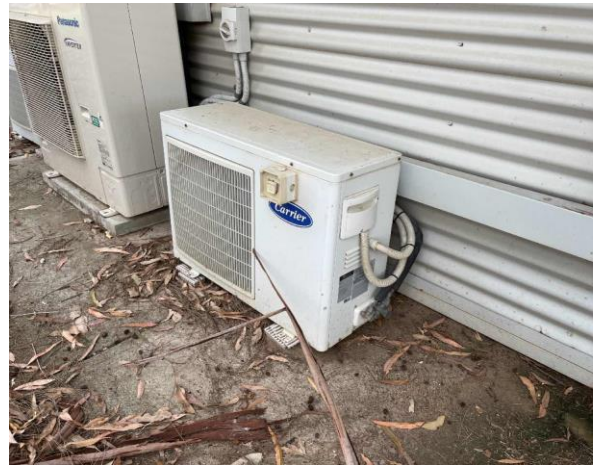
Line ID 110: External, Old Compound, South East Side, AC Unit, R22 Hydrochlorofluorocarbon (HCFC) - ODS Refrigerant

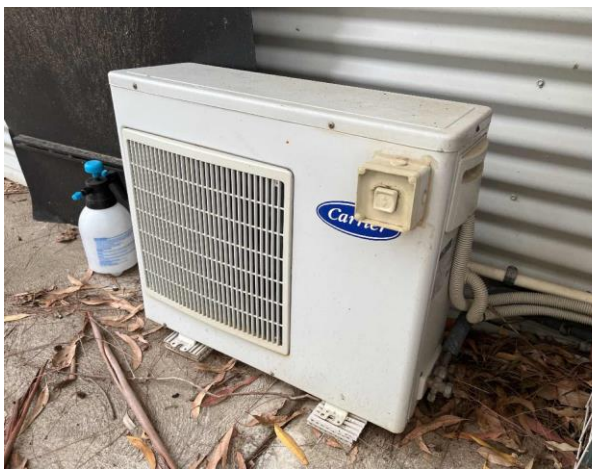
Line ID 111: External, Venue Operations Centre, South Side of Building, Carrier AC Unit, R22 Hydrochlorofluorocarbon (HCFC) - ODS Refrigerant

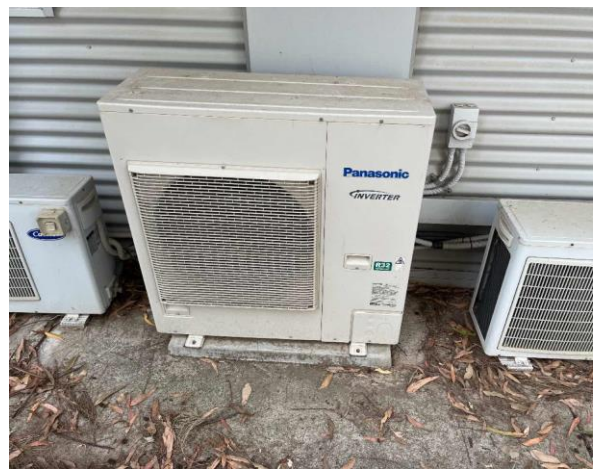
Line ID 111.1: External, Venue Operations Centre, South Side of Building, Carrier AC Unit, R22 Hydrochlorofluorocarbon (HCFC) - ODS Refrigerant

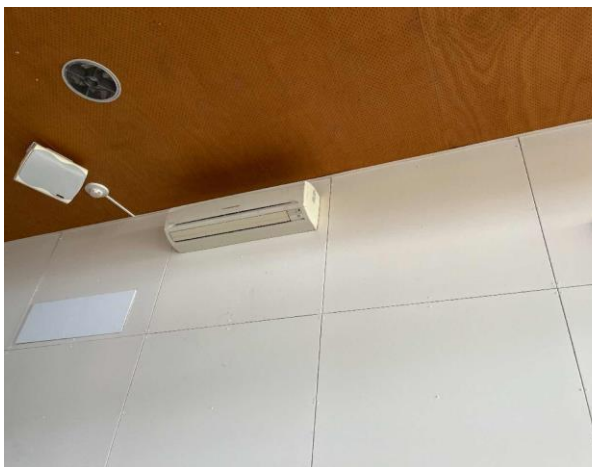
Line ID 115: Internal, Front Gate Security Office, Throughout, TECO AC Unit, Unknown Refrigerant - Suspected ODS

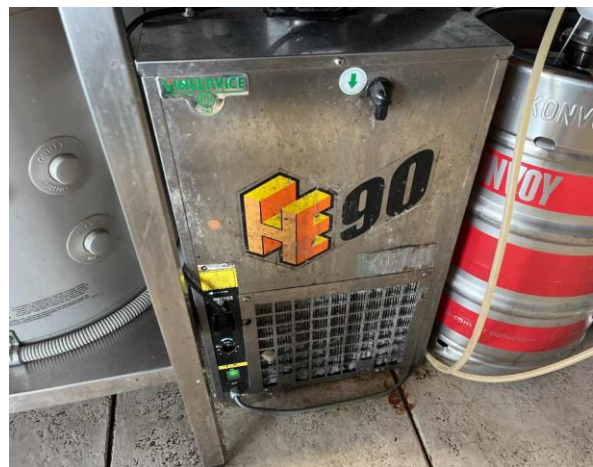
Line ID 116: Internal, Restaurant, East Dining Room, AC Units, Unknown Refrigerant - Suspected ODS
