**Asbestos and Hazardous Materials Reinspection Assessment**

Sydney International Shooting Centre

28/03/2023

754-SYDEN311850 - Sydney International Shooting Centre - HMRR - 06032023

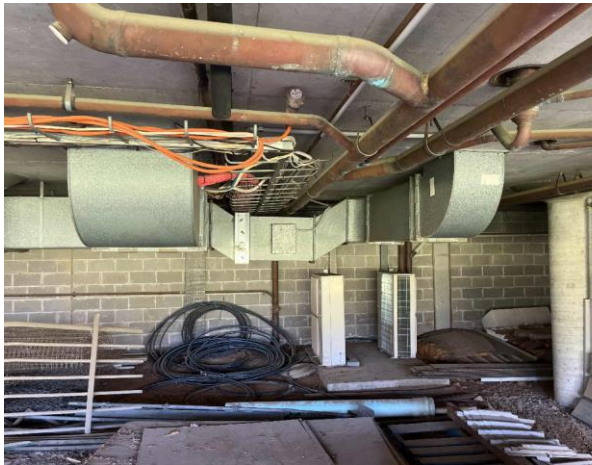
Line ID 1: External, Michael Diamond Building, Throughout, Ductwork, Electrical Distribution Heater, Millboard Insulation - Suspected Asbestos

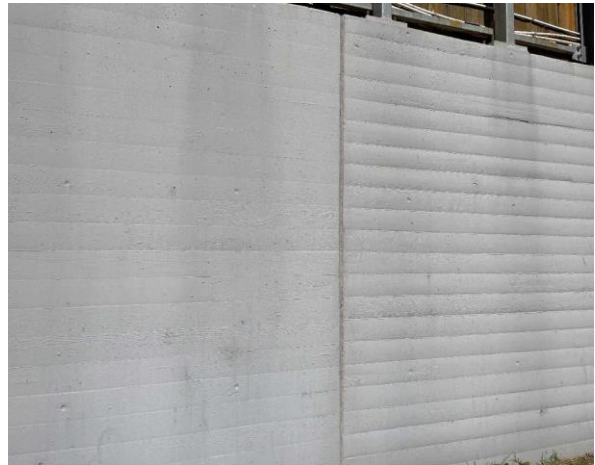
Line ID 2: External, Michael Diamond Building, Throughout, Walls, Expansion Joints, Mastic - No Asbestos Detected

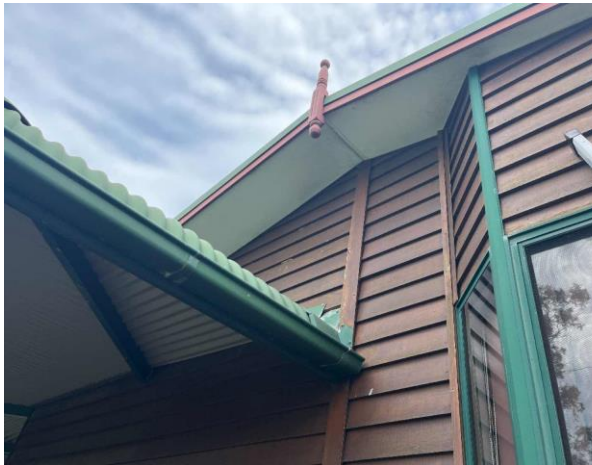
Line ID 3: External, Residence, Throughout, House and Garage, Eaves, Fibre Cement Sheet - No Asbestos Detected

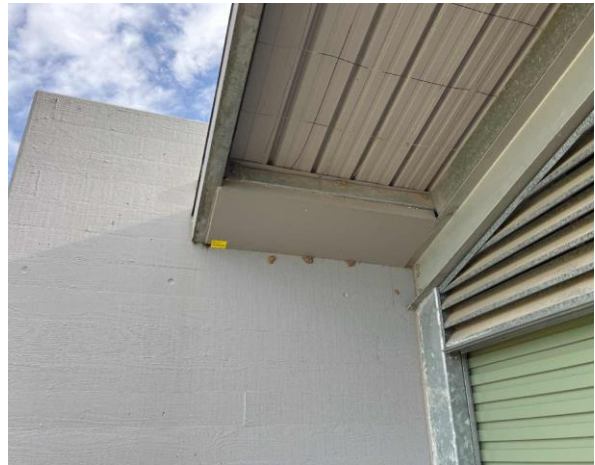
Line ID 4: External, Russell Mark Control Room, West Side, High Level Boxing, Fibre Cement Sheet - No Asbestos Detected

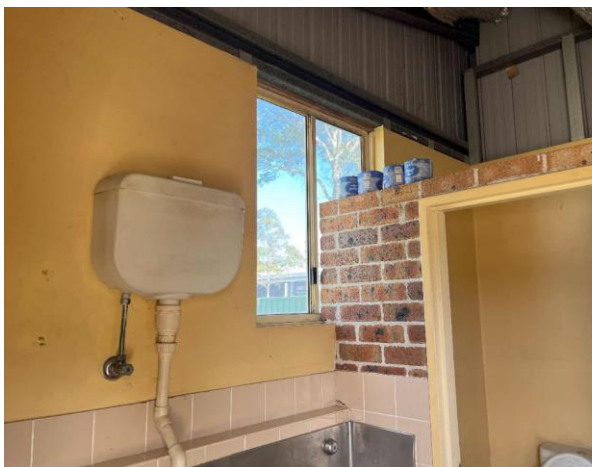
Line ID 5: Internal, Maintenance Shed, Bathroom, Walls, Fibre Cement Sheet - No Asbestos Detected

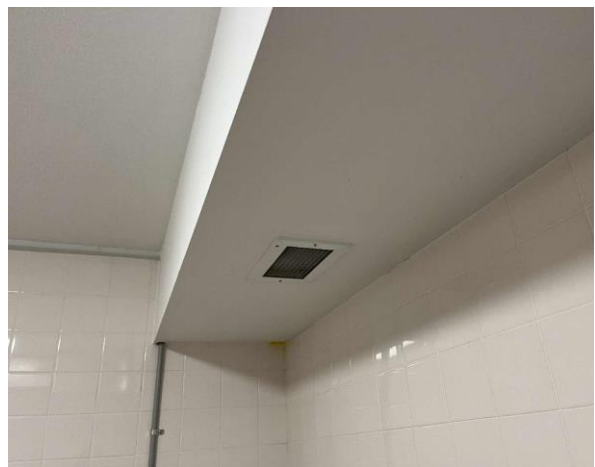
Line ID 6: Internal, Michael Diamond Building, Level 1, Bathrooms, Boxing to Ventilation System, Fibre Cement Sheet - No Asbestos Detected

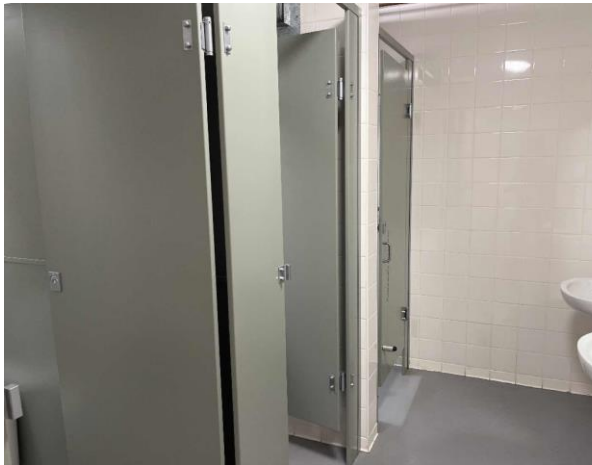
Line ID 7: Internal, Michael Diamond Building, Level 1, Toilets, Partition Walls, Fibre Cement Sheeting - No Asbestos Detected

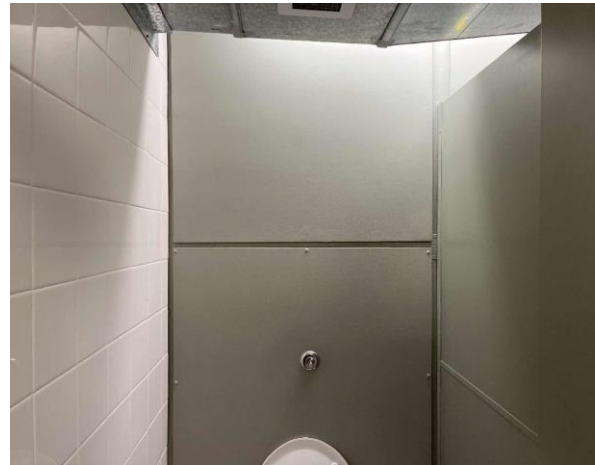
Line ID 8: Internal, Michael Diamond Building, Level 1, Walls Behind Toilets, Fibre Cement Sheet - No Asbestos Detected

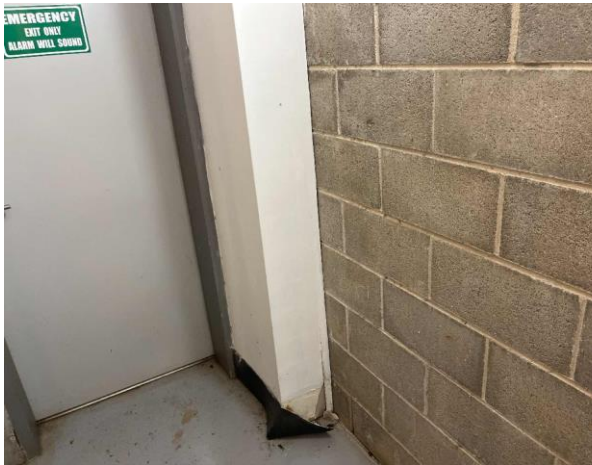
Line ID 9: Internal, Michael Diamond Building, Level 2, Bathrooms, Boxing to Ventilation System, Fibre Cement Sheet - No Asbestos Detected

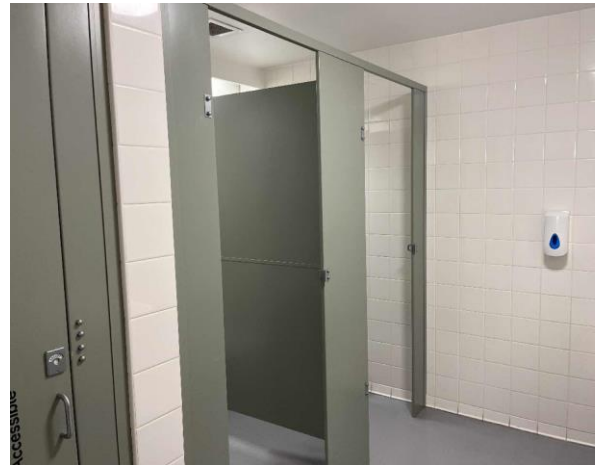
Line ID 10: Internal, Michael Diamond Building, Level 2, Toilets, Partition Walls, Fibre Cement Sheeting - No Asbestos Detected

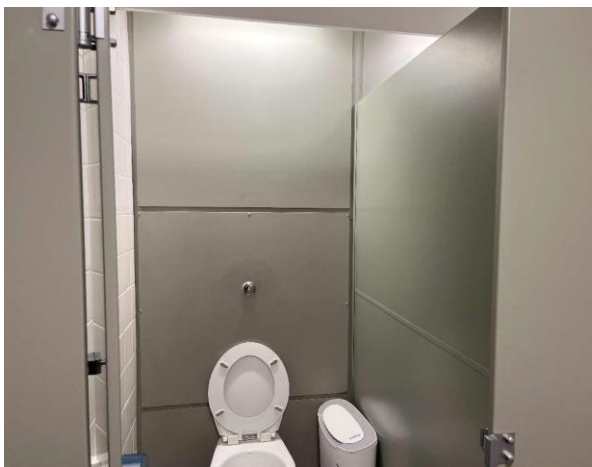
Line ID 11: Internal, Michael Diamond Building, Level 2, Walls Behind Toilets, Fibre Cement Sheet - No Asbestos Detected

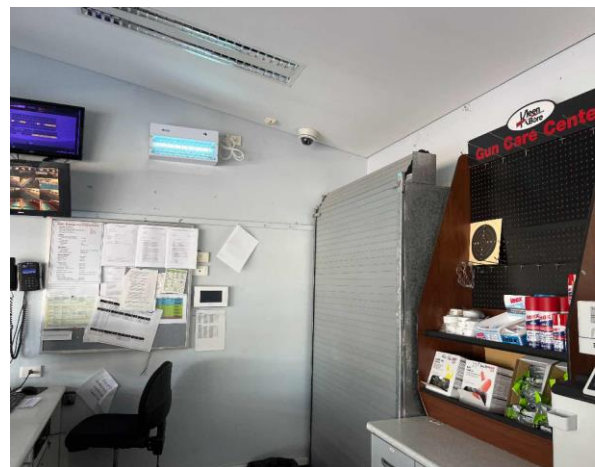
Line ID 12: Internal, Michael Diamond Building, Level 3 Canteen, Walls, Fibre Cement Sheet - No Asbestos Detected

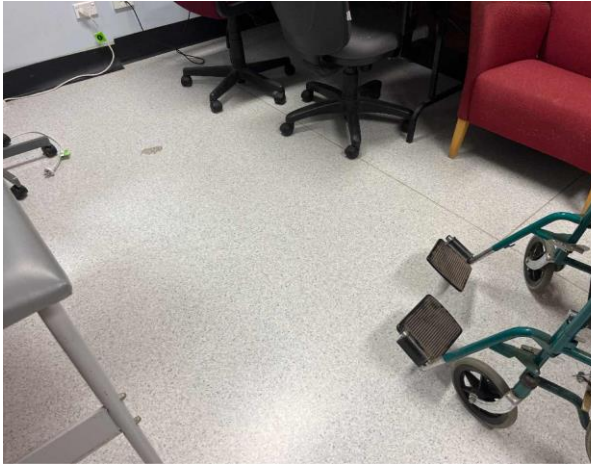
Line ID 13: Internal, Michael Diamond Building, Percy Pavey Range, First Aid Office, Floor Covering, White Vinyl Sheet - No Asbestos Detected

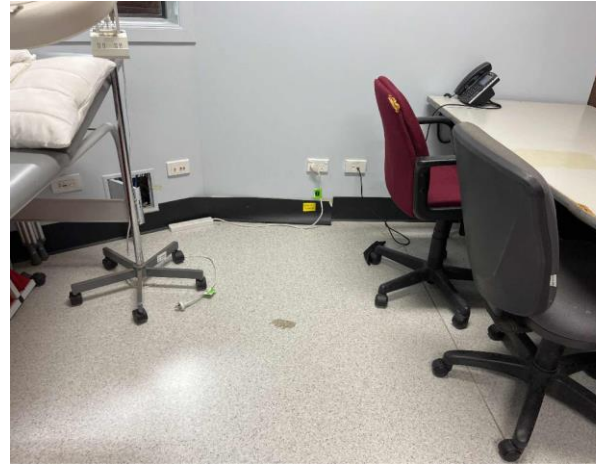
Line ID 14: Internal, Michael Diamond Building, Percy Pavey Range, First Aid Office, Skirting Board, Black Vinyl - No Asbestos Detected

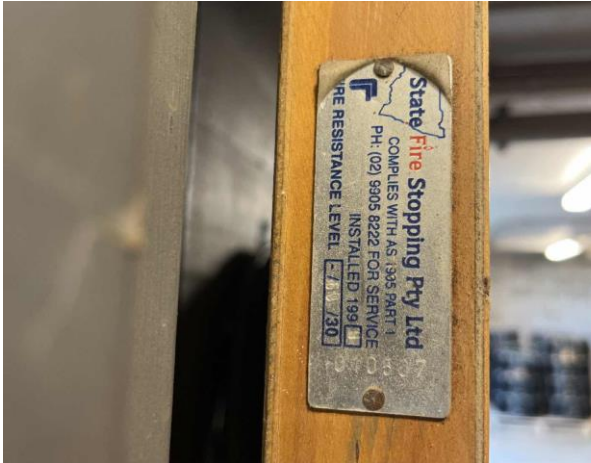
Line ID 15: Internal, Michael Diamond Building, Throughout, Fire Door, Fire Door Core - No Asbestos Detected

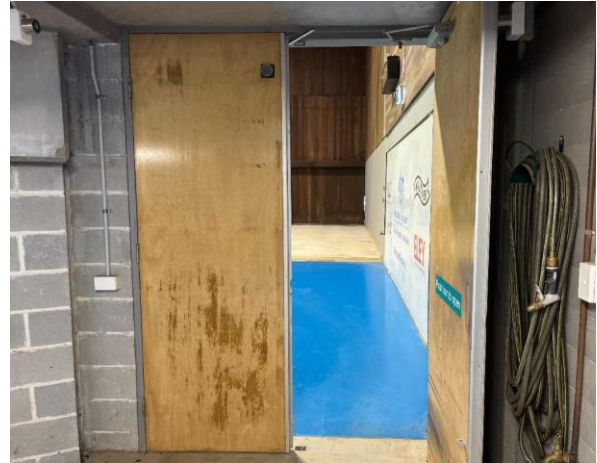
Line ID 15.1: Internal, Michael Diamond Building, Throughout, Fire Door, Fire Door Core - No Asbestos Detected

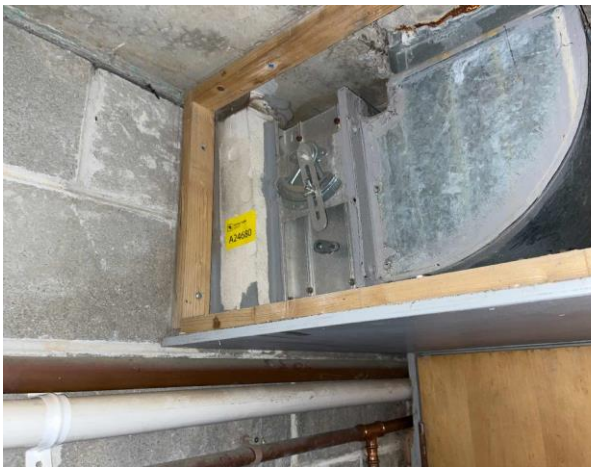
Line ID 16: Internal, Michael Diamond Building, Throughout, Fire Stopping to Ventilation System, Millboard Insulation - No Asbestos Detected

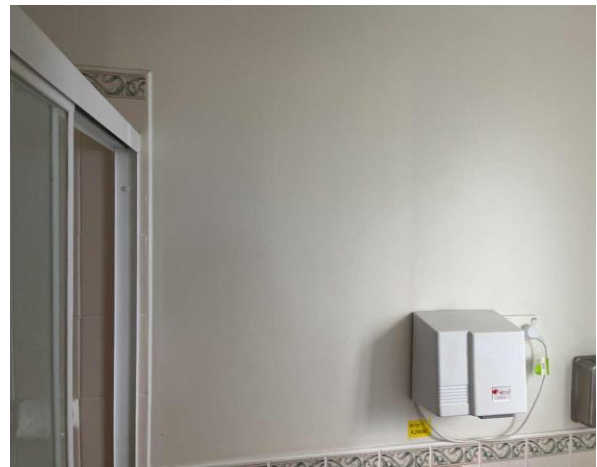
Line ID 17: Internal, Residence, Bathrooms, Walls, Fibre Cement Sheet - No Asbestos Detected

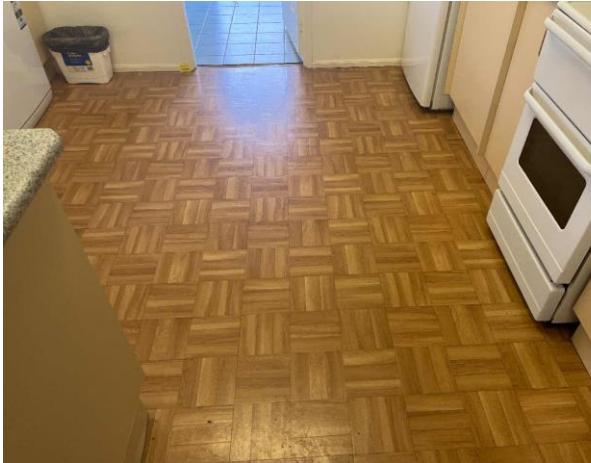
Line ID 18: Internal, Residence, Kitchen, Floor Covering, Timber Look Vinyl Sheet - No Asbestos Detected

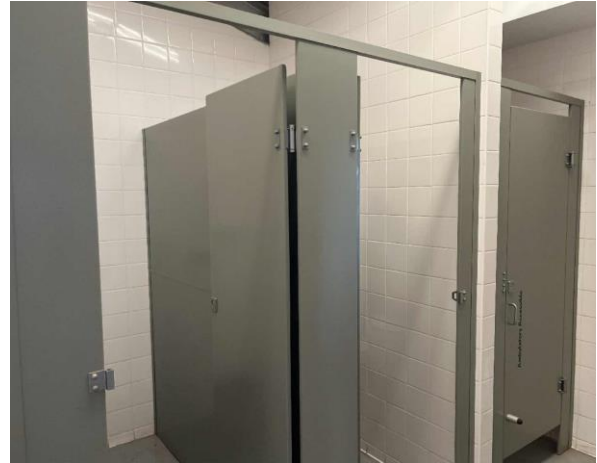
Line ID 19: Internal, Russel Mark Control Room, Bathrooms, Cubicle Partition Walls, Compressed Cement Sheet - No Asbestos Detected

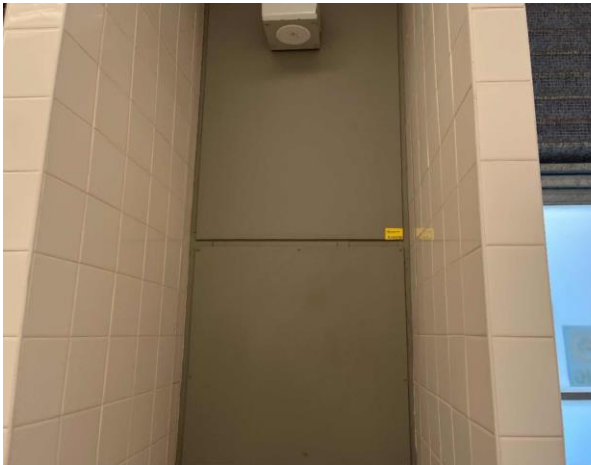
Line ID 20: Internal, Russel Mark Control Room, Bathrooms, Male and Disabled Toilet, Wall Panels, Fibre Cement Sheet - No Asbestos Detected

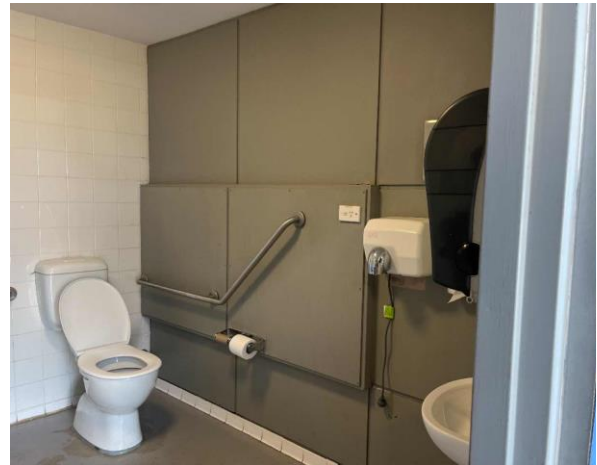
Line ID 20.1: Internal, Russel Mark Control Room, Bathrooms, Male and Disabled Toilet, Wall Panels, Fibre Cement Sheet - No Asbestos Detected

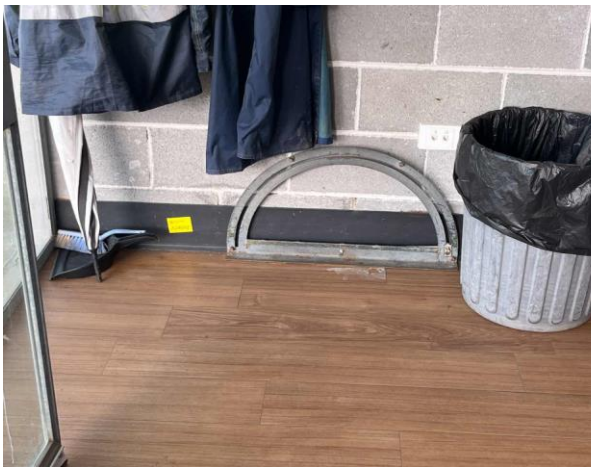
Line ID 21: Internal, Russel Mark Control Room, Bathrooms, Office and Kitchen, Skirting, Black Vinyl Skirting - No Asbestos Detected

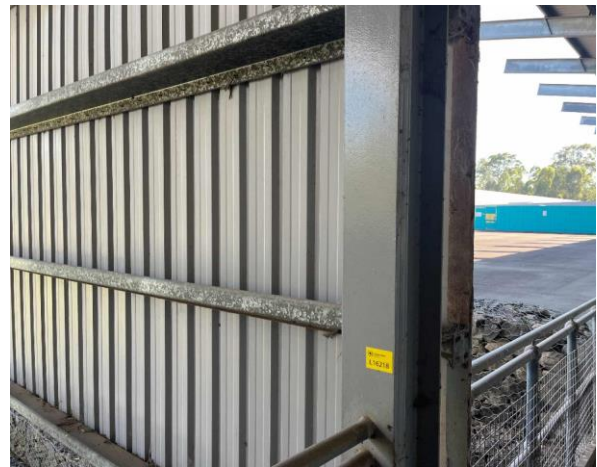
Line ID 22: External, Michael Diamond Building, Throughout, Metal Beams, Grey (Light) Paint - Lead Detected (<0.005% w/w)

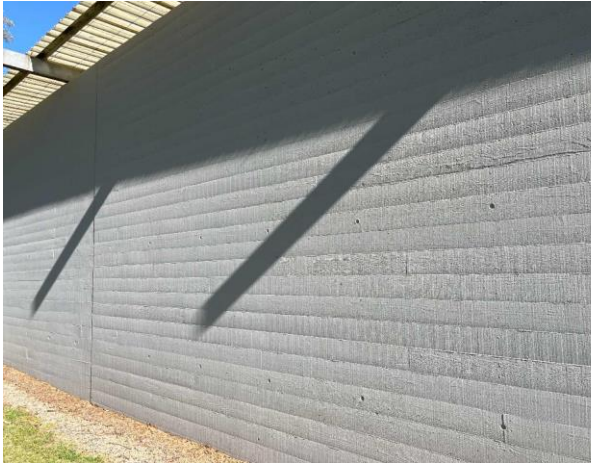
Line ID 23: External, Michael Diamond Building, Throughout, Walls, Grey (Light) Paint - Lead Detected (0.009% w/w)

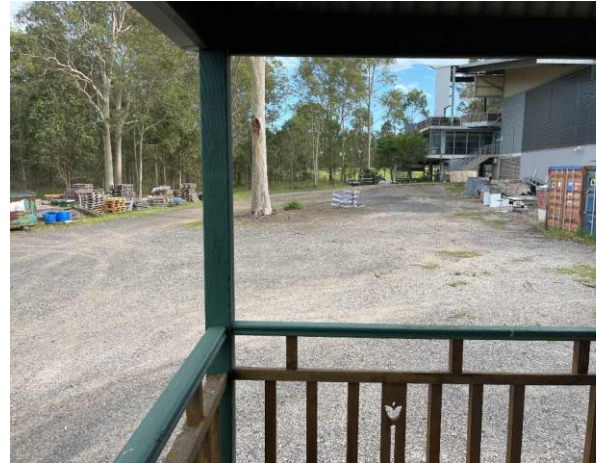
External	Residence / Throughout / Handrails and Columns	Green Paint	Lead Paint	L16222	Lead Detected (0.02% w/w)	-	50 m	-	-	<0.1% lead content, not lead-containing paint as described in AS 4361.2, Guide to hazardous paint management - 2017 Part 2: Lead paint in residential, public and commercial buildings.	24
External	Russell Mark Control Room / Throughout / Walls	Grey Paint	Lead Paint	L16223	Lead Detected (0.007% w/w)	-	100 m <sup>2</sup>	-	-	<0.1% lead content, not lead-containing paint as described in AS 4361.2, Guide to hazardous paint management - 2017 Part 2: Lead paint in residential, public and commercial buildings.	25

Line ID 24: External, Residence, Throughout, Handrails and Columns, Green Paint - Lead Detected (0.02% w/w)

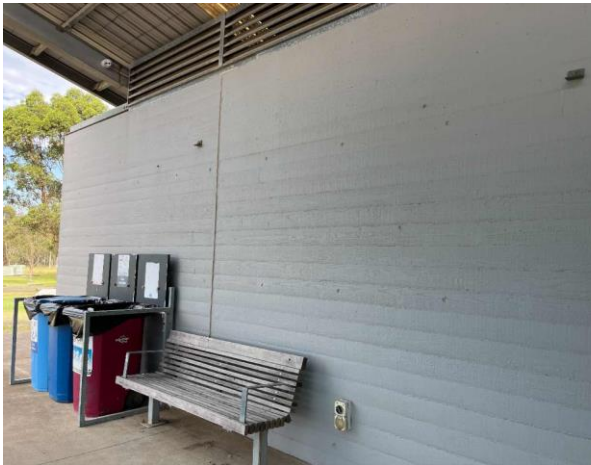
Line ID 25: External, Russell Mark Control Room, Throughout, Walls, Grey Paint - Lead Detected (0.007% w/w)

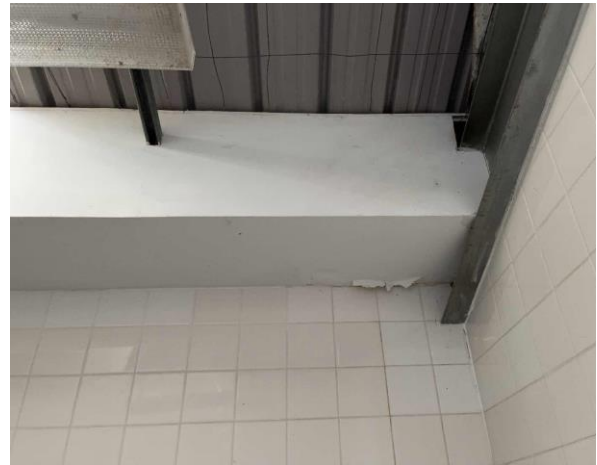
Line ID 26: Internal, Russel Mark Control Room, Bathrooms, High Level Boxing, White Paint - Lead Detected (<0.005% w/w)

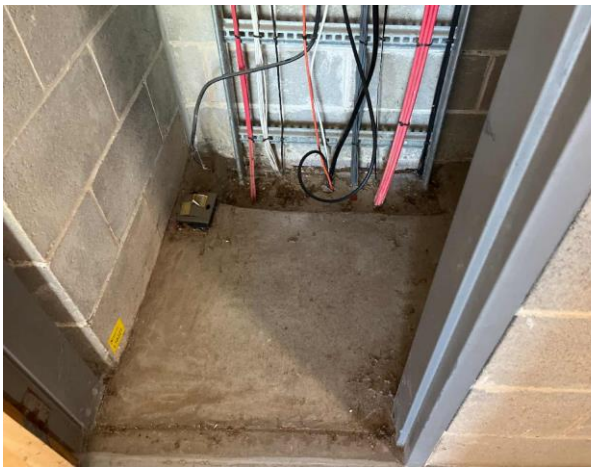
Line ID 27: Internal, Michael Diamond Building, Level 3, East Service Riser next to Male Toilets, Dust - Lead Detected (4,800 mg/kg)

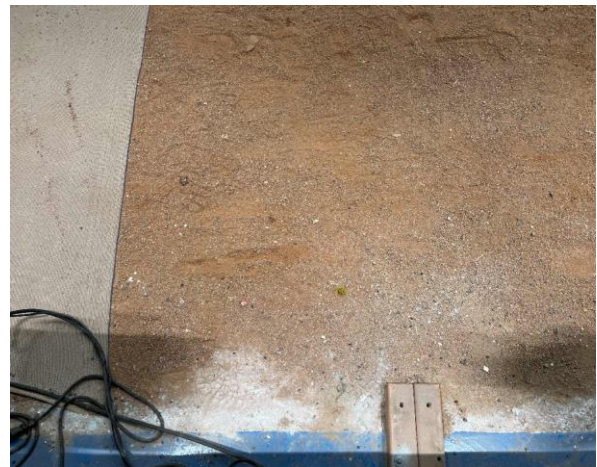
Line ID 28: Internal, Michael Diamond Building, Philip Adams Range 10m Range, Shooting Area, Floor, Dust - Lead Detected (410 mg/kg)

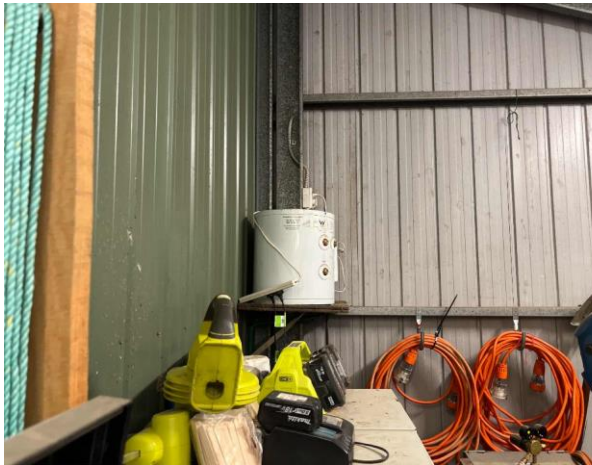
Line ID 29: Internal, Maintenance Shed, Cage Area, Hot Water Heater, Insulation Material - Suspected SMF

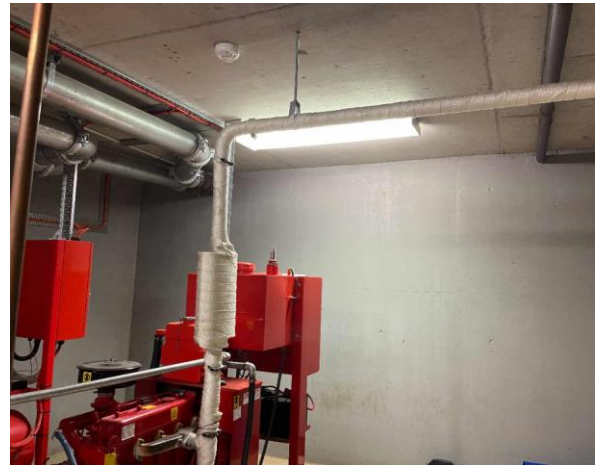
Line ID 30: Internal, Michael Diamond Building, Level 2 Fire Hydrant Room, Diesel Fire Pump Pipework, Insulation Material - Suspected SMF

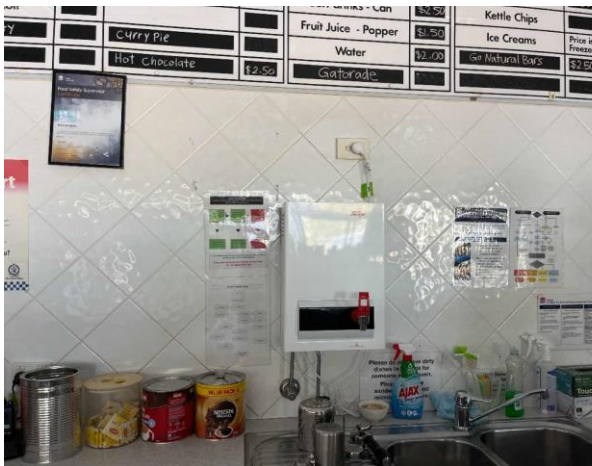
Line ID 31: Internal, Michael Diamond Building, Level 3 Canteen, Above Sink, Hot Water Heater, Insulation Material - Suspected SMF

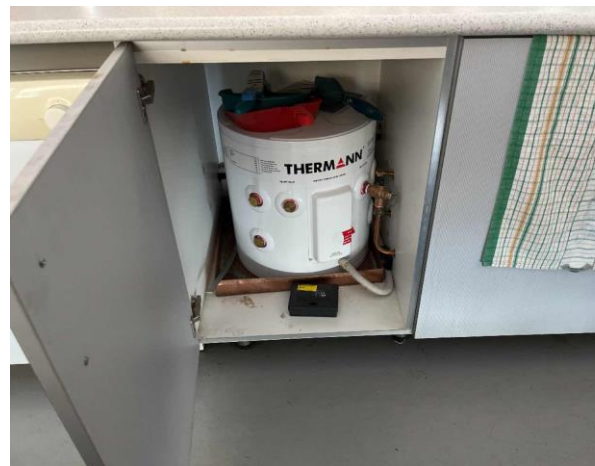
Line ID 32: Internal, Michael Diamond Building, Level 3 Canteen, Under Sink, Hot Water Heater, Insulation Material - Suspected SMF

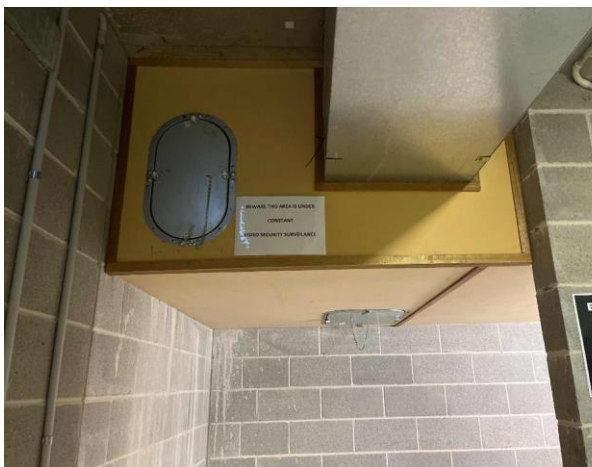
Internal	Michael Diamond Building / Throughout / Air Conditioning Ductwork	Internal Insulation	SMF	754-SYDEN311850 Shooting Centre168S5	Suspected SMF	-	1000 m <sup>2</sup>	Very Low	-	Maintain in current condition if to remain in-situ. Remove under controlled SMF conditions as per the Code of Practice for the Safe Use of Synthetic Mineral Fibres [NOHSC: 2006 (1990)].	33
Internal	Michael Diamond Building / Throughout / Ceiling	Sarking Insulation	SMF	754-SYDEN311850 Shooting Centre168S4	Suspected SMF	-	1000 m <sup>2</sup>	Very Low	-	Maintain in current condition if to remain in-situ. Remove under controlled SMF conditions as per the Code of Practice for the Safe Use of Synthetic Mineral Fibres [NOHSC: 2006 (1990)].	34

Line ID 33: Internal, Michael Diamond Building, Throughout, Air Conditioning Ductwork, Internal Insulation - Suspected SMF

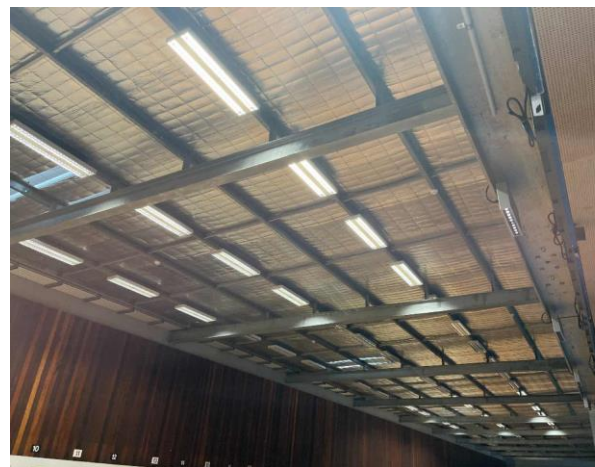
Line ID 34: Internal, Michael Diamond Building, Throughout, Ceiling, Sarking Insulation - Suspected SMF

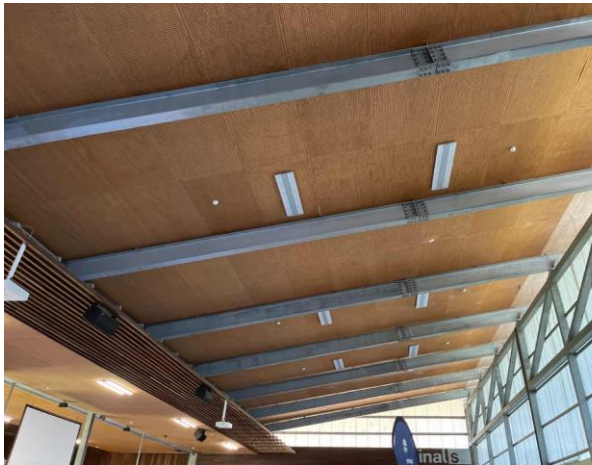
Line ID 35: Internal, Michael Diamond Building, Throughout, Ceiling Above Tiles, Insulation Material - Suspected SMF

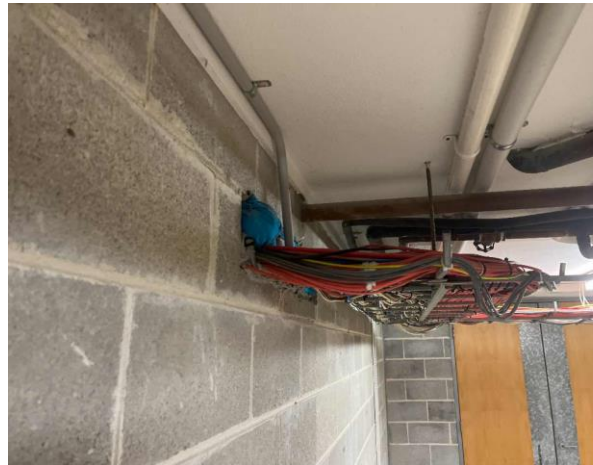
Line ID 36: Internal, Michael Diamond Building, Throughout, Penetrations, Pillow Insulation - Suspected SMF

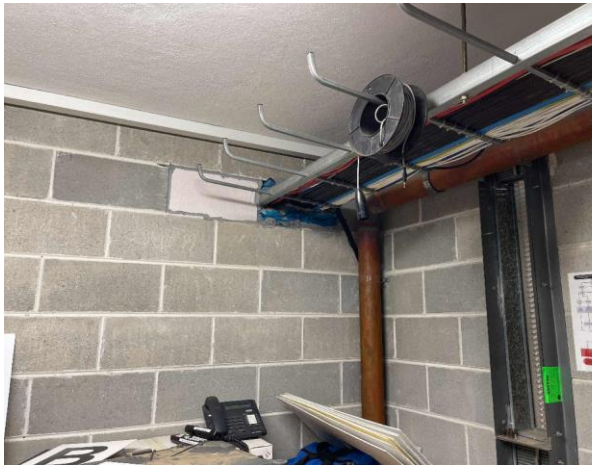
Line ID 36.1: Internal, Michael Diamond Building, Throughout, Penetrations, Pillow Insulation - Suspected SMF

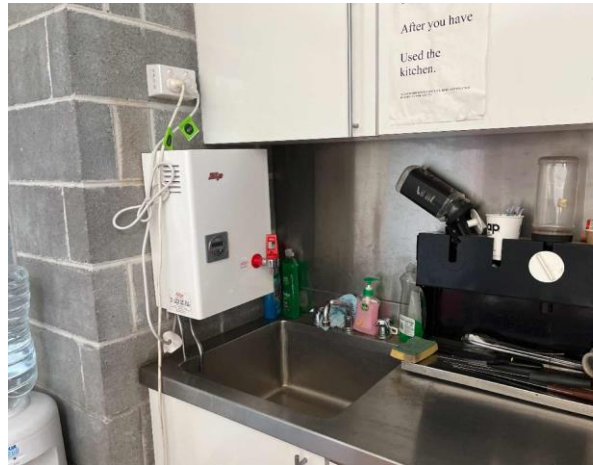
Internal	Russel Mark Control Room / Kitchen / Above Sink, Hot Water Boiler	Internal Insulation	SMF	754-SYDEN311850 Shooting Centre168S8	Suspected SMF	-	1 Unit	Very Low	-	Maintain in current condition if to remain in-situ. Remove under controlled SMF conditions as per the Code of Practice for the Safe Use of Synthetic Mineral Fibres [NOHSC: 2006 (1990)].	38
External	Michael Diamond Building / North Side / Daikin AC Unit	R410A Hydrofluorocarbon (HFC)	ODS	754-SYDEN311850 Shooting Centre168O5	Non ODS Refrigerant	-	1 Unit	-	-	Hydrofluorocarbon (HFC) non ozone depleting substances.	39

Line ID 38: Internal, Russel Mark Control Room, Kitchen, Above Sink, Hot Water Boiler, Internal Insulation - Suspected SMF

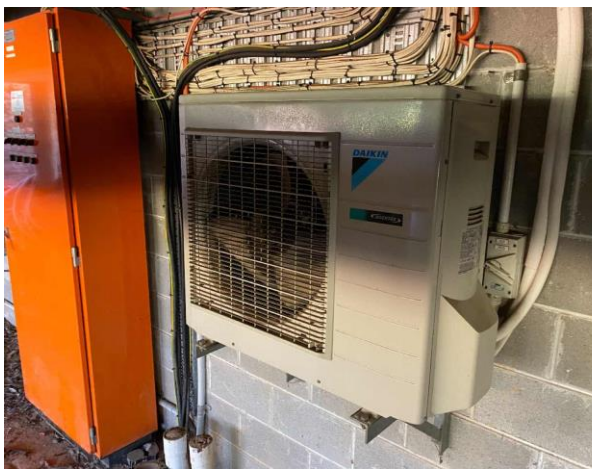
Line ID 39: External, Michael Diamond Building, North Side, Daikin AC Unit, R410A Hydrofluorocarbon (HFC) - Non ODS Refrigerant

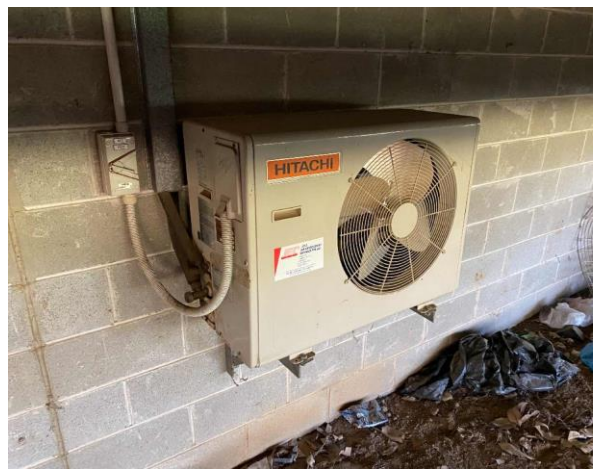
Line ID 40: External, Michael Diamond Building, North Side, Hitachi AC Units, R407C Refrigerant - Non ODS Refrigerant

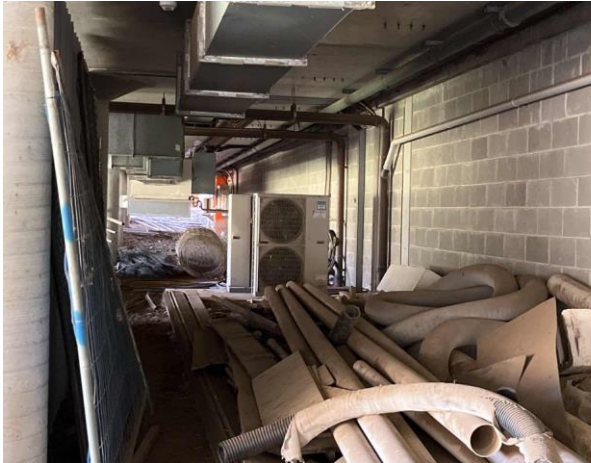
Line ID 41: External, Michael Diamond Building, West Side, Hitachi AC Units, R407C Refrigerant - Non ODS Refrigerant

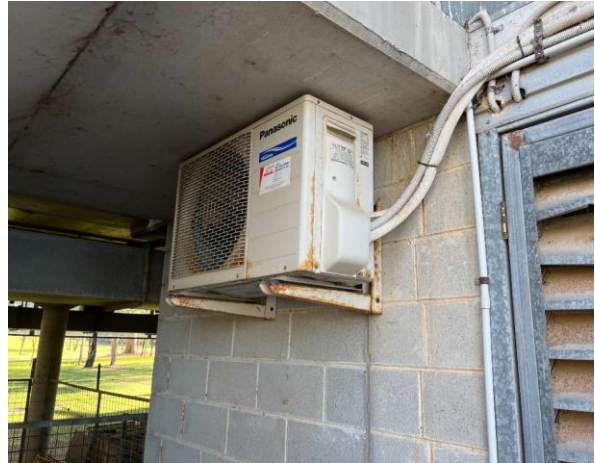
Line ID 42: External, Michael Diamond Building, West Side, on Wall, Panasonic AC Unit, R410A Hydrofluorocarbon (HFC) - Non ODS Refrigerant

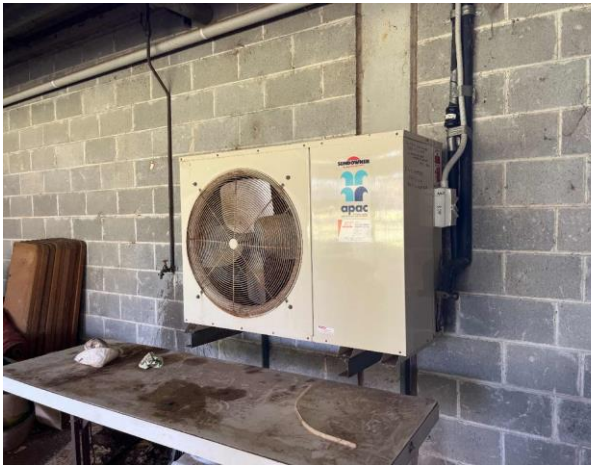
Line ID 43: External, Michael Diamond Building, West Side, SunDowner AC Unit, Unknown Refrigerant - Suspected ODS

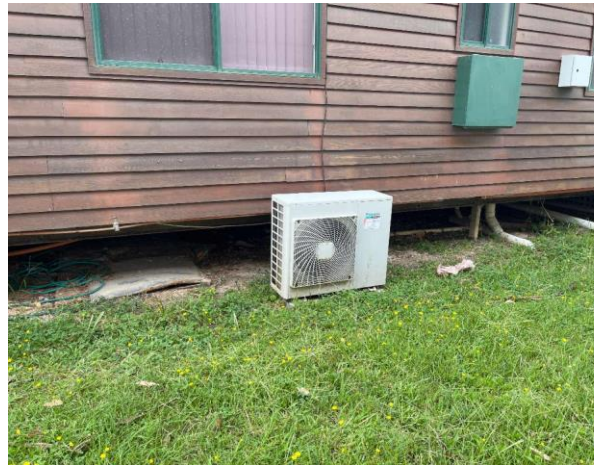
Line ID 44: External, Residence, North East Side, Daikin AC Unit, R410A Hydrofluorocarbon (HFC) - Non ODS Refrigerant

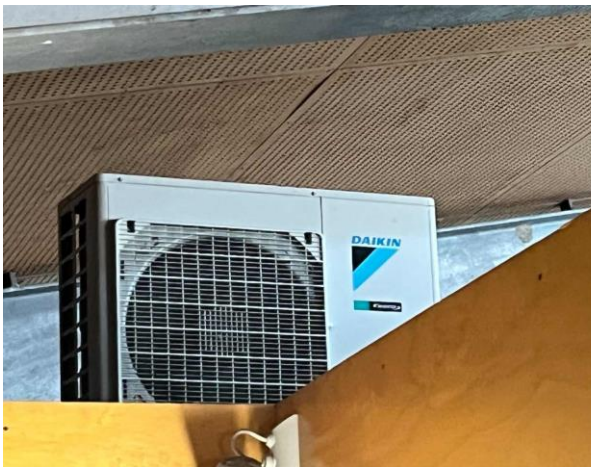
Line ID 45: Internal, Michael Diamond Building, Level 3, Above Offices, R410A Hydrofluorocarbon (HFC) - Non ODS Refrigerant
