SOUTHERN HIGHLANDS REGIONAL SHOOTING
COMPLEX (SHRSC)

QUARTER 3 MONITORING REPORT

(FOR SAMPLING 15 & 16 APRIL 2021)

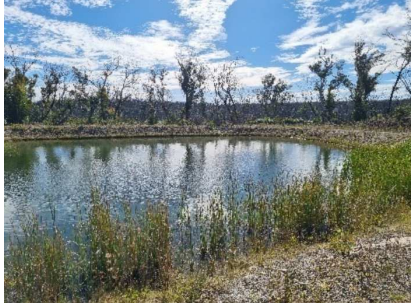
Basins	
Basin 5 (at 50m range)

<ul style="list-style-type: none"> • basin full water very clear.

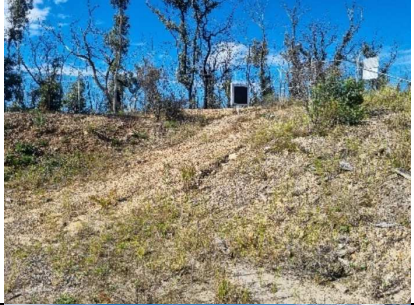
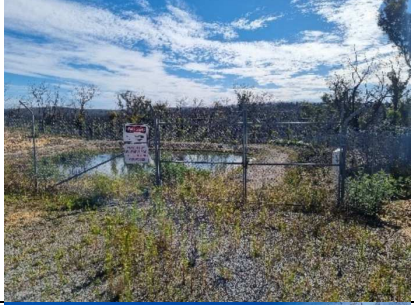
<ul style="list-style-type: none"> • Erosion at entrance at gate and ramp has not progressed • Sample from trickle line from range WQ measures not taken - no flows

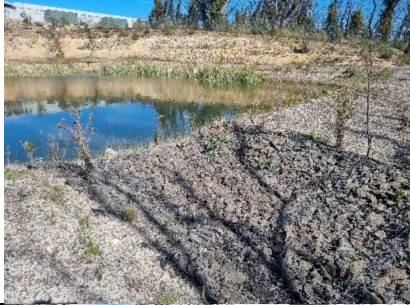
<ul style="list-style-type: none"> • Spillway protection stable with no evident erosion

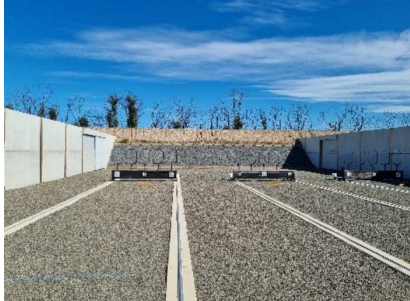
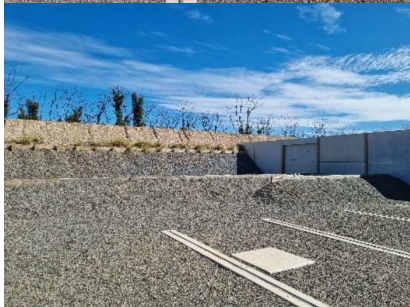
<ul style="list-style-type: none"> • Grave surfaces weed generally free • Weeds evident across all areas – top of butt/above bullet catchers

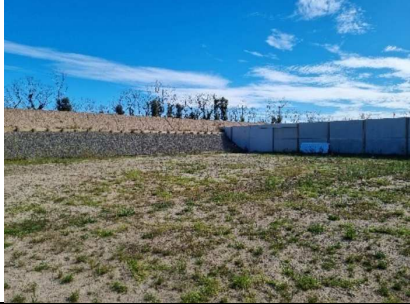
<p>Range/Bay 1</p> <ul style="list-style-type: none"> • Current surface cover poor - 30 to 50% cover • Surface is stable • Vegetation cover on eastern mound good 70% • Some weeds evident across all areas

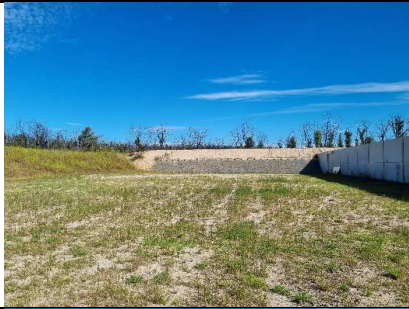
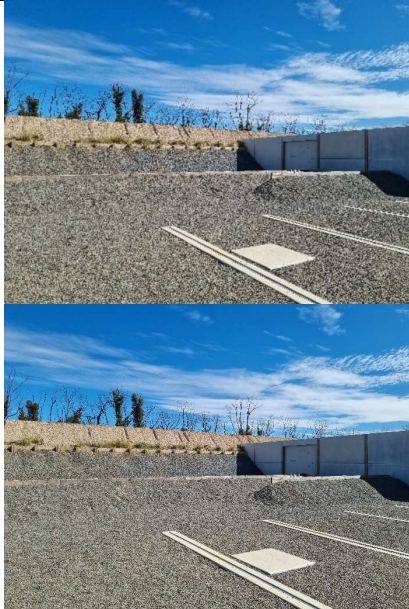
<ul style="list-style-type: none"> • Top of butt erosion progressing all bays especially 2,3 & 4

Rework of top of the mound formation will be required to prevent surface water passing over the batters of the stop butt.
2.	Pit at South East corner of 50m stop butt	Pit is full of sediment and being bypassed Modification of this outlet area may be required depending on existing stormwater arrangement E.g. additional control to prevent pit becoming blocked or otherwise replace with a stable surface level outlet and spreader.

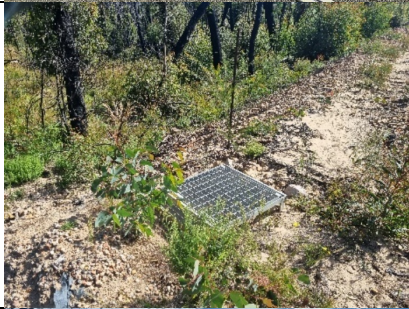
<ul style="list-style-type: none"> • Pit at South East corner of 50m stop butt • Pit is full of sediment and being bypassed <p>Modification of this outlet area may be required.</p>

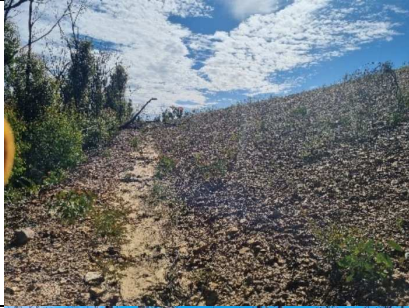
<ul style="list-style-type: none"> • Drain to stormwater pit bare • Minor sediment loss evident <p>Further stabilization of the back of the mound will be required to reduce the sediment load to the drainage outlets.</p>

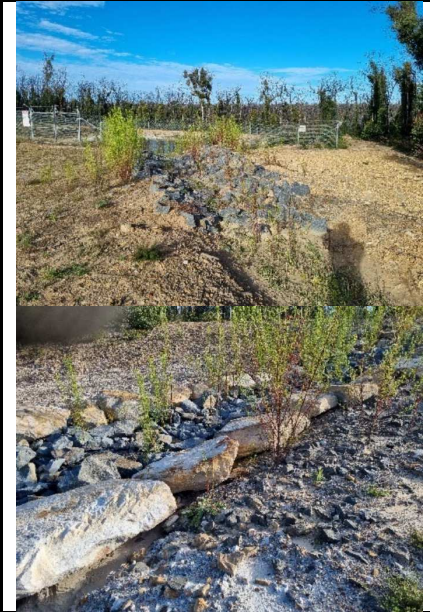
Basin 3 (500m east)

<ul style="list-style-type: none">• Inlet seems to have become stable having eroded down to stable rock underneath riprap.• Localised erosion on batters to the basin may become an issue in the future – this area should be monitored in future inspections.• Water with the basin is clear

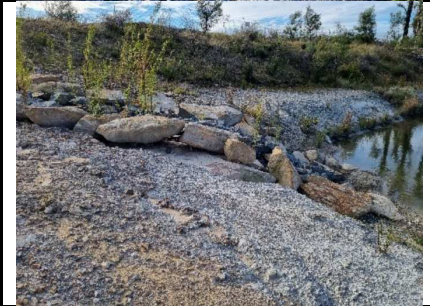
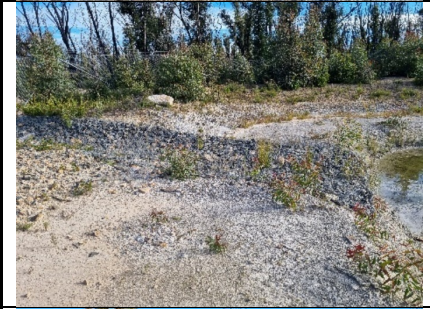
<ul style="list-style-type: none">• Secondary Inlet is fully stable

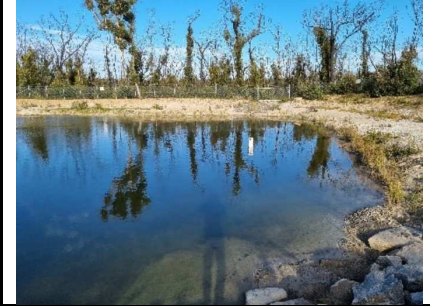
<ul style="list-style-type: none">• Gabion outlet control is stable.• The area below main outlet is stable

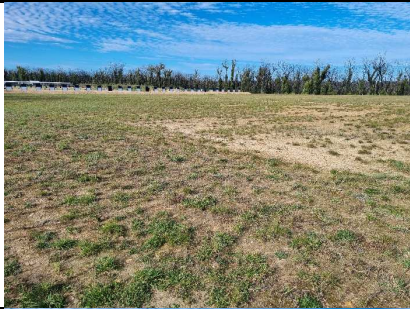
<p>Intermediate mound 200m to intermediate mound 300m</p> <ul style="list-style-type: none"> • Vegetation patchy with large patches 0 to 25%. other areas generally 50% to 70%+. Surface is stable

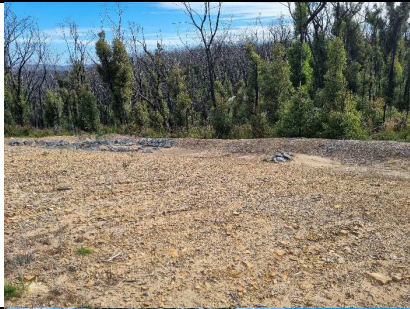
<ul style="list-style-type: none"> • Swale drain leading to southwest corner of 500m stop butt • Invert of drainage swales bare with some sediment accumulating within blue metal check dams

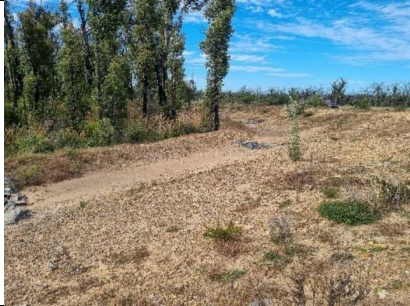
<p>Swale drains at 500m east</p> <ul style="list-style-type: none"> • Installed rock checks with diameter 75-100mm • Some without fabric • These checks appear to be stable

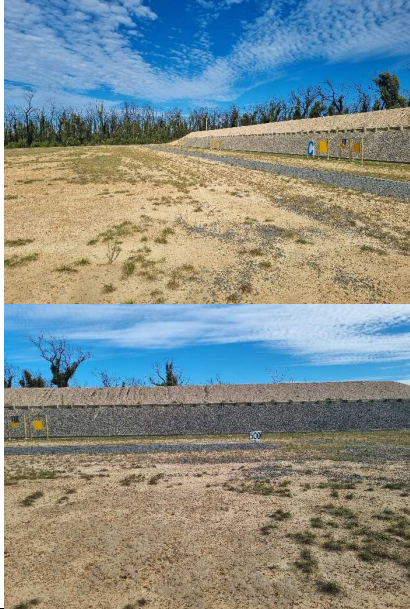
<p>Top of Stop butt at 500m</p> <ul style="list-style-type: none"> • Some riling at front of batter • Occurs where water is pooling on top of butt formation and overflows over face
<p>Shot Loss: No evident shot loss</p>	
<p>Engineering controls: Road Infrastructure and Drainage</p>

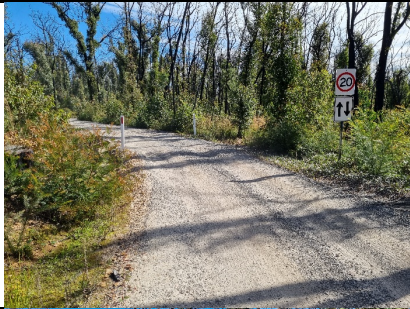
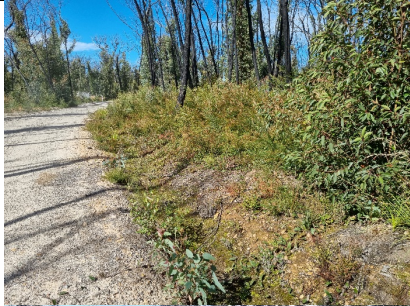
<ul style="list-style-type: none">• Table drain stable with vegetation growing. This may become an issue in the long term• Track is beginning to get rutted this will require re grading.• The surface has been impacted by high rains especially over culverts areas with localised potholes forming,

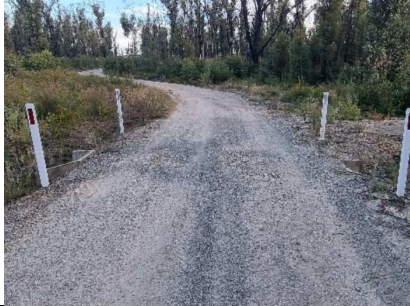
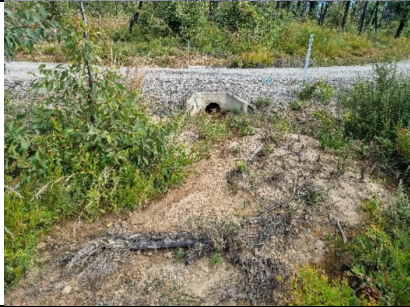
<ul style="list-style-type: none">• Some sediment deposition within table drains and at culverts

<p>Maintenance of these area should be scheduled</p>

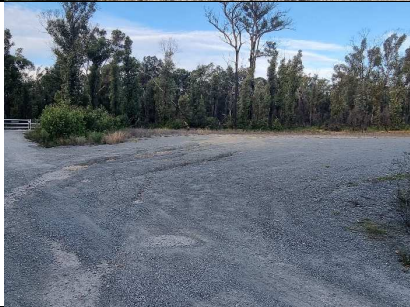
<ul style="list-style-type: none">• Minor erosion to gravel surface of main car park at entrance. This area will be monitored or otherwise repaired as part of general maintenance

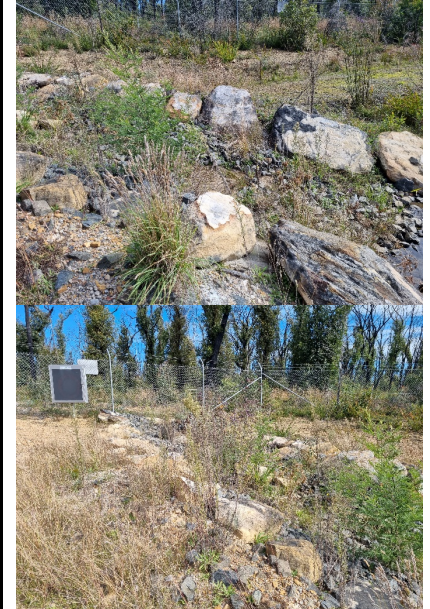
<ul style="list-style-type: none">• Inlet channel - erosion and rock movement has not progressed from previous inspection• Vegetation is establishing with the inlet area

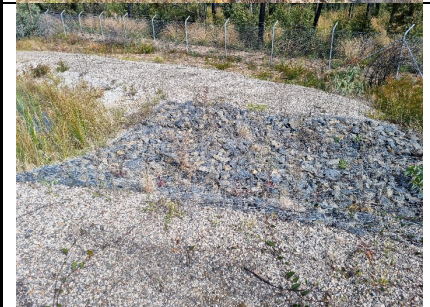
<ul style="list-style-type: none">• Gabion spillway is stable• Erosion area below outlet may have progressed slightly. work will be required if this continues• Note this movement may be subsequent to removal of retaining material as part of fires.

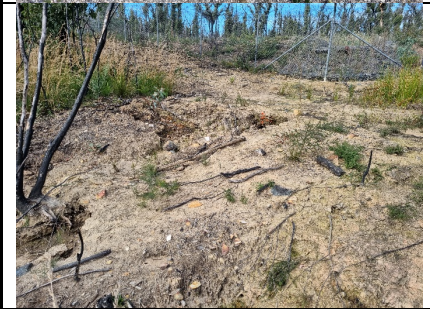
<ul style="list-style-type: none">• Erosion area below outlet may have progressed slightly. work will be required if this continues• Note this movement may be subsequent to removal of retaining material as part of fires.

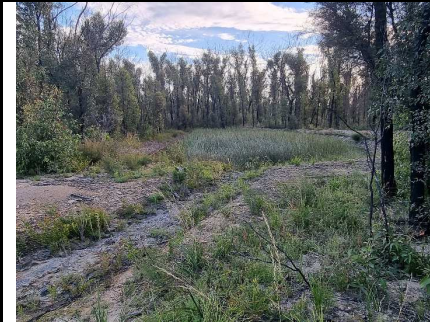
<p>Basin 4 (at car park)</p>

<ul style="list-style-type: none">• Basin inlet and outlet stable• Basin full of reeds

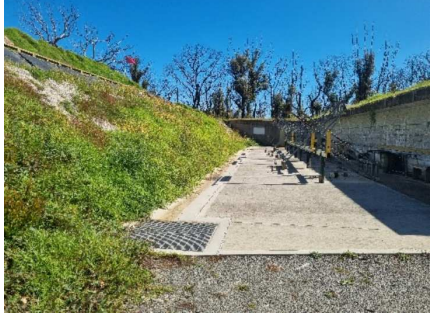
<p>Vegetative health – bench in-front of stop but and bullet catchers</p> <ul style="list-style-type: none"> Batter covered with jute mesh beginning to grass over with thick kikuyu and weeds

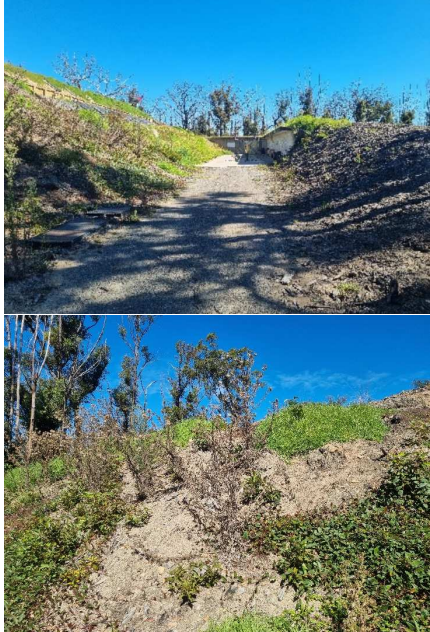
<ul style="list-style-type: none"> • Lime treatment lids secure – no damage visible • Some bullet fragments observed within gallery. Some gravel and sand accumulated over surfaces • This sand and fragments need to be regularly cleaned • Weeds establishing over batter to gallery
<p>Engineering controls: Road Infrastructure and Drainage</p>

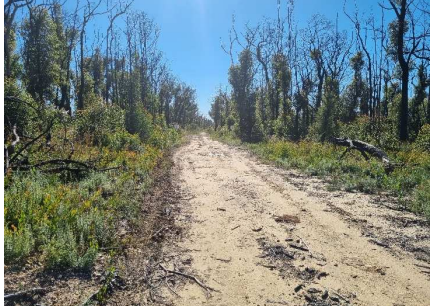
<p>Roads and Access tracks</p> <ul style="list-style-type: none"> • Main access track is stable, some minor erosion with shallow pot holes only
