SOUTHERN HIGHLANDS REGIONAL SHOOTING
COMPLEX (SHRSC)

Sampling & Analysis Quality Plan

2021-22 Annual Operational Monitoring Program
Report

SEPT 2022

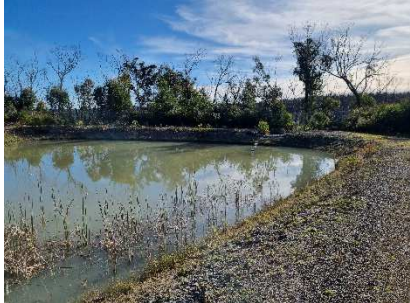
Basins	
Basin 5 (at 50m range)

<ul style="list-style-type: none"> • Basin full to trickle pipe invert • Note scour near entrance – this does not seem to have progressed- discussed further

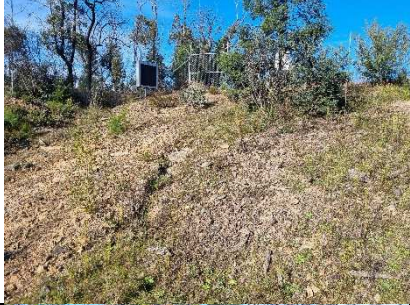
<ul style="list-style-type: none"> • Scour over batter at entrance to basin enclosure • Water directed by surface water swale to entrance track to basin • Scour leads down access track to spread at bench and then down batter at basin <p>This scour does not seem to have progressed and is now stable - no further action suggested</p>

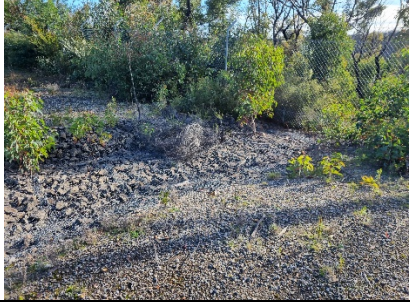
<ul style="list-style-type: none"> • Outlet from basin is stable – no scour evident from sides or flanks of gabion scour protection. • Some plants are establishing within the gabion scour protection. These should be poisoned and removed before their growth disturbs the stability of the gabion structure.
No Photo	Water is flowing from the trickle pipe from the 50-metre range

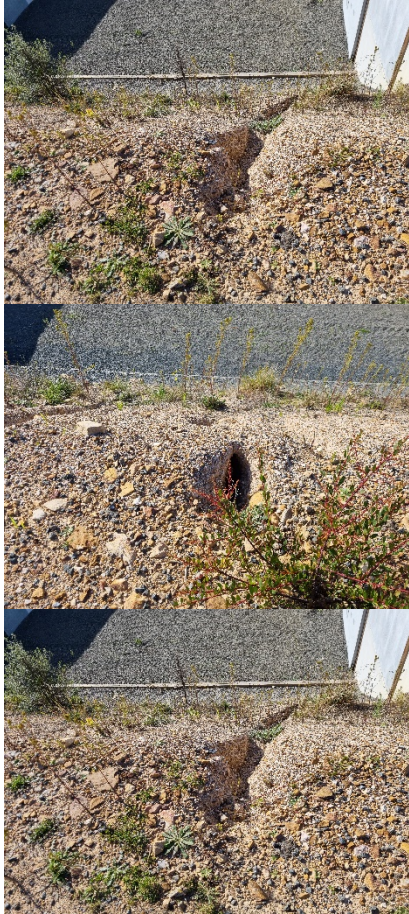
<p>Top of Stop butt at 50m</p> <ul style="list-style-type: none"> • Erosion at face of butt above bullet catcher is progressing and getting more severe and some areas particularly shooting base 4 and 3. • Occurs where water is pooling on top of butt formation and overflows over face • Evidence of erosion to approximately 30 cm deep. • Evidence of some dispersible material within the stop button material- Some evident of tunnelling • Localised scour is significant in some areas <p>Confirm previous recommendations to rework of top of the mound formation to prevent surface water passing over the batters of the stop butt.</p> <p>It is suggested that the material may require addition of gypsum or lime to mitigate dispersive materials.</p> <p>Re surfacing of the top of butt / face of butt may be required</p>

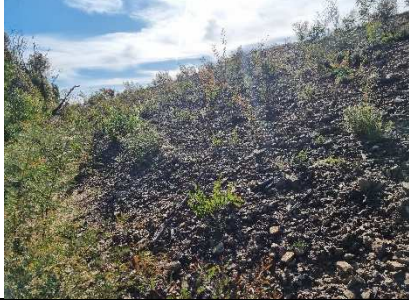
<p>Rear of main butt</p> <ul style="list-style-type: none"> • Vegetation at back of butt is patchy to bare, with cover mostly by small woody species. • Drainage swale at rear of butt is accumulating sediment but still functional. At eastern end the drainage swale is full and no longer functional. • To reduce ongoing sediment loss from this area it would be necessary to topsoil rear of butt or cover with a spray on soil blanket plus additional revegetation works.

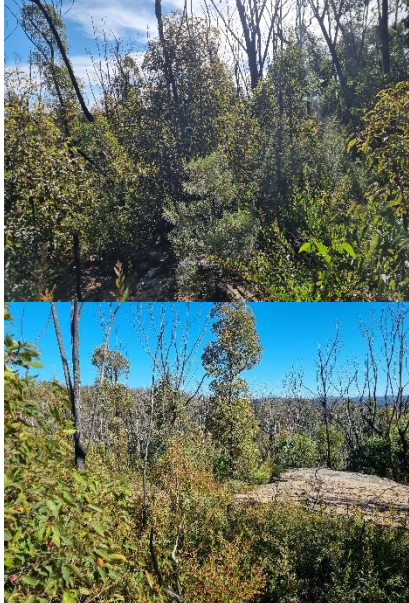
<ul style="list-style-type: none"> • Vegetation external to the 50m range is regenerating vigorously • Thick vegetation establishing across all areas

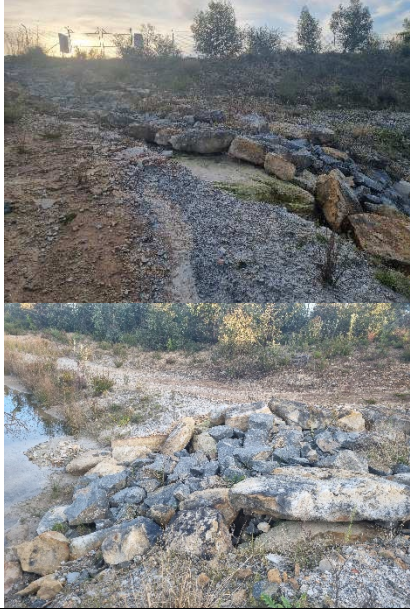
<p>Basins</p>	
<p>Basin 3 (500m east)</p>

<ul style="list-style-type: none"> • The eastern Basin and surrounds show evidence of minor erosion to the batter is however all the sediment is captured within the basin. • The main Basin inlet is showing signs of scour through recent rain events, especially on the southern side. • It's expected that in time this Basin inlet will need to be reworked. • Other secondary inlets to the north stable. The outlet of the basin it's stable. The area below the outlet of the basin this table.

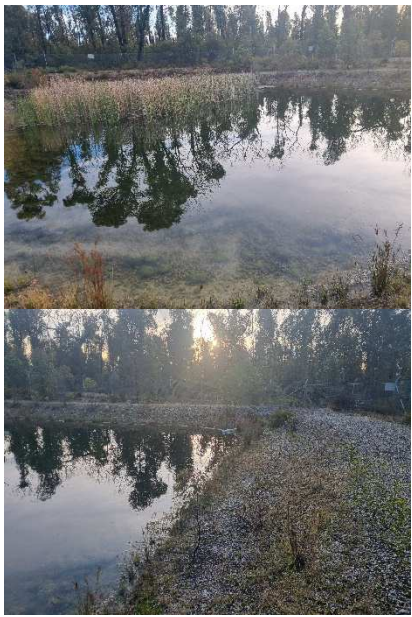
Basin 2 (500m west)

<ul style="list-style-type: none"> • The western basins and surrounds are stable. • The inlet and outlet to the basin are stable. • The water is clear.
<p>Vegetation Health Surface Cover General comment to vegetation on 500m range</p> <ul style="list-style-type: none"> • No significant erosion evident • Significant percentage of surface cover provided by moss and lichens and weeds • Currently much of the cover is also clover – this is different to previous inspections

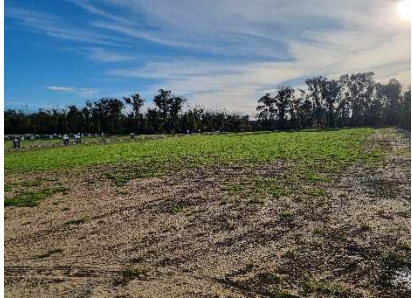
<p>Shooting Point 0m to Intermediate mound 50m</p> <ul style="list-style-type: none"> • Grass cover is good approximately 100% • Some bare areas in North-East corner. • Cover is grass and clover

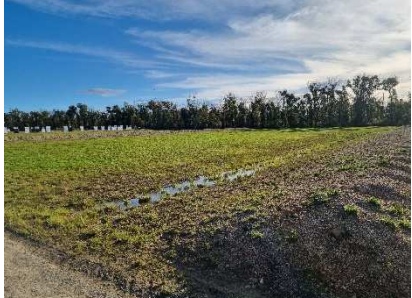
<p>Intermediate mound 50m to intermediate mound 100m</p> <ul style="list-style-type: none"> • Grass cover is good 100% of grass and clover. • Central area is saturated.

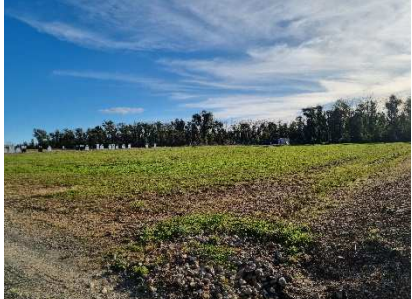
<p>Intermediate mound 100m to intermediate mound 150m</p> <ul style="list-style-type: none"> • Grass cover is good approaching 100% comprising moss lichens and grass and clover. • Water is ponding at the rear of the 100m intermediate mound.

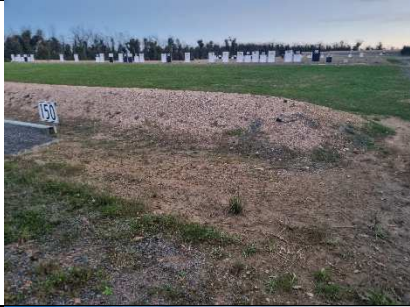
<p>Intermediate mound 150m to intermediate mound 200m</p> <ul style="list-style-type: none"> • Grass cover is good approaching 100% comprising moss lichens and grass and clover.

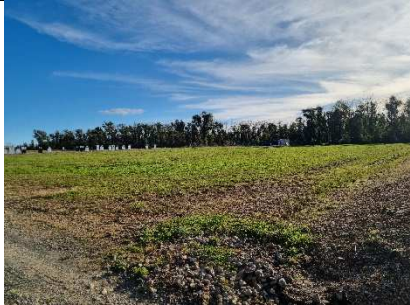
<p>Intermediate mound 200m to intermediate mound 300m</p> <ul style="list-style-type: none"> • Grass cover is good approaching 100% comprising moss lichens and grass and clover. • Poor drainage at rear of target
<p>No Photo</p>	<p>Intermediate mound 300m to intermediate mound 385m</p> <ul style="list-style-type: none"> • Vegetation is good • Ground cover approaching 100% mostly lichen Moss and fresh growth of clover. • Water is ponding at the rear of the 200m stopbutt.

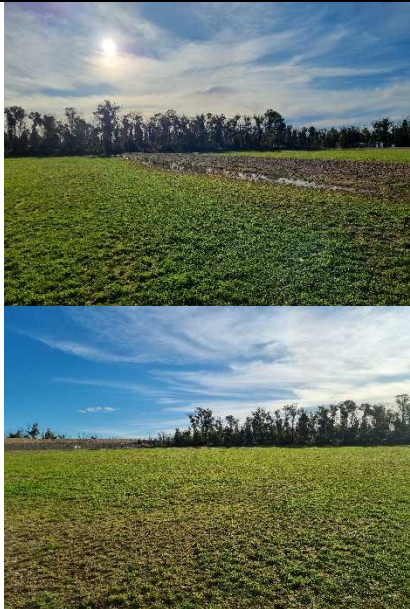
<p>Intermediate mound 385m to 500m Butt</p> <ul style="list-style-type: none"> • Vegetation cover is good • 80% + over most of range except for bare areas (less than 50% cover) in first 20m offset from main stop butt.
<p>No Photo</p>	<p>New lay-down area located to north of basin2</p> <ul style="list-style-type: none"> • Gravel surface is stable • 4 shipping containers placed to replace storage lost in fire

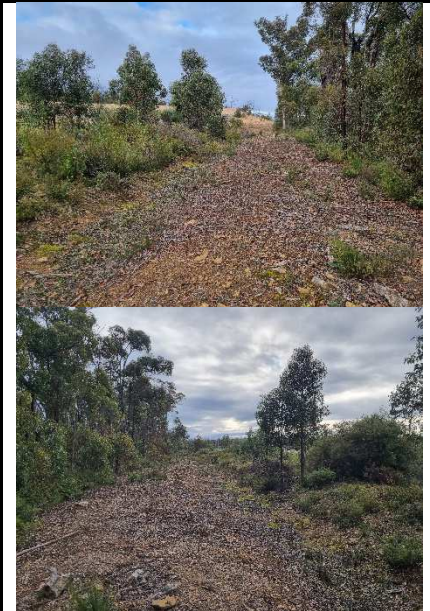
<ul style="list-style-type: none">• Swale drains western side of 500– grassed up and stable

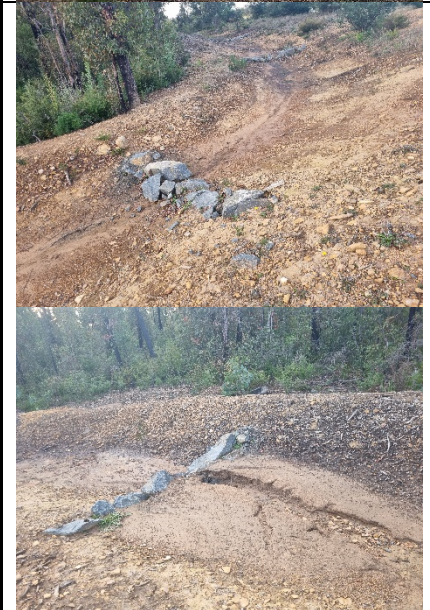
<ul style="list-style-type: none">• Swale drain leading to southwest corner of 500m stop butt• Invert of drainage swales are bare with some scour/sediment loss evident• New rock check dams installed• rock size too large & no fabric installed causing water to be focused through with scour underneath <p>Recommend intermix smaller rock (75mm-150mm) into gaps of existing structures plus some smaller rock (diameter 25mm)</p>

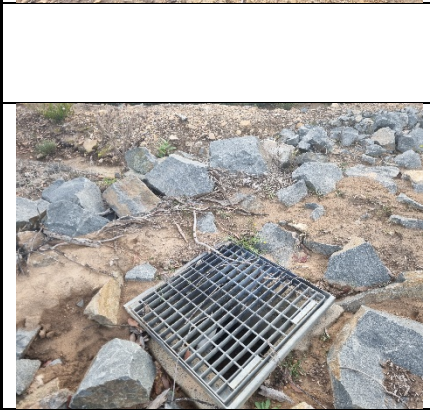
<p>Stormwater pit located at rear western corner of stop butt</p> <ul style="list-style-type: none">• pit function reinstated following fire damage• surrounds of pit protected with rockwork

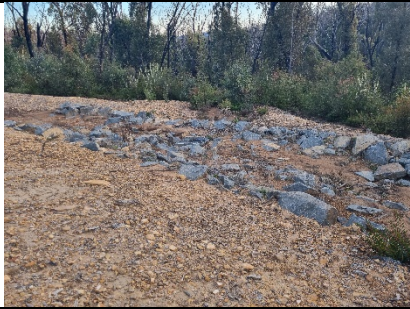
<p>Rock inlet to stormwater pit located western corner at rear of butt</p> <ul style="list-style-type: none"> • Sediment from drainage swale accumulating in rock work

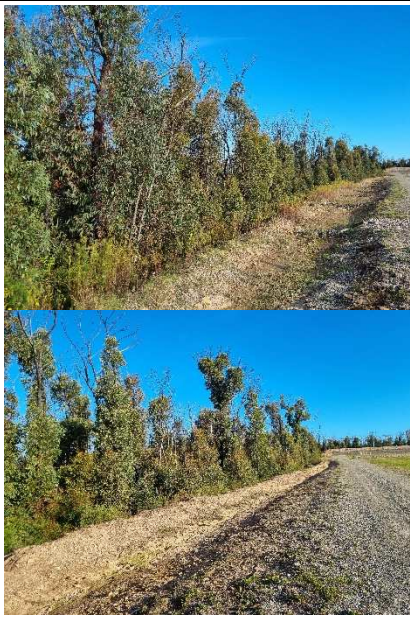
<p>Eastern side</p> <ul style="list-style-type: none"> • Eastern area drainage is good • Some erosion is evident however this is not severe. • Coir logs have been used to control erosion however these appear to be getting eaten by pigs. • The Central portion of the eastern table drain should be monitored and if erosion control is required. It is suggested that small check structures using 75 to 150mm graded ballast shaped into checks dams are recommended.

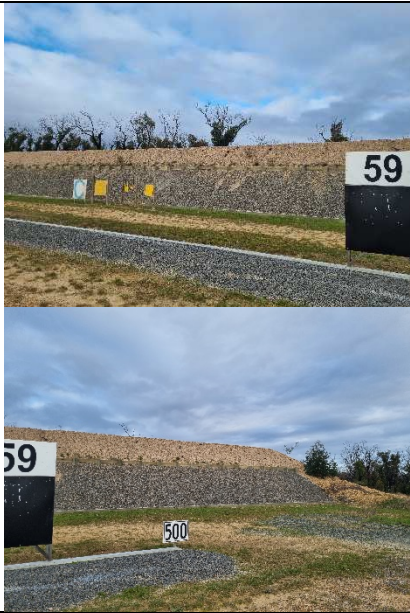
<p>Top of Stop butt at 500m</p> <ul style="list-style-type: none"> • Some riling at front of batter • Occurs where water is pooling on top of butt formation and overflows over face

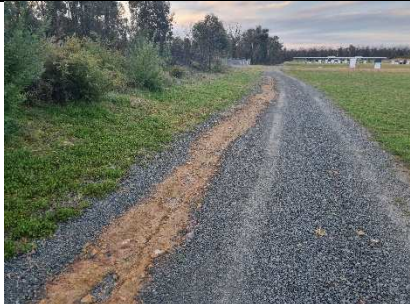
- Access road on eastern side of 500m range
- Moderate scour extending through gravel of access track

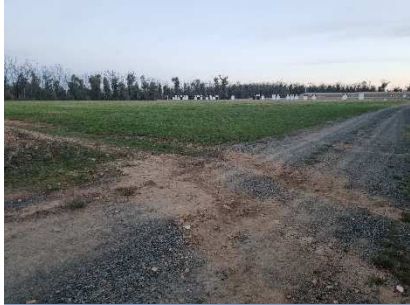
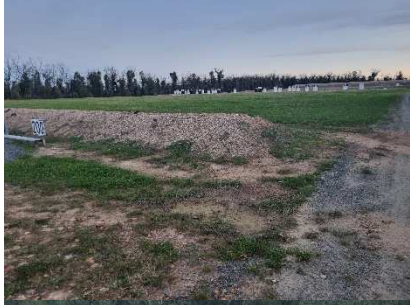
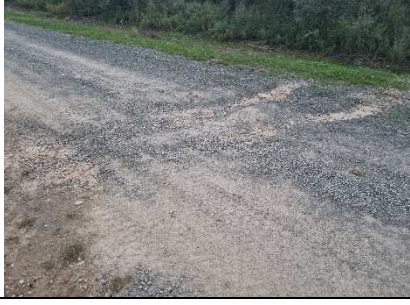
Access roads on each side of 500m range are mostly stable. Minor scour is evident adjacent to the intermediate mounds where these have acted to direct water to the adjacent swales. This scour should be monitored and repaired as required as part of regular ongoing maintenance.

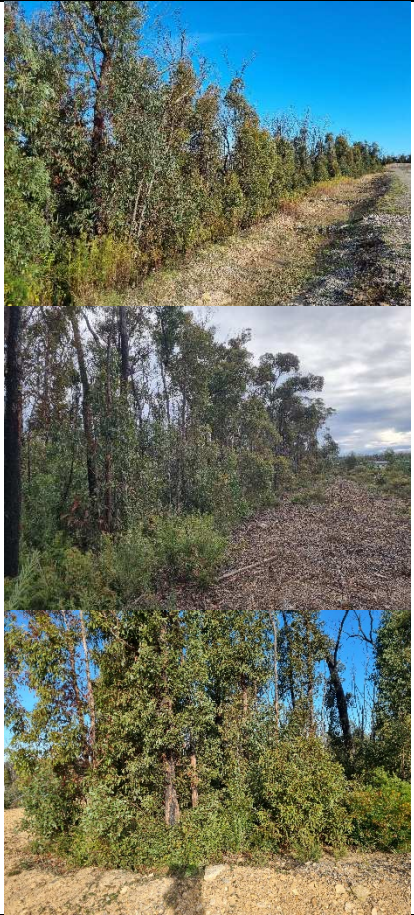
<p>Shot loss assessment along the eastern and western side of the 500m range.</p> <p>No evidence of marks on trees from shot loss.</p>
Engineering controls: Road Infrastructure and Drainage

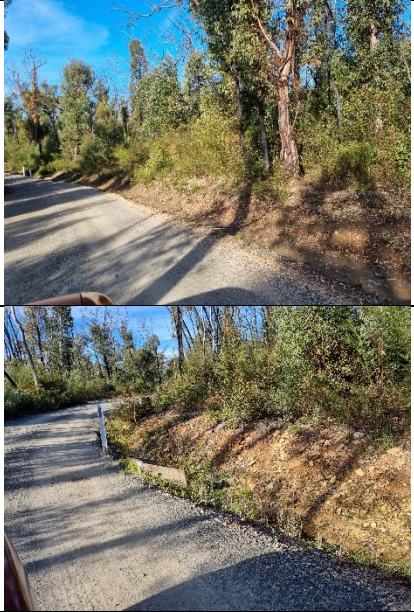
<ul style="list-style-type: none">• All road areas are stable• Table drains and culverts are well maintained and stable

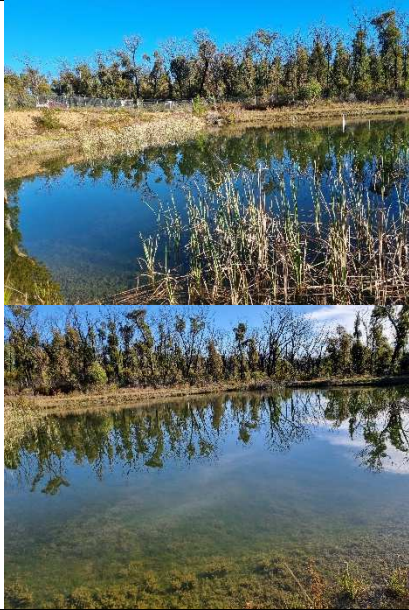
<p>Basin 1 (at future 200m range)</p>	
<p>Basin 1 (Future 200m)</p>

<ul style="list-style-type: none"> • The basin is full and very clear. • Water is flying from the low flow outlet through the creek area below.

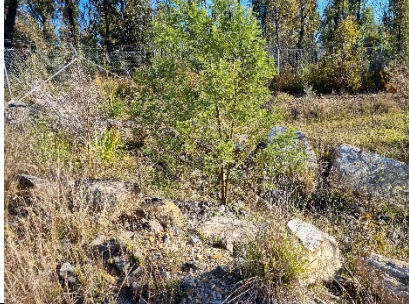
<ul style="list-style-type: none"> • The inlet is stable however; • woody vegetation growing within the inlet should be poisoned so it's growth does not undermine the structure of the inlet.

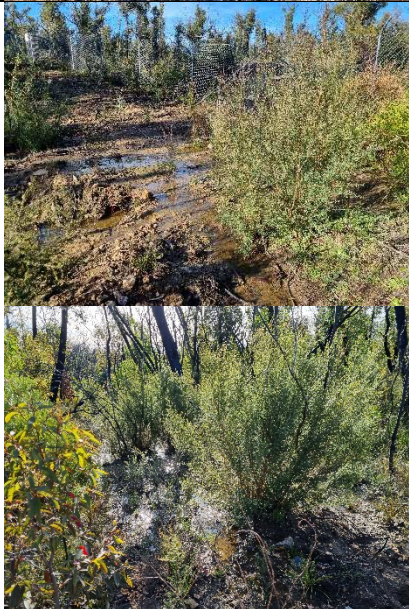
<ul style="list-style-type: none"> • The Basin outlet is stable. • The surrounds of The Basin and access track a stable with no significant scour to be seen
<p>Basin 4 (at car park)</p>

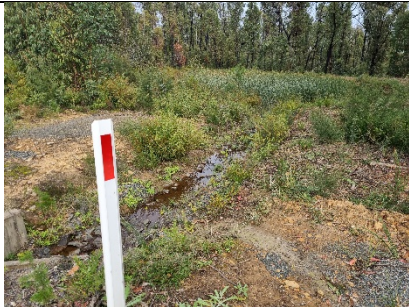
<ul style="list-style-type: none"> • Basin inlet and outlet stable • Basin full of reeds

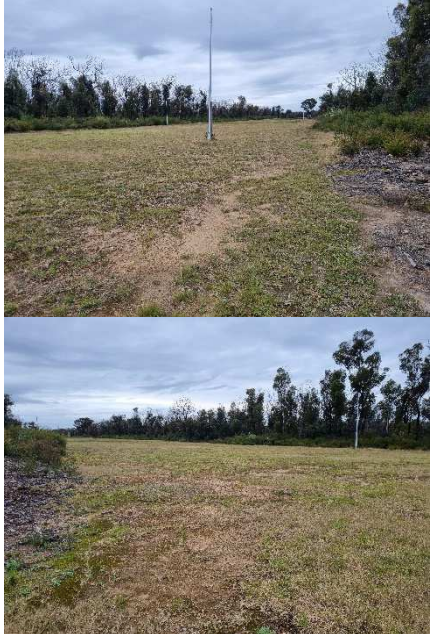
<p>Vegetative health 0-100m from target</p> <ul style="list-style-type: none"> • Improved grass cover from previous inspections • Some areas at sides of range slightly cover more • Rest of range grass cover good

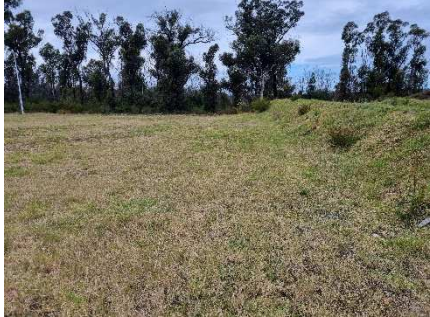
<p>Vegetative health first 6-10m from Mantlet</p> <ul style="list-style-type: none"> • 70% Plus cover with limited bare areas

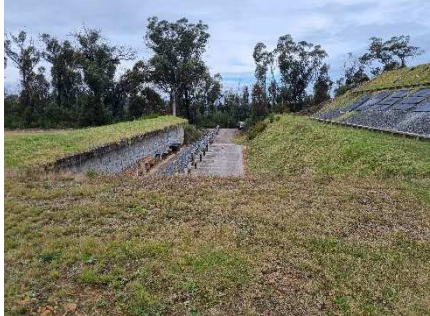
<p>Vegetative health – bench in-front of stop but and bullet catchers</p> <ul style="list-style-type: none"> • Good thick ground cover • Batter to gallery now covered with thick Kikuyu

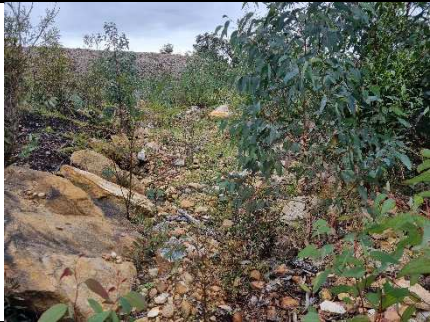
<p>Vegetative health rear of stop butt</p> <ul style="list-style-type: none"> • Vegetation establishing within channel • Mulched area still leaching water following rainfall • Organic sheen evident on surface of water
<p>Concrete Galley</p>

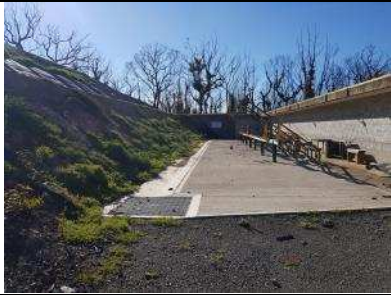
<ul style="list-style-type: none"> • Galley has been swept and is clear of small debris • Other general waste being removed at time of inspection as part of working bee
<p>Engineering controls: Road Infrastructure and Drainage</p>	
<p>No Photos</p>	<p>Roads and Access tracks</p> <ul style="list-style-type: none"> • Access track in fair condition • Some impact of heavy rainfall noted • Leaf litter and debris over surface
<p>No Photos</p>	<p>Safety and signage</p> <ul style="list-style-type: none"> • Signage in place at entrance to 800m range
<p>Engineering controls: Lime treatment Process</p> <ul style="list-style-type: none"> • The lime treatment process is a closed sealed unit. • Inspection of the unit is not possible <p>This item has been removed from the sampling program. Servicing or inspection by a qualified technician may be recommended by monitoring outcomes.</p>
