SOUTHERN HIGHLANDS REGIONAL SHOOTING
COMPLEX (SHRSC)

QUARTER 3 MONITORING REPORT

(FOR SAMPLING 8 APRIL 2024)

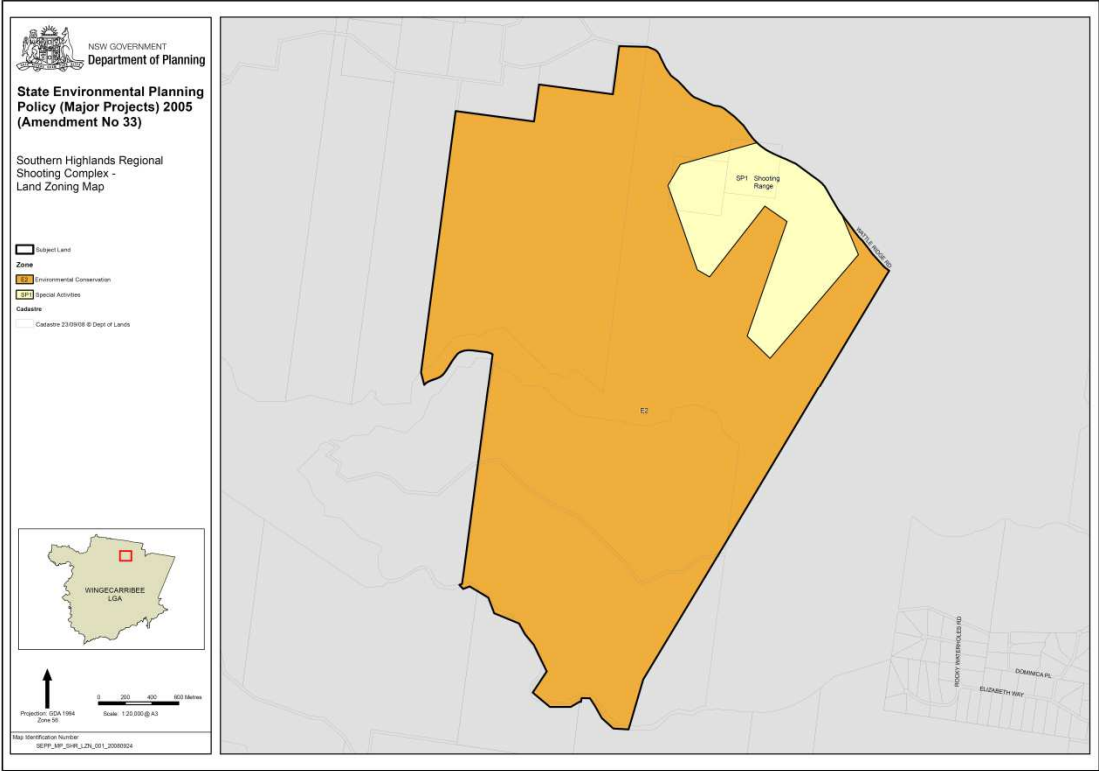
FIGURE 2: SHRSC Zoning Plan showing SP1 Special Activities and E2 Environmental Conservation

Figure 2 presents the current zoning of the SHRSC as SP1: Special Activities – Shooting Range referenced from the NSW Department of Planning SEPP 2005. For the purposes of this contamination assessment the area within the range will therefore be considered ‘recreational and open space’.

The SP1 areas are bounded by a large parcel of land zoned E2: environmental conservation. This E2 land includes the receiving catchments of the shooting ranges from the Wattle Ridge Range to the nearest water course of Rocky Waterholes Creek. For the purposes of this SAQP the area outside the range is considered ‘recreational and open space’.

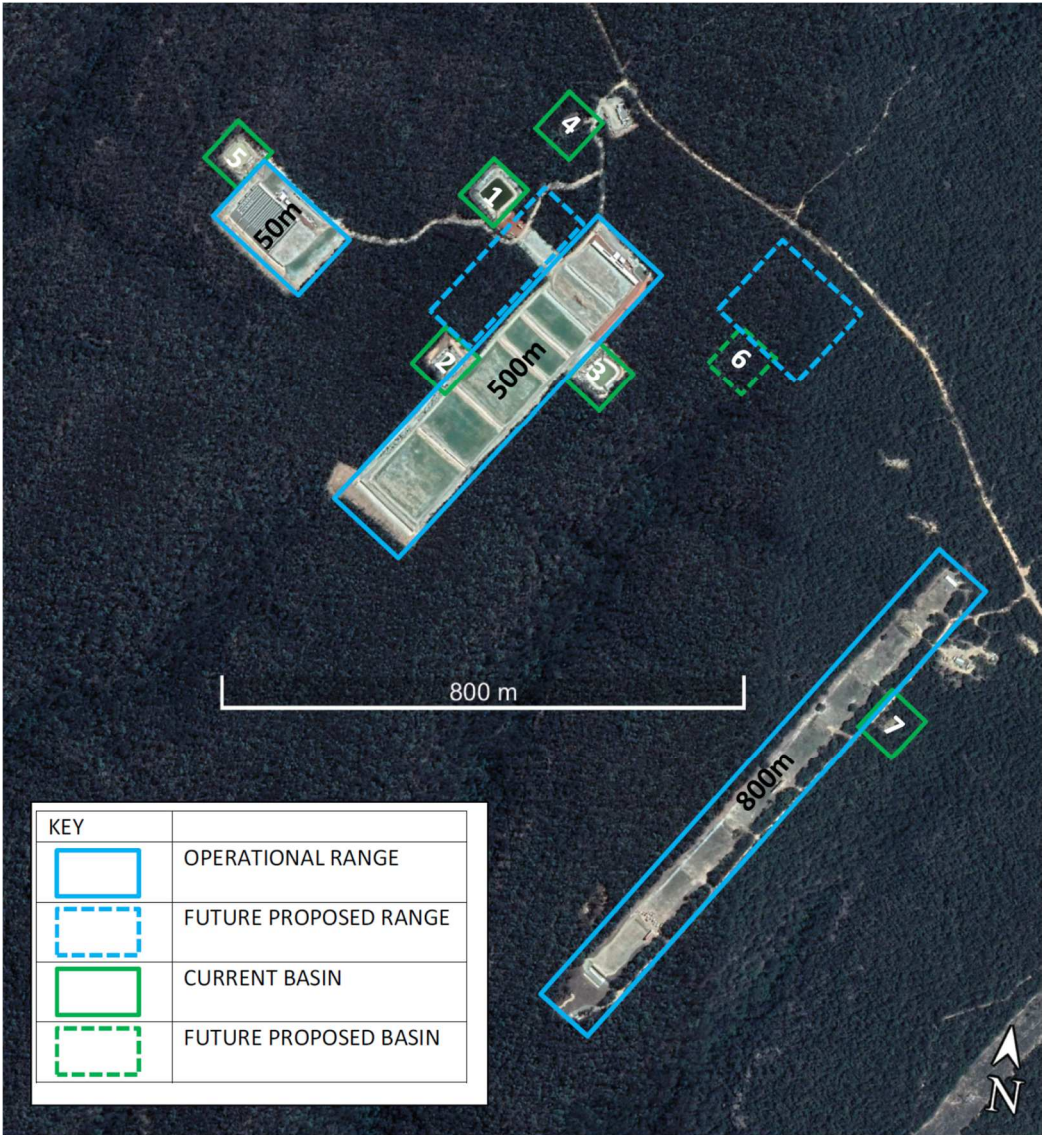
FIGURE 3: Site Layout of the SHRSC

Figure 3 shows the layout at the SHRSC. Range and basin numbers are also indicated.

The investigation is confined to range areas including fairway, rear of stop butt and associated drainage as shown in Figure 3.

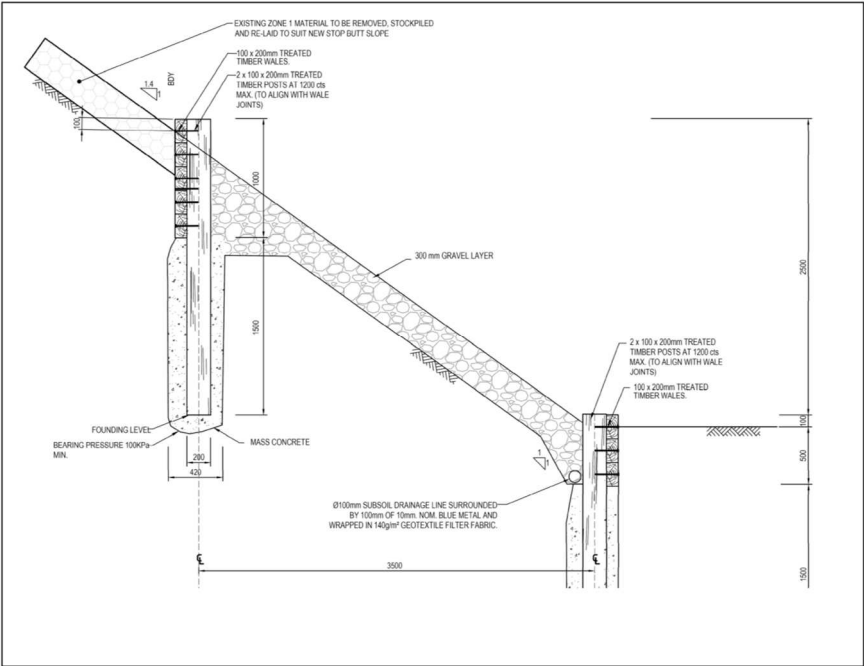
FIGURE 5: Bullet Catcher and Stop Butt Detail.

Figure 5 provides an indicative bullet catcher and stop butt detail.

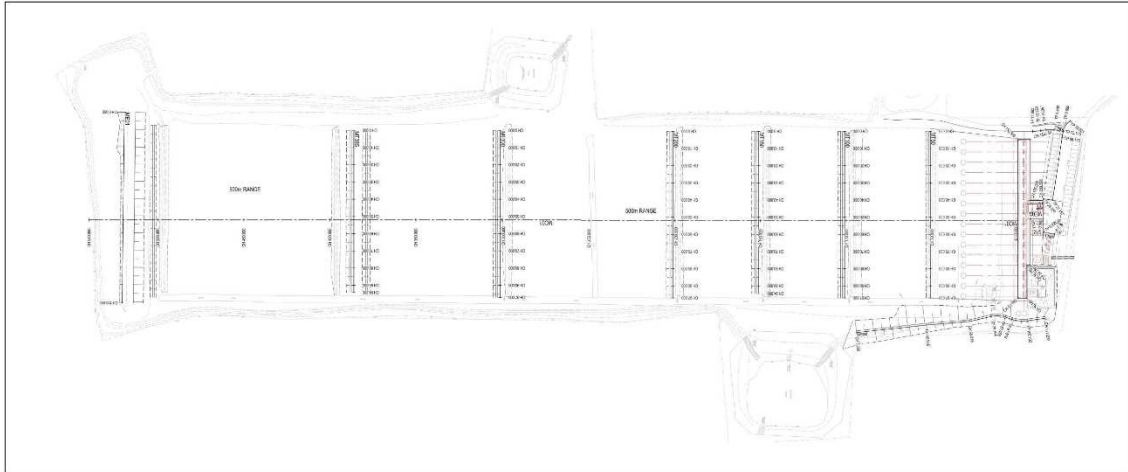
FIGURE 10 - 500m Range Layout

Surface water from the 500m range fairway flows to strip drains set at the rear of the intermediate target mounds and at the toe of the stopbutt face. These drains then are connected via pipes to either of the two water quality basins.

Refer to Figure 10 for the for the current 500m Range layout.

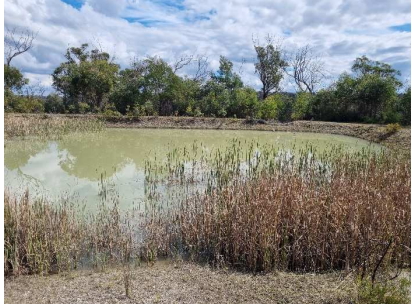
<ul style="list-style-type: none"> • Basin full and turbid

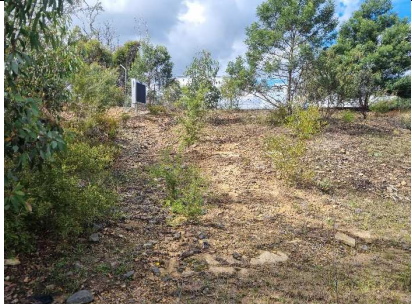
<ul style="list-style-type: none"> • Previously observed scour near entrance does not appear to have progressed.

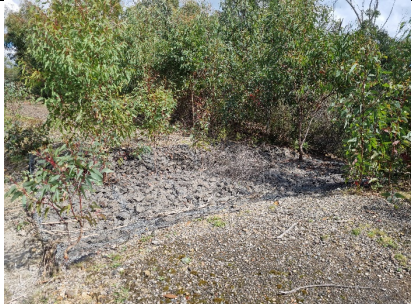
<ul style="list-style-type: none"> • Spillway and outlet area stable • Woody plants are growing in the gabion outlet protection – these plants need to be controlled as they will degrade the baskets

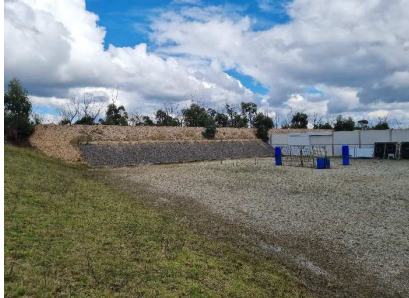
<ul style="list-style-type: none"> • The Gravel & DGB surfaces Range 1 is stable • The Eastern mound to Range 1 is stable with cover greater than 70% • Stability of butt to range 1 is stable • Some woody plants beginning to establish to the top of the butt.

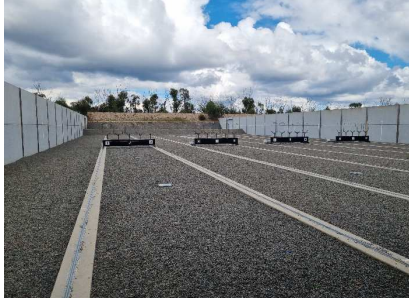
<p>Gravel surfaces Range 2</p> <ul style="list-style-type: none"> • erosion evident at the area from the top of the butt • Some weed growth is evident and appears to be actively controlled. <p>Woody plants beginning to establish to the top of the butt.</p>

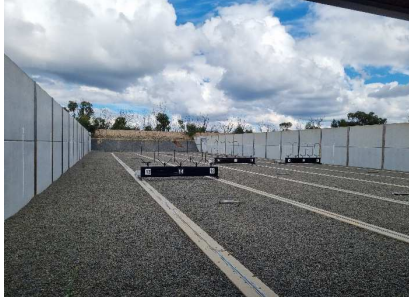
<p>Gravel surfaces Range 3</p> <ul style="list-style-type: none"> • erosion evident at the area from the top of the butt • Some weed growth is evident and appears to be actively controlled. <p>Woody plants beginning to establish to the top of the butt.</p>

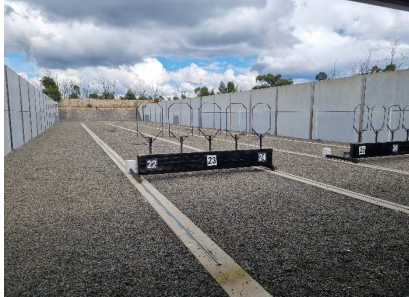
<p>Gravel surfaces Range 4</p> <ul style="list-style-type: none"> • Erosion evident at the area from the top of the butt • Some weed growth is evident and appears to be actively controlled. <p>Woody plants beginning to establish to the top of the butt.</p>

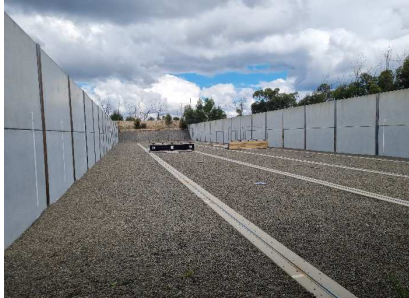
<p>Gravel surfaces Range 5</p> <ul style="list-style-type: none"> • Erosion evident at the area from the top of the butt • Some weed growth is evident and appears to be actively controlled. <p>Woody plants beginning to establish to the top of the butt.</p>

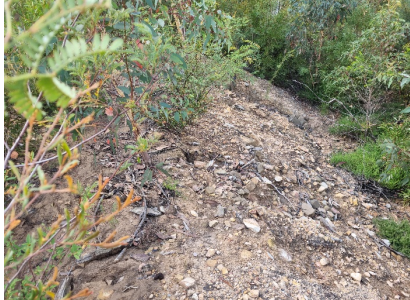
<ul style="list-style-type: none"> • Pit at South East corner of 50m stop butt • Pit is full of sediment and being bypassed <p>Modification of this outlet area may be required. It is recommended that that the pit be replaced with a rock and geotextile drop structure</p>

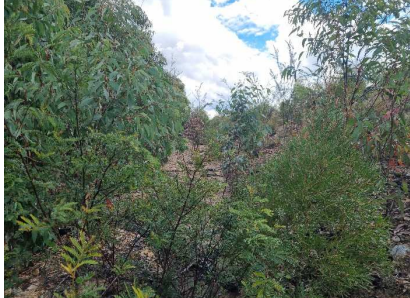
<ul style="list-style-type: none"> • The Drain to stormwater pit is bare • Minor sediment loss is evident • This is consistent with previous observations <p>Further stabilization of the back of the mound will be required to reduce the sediment load to the drainage outlets.</p> <p>This is consistent with previous observations</p>

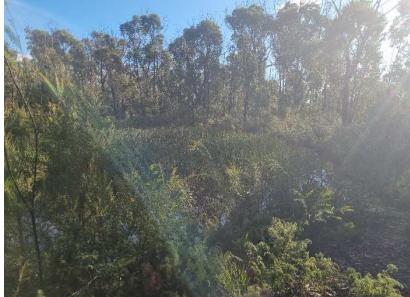
<p>Bushland external to 50m range</p> <ul style="list-style-type: none"> • Natural bushland is dense with little weed growth evident 	
<p>Engineering controls: Lime treatment Process</p> <ul style="list-style-type: none"> • The lime treatment process is a closed sealed unit. • Inspection of the unit is not possible <p>This item has been removed from sampling program. Servicing or inspection by a qualified technician may be recommended by monitoring outcomes.</p>

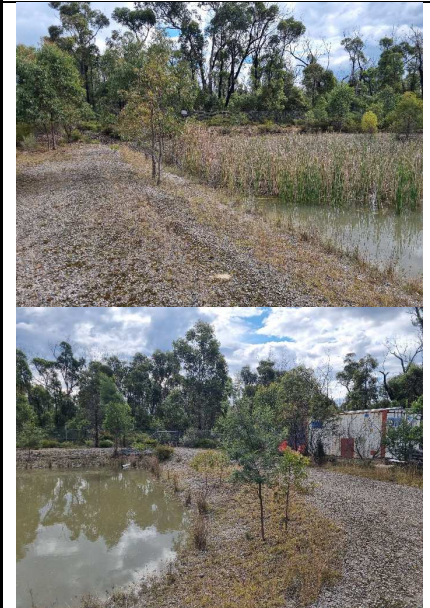
<ul style="list-style-type: none">• Basin is full to trickle/low flow level• Inlet and out let areas to basin are stable• The water is Turbid	
Basin 3 (500m east)

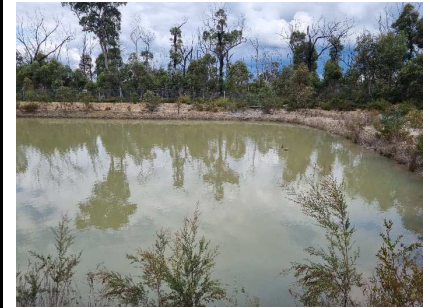
<ul style="list-style-type: none">• Basin is full to trickle/low flow level

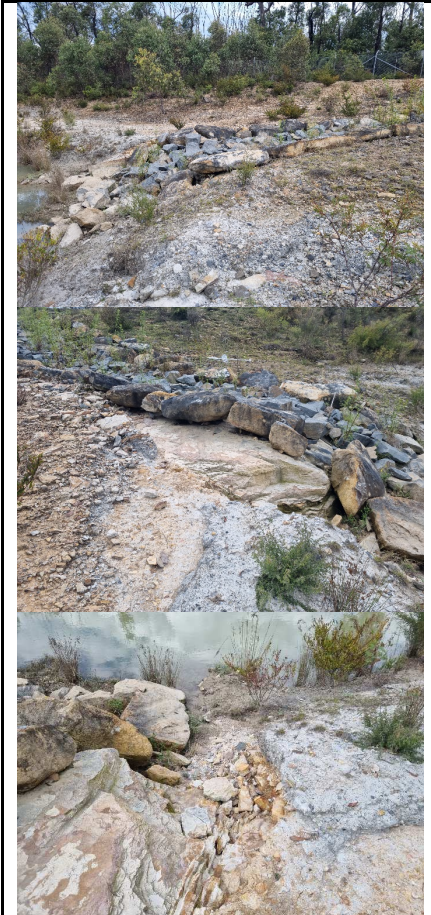
<p>Water is passing out the side of the primary inlet control and is leading to scour adjacent to the inlet and sediment material being moved to the surrounds of the basin inlet.</p> <p>It is likely that re work of the inlet structure will be required. Geotextile will be required within any re work of the invert to the control.</p>

2.	Basin 2 (500m west)	<p>Inlets and outlet areas are stable. No issues evident or required action.</p>
3.	Basin 3 (500m east)	<p>Significant erosion has occurred at the main (Southern) inlet of the basin with placement of rock. Water is passing out the side of the inlet control and is leading to scour adjacent to the inlet.</p> <p>Re-work the inlet structure will be required.</p> <p>It is recommended that re work is undertaken to reshape the inlet channel to create a defined inflow. The new rock work should be under-laid with geotextile.</p> <p>The rock used should consist of well graded angular material. Geotextile will be required under the rock to create a stable inlet.</p> <p>Review other adjacent inlets at this time to confirm if additional work should be scheduled.</p> <p>Woody plants are establishing in the outlet of the basin – these will need to be controlled as part of scheduled maintenance.</p>

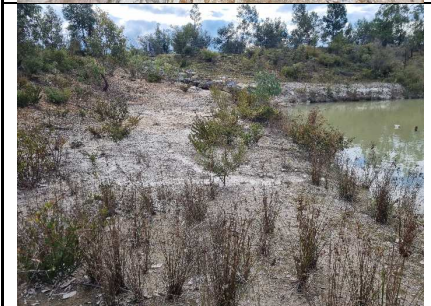
<p>The secondary inlets are stable with surface erosion not progressing</p>

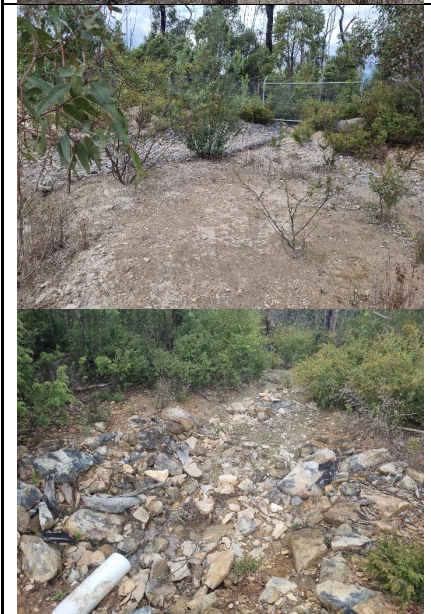
<p>The outlet control is stable.</p> <p>Some woody plants are establishing within the gabions . These will require treatment before the growth impacts the baskets</p> <p>The area below the outlet is stable.</p>

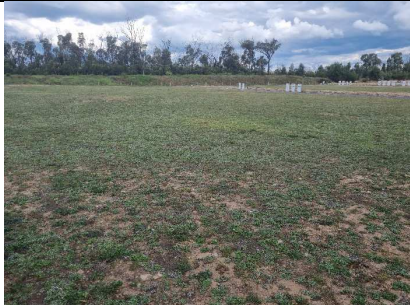
<p>Shooting Point 0m to Intermediate mound 50m</p> <ul style="list-style-type: none"> • Ground cover good – greater than 70% • Nil erosion evident

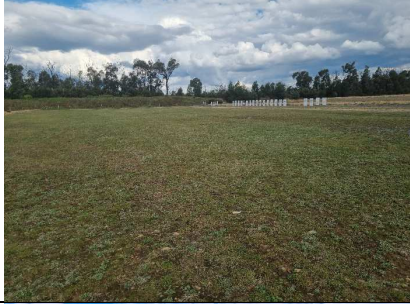
<p>Intermediate mound 50m to intermediate mound 100m</p> <ul style="list-style-type: none"> • Ground cover good – greater than 70% • Grasses and lichens • Some bare patches • Nil erosion evident • Some ponding evident in the central areas

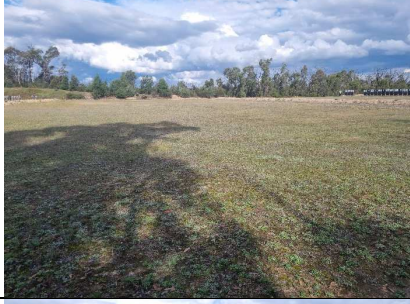
<p>Intermediate mound 100m to intermediate mound 150m</p> <ul style="list-style-type: none"> • Ground cover good – greater than 70% • Grasses and lichens • Nil erosion evident

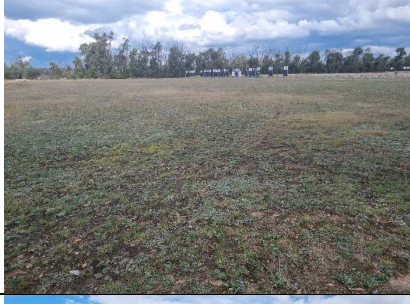
<p>Intermediate mound 150m to intermediate mound 200m</p> <ul style="list-style-type: none"> • Ground cover good – greater than 70% • Grasses and lichens • Nil erosion evident

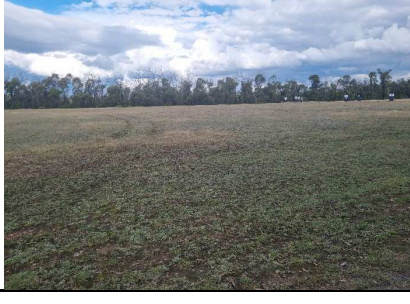
<p>Intermediate mound 200m to intermediate mound 300m</p> <ul style="list-style-type: none"> • Ground cover good – greater than 70% • Grasses and lichens • Some bare patches • Nil erosion evident

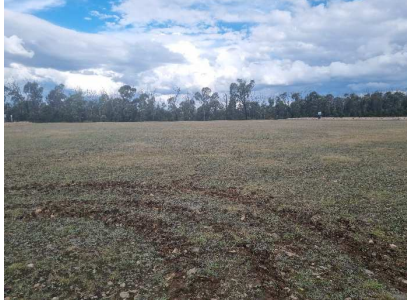
<p>Intermediate mound 300m to intermediate mound 385m</p> <ul style="list-style-type: none"> • Ground cover good – greater than 70% • Grasses and lichens • Nil erosion evident
 	<p>Intermediate mound 385m to 500m Butt</p> <ul style="list-style-type: none"> • Ground cover good – greater than 70% • Bare areas/patchy areas at the southern end of the range • Grasses and lichens • Nil erosion evident

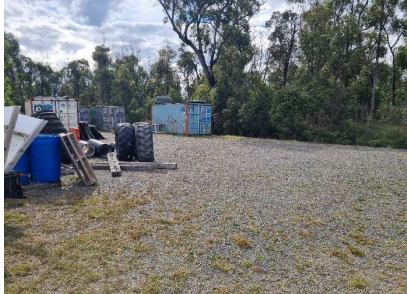
<p>Gravel lay down area located to north of basin 2</p> <p>Gravel surface stable. Limited weed growth is evident.</p>
 	<p>Swale drain leading to south west corner of 500m stop butt</p> <ul style="list-style-type: none"> • Invert of drainage swales bare, with some scour/sediment loss evident • Rock check dams installed <p>Recommend intermix smaller rock (75mm-150mm) into gaps of existing structures plus some smaller rock (diameter 25mm)</p>

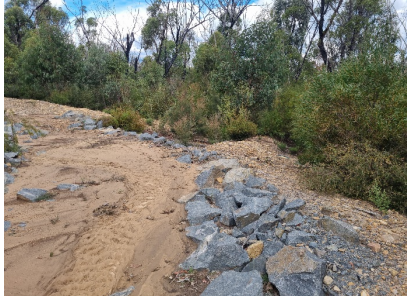
<p>Stormwater pit located at rear western corner of stop butt</p> <ul style="list-style-type: none"> • surrounds of pit protected with rockwork • pit and surrounds are full of sediment. The previous outlet and control is bypassed.

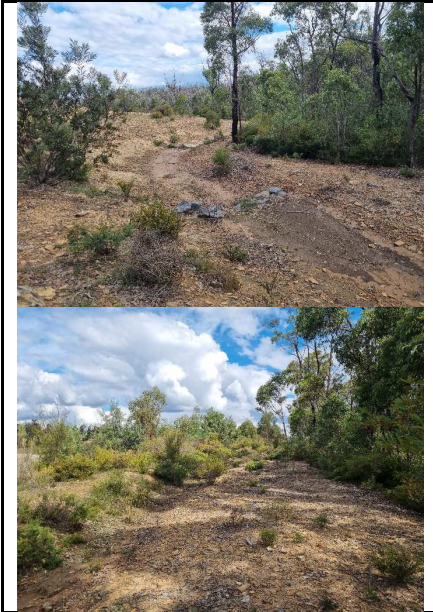
<p>Swale drains at 500m West</p> <ul style="list-style-type: none">• Installed rock checks with diameter 75-100mm• Invert between check dams is acceptably stable.

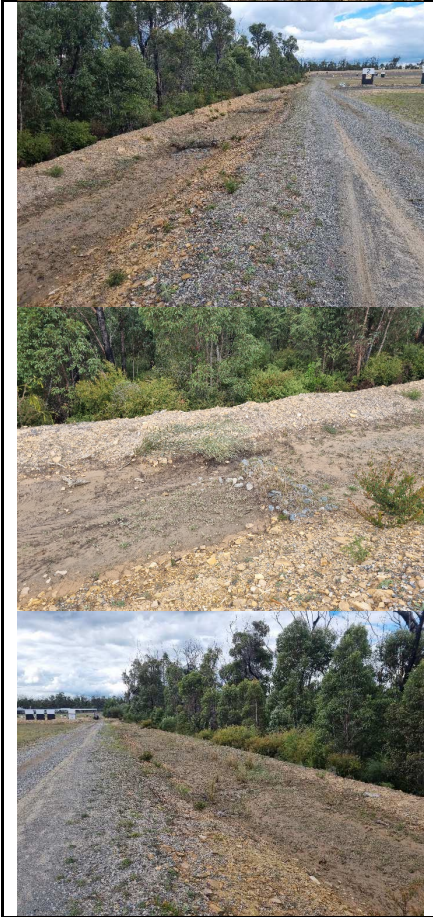
<p>Swale drains at 500m east</p> <ul style="list-style-type: none">• Installed rock checks with diameter 75-100mm• Invert between check dams beginning to stabilise with grass.• Sediment is accumulating behind the numerous check measures• In some cases the check measures require maintenance and reinstatement• In some areas the accumulated sediment has filled the swale to the point that the capacity is threatened and there is risk that water will flood out of the swale to the east. <p>Clearing of sediment and reinstatement of controls and swale capacity is required.</p>

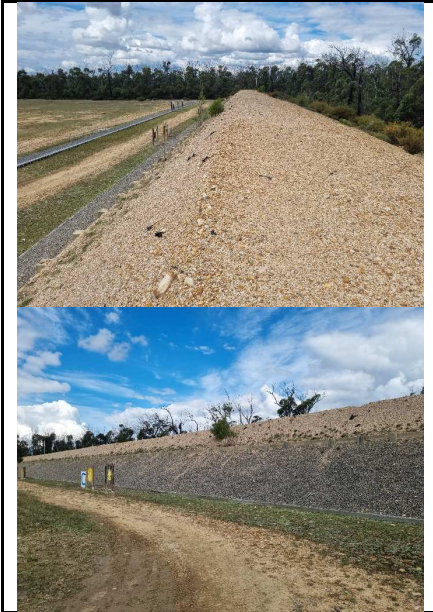
<p>Top of Stop butt at 500m</p> <ul style="list-style-type: none"> • Some riling at front of batter • This riling occurs where water is pooling on top of butt formation and overflows over face • Some vegetation is establishing above the bullet catcher. This vegetation will need to be managed as part of scheduled maintenance.

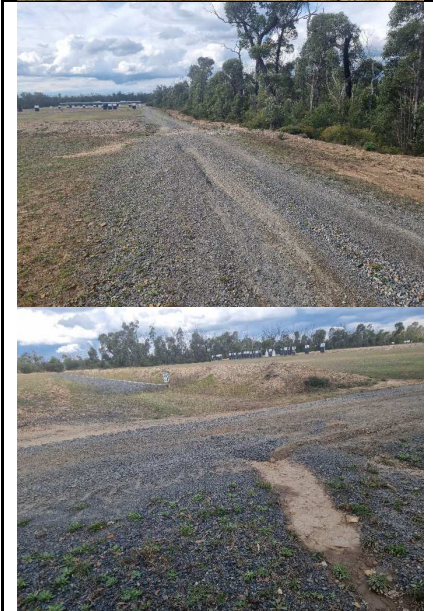
<p>Side track drainage 500m</p> <ul style="list-style-type: none"> • Some riling and localised erosion is occurring from intermediate mounds directing waters to the east and west • These have been repaired in some areas with placement of gravel and aggregate. • Ongoing maintenance of these areas will be required as part of annual programmed works

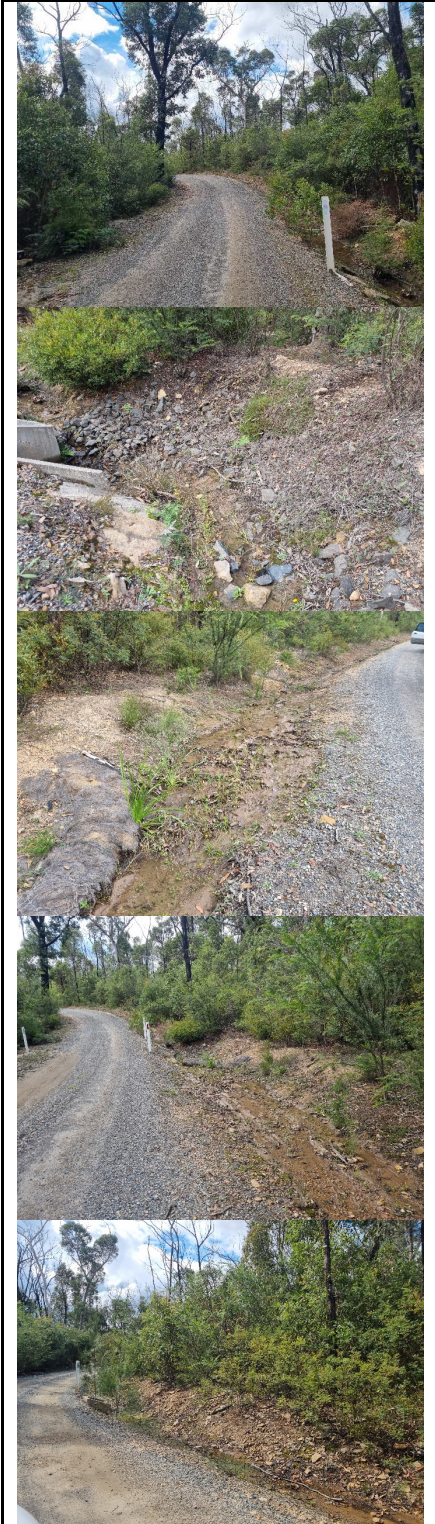
<ul style="list-style-type: none">• All road areas are stable• Coir logs are set to reduce scour and accumulate sediment.• The accumulated sediment will need to be cleared as part of general maintenance• See comments regarding inlet to Basin 1 Drainage• Culvert crossings are maintained.

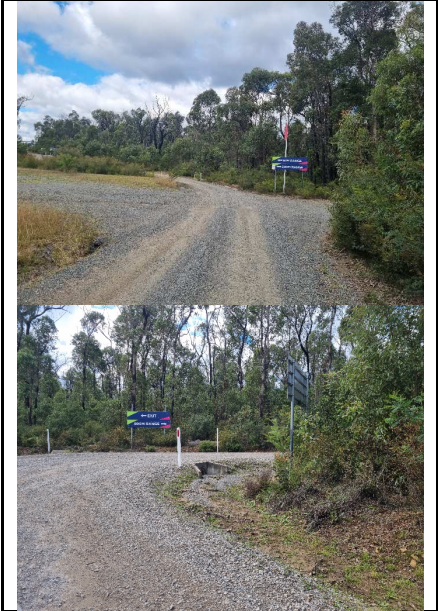
<p>Road drainage leading to Basin 1</p>	<ul style="list-style-type: none">• Sediment movement to the inlet area to Basin 1 has led to this inlet being bypassed.• Maintenance is required in this area.

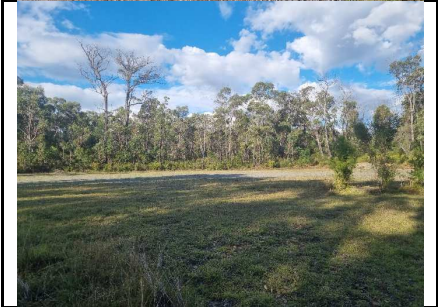
<ul style="list-style-type: none">• The main access area road is stable and well maintained.• Signage is in place

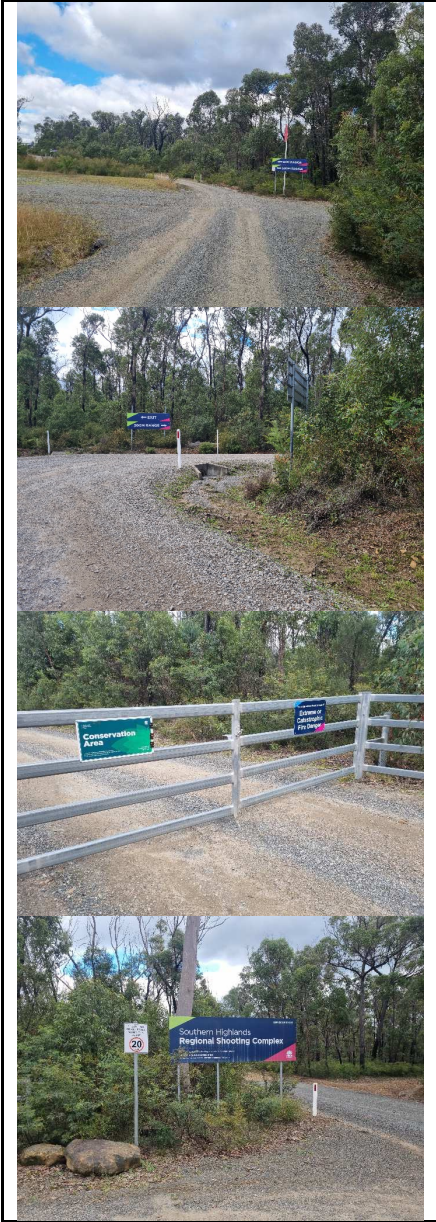
<p>The first photograph shows a gravel path leading into a wooded area with a blue directional sign. The second photograph shows a gravel area with a blue directional sign and a white post. The third photograph shows a gravel area enclosed by a white fence with a green 'Conservation Area' sign and a blue directional sign. The fourth photograph shows a gravel path with a speed limit sign (20) and a large blue sign for the 'Southern Highlands Regional Shooting Complex'.</p>	<p>Safety direction signage is in place.</p>

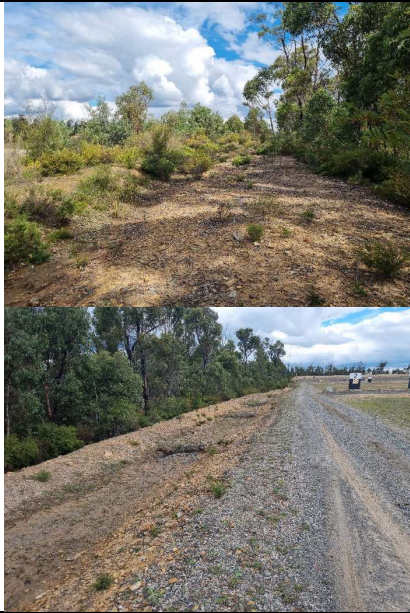
<p>the eastern and western interface between the range and the bushland was walked.</p> <p>No evidence of shot loss was seen at this interface. It is suggested that cut logs and branches be set as targets on the range and photographed to create examples of impacts / bullet strike on woody material.</p>

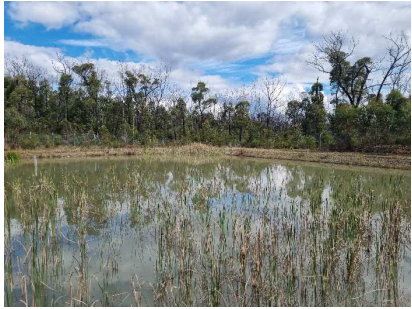
TABLE 15: VISUAL INSPECTIONS – OTHER BASINS		DATE: 08 APRIL 24
Basin 1 (at future 200m range)

<ul style="list-style-type: none"> • Surrounds to basin are stable • Basin is full to low flow outlet pipe

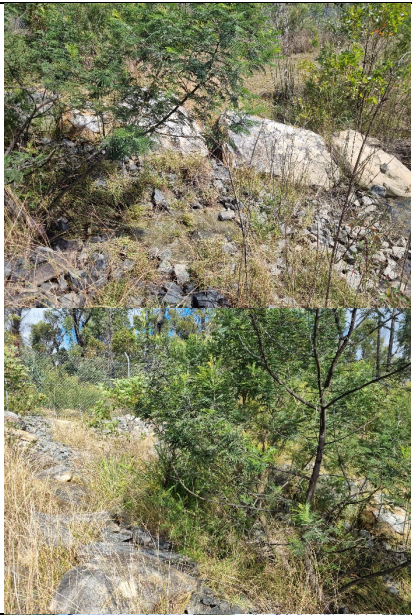
<ul style="list-style-type: none"> • Rock work at the invert has been moved by flows • Geotextile has been exposed • Some woody plants are establishing in the inlet channel. <p>Additional works may be required in this area to control the woody plants before they disturb the channel protections.</p>

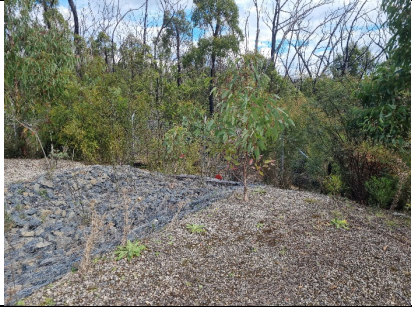
<ul style="list-style-type: none"> • Outlet control/spillway is stable • Previously observed “erosion” or movement of material below basin outlet has not progressed. No further action recommended at this time.

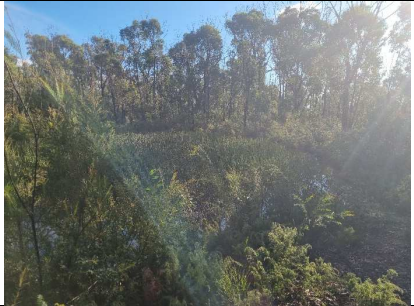
TABLE 15: VISUAL INSPECTIONS – OTHER BASINS		DATE: 08 APRIL 24
Basin 4 (at car park)

<ul style="list-style-type: none"> • Basin inlet and outlet stable • Basin full of reeds • Water level is low • The water is clear

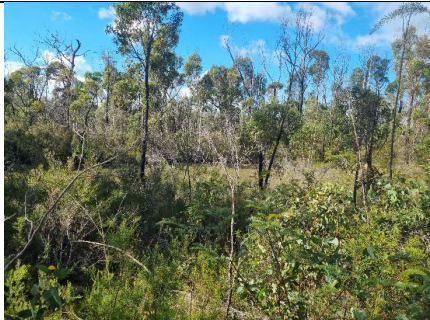
TABLE 16: VISUAL INSPECTIONS – 800M RANGE AND SURROUNDS		DATE: 08 APRIL 24
Basin 7 (800m Range)

<p>Basin 7 - Bushland Pond</p> <ul style="list-style-type: none"> • The pond is full following recent rainfall. The water is turbid. 	
Vegetation Health

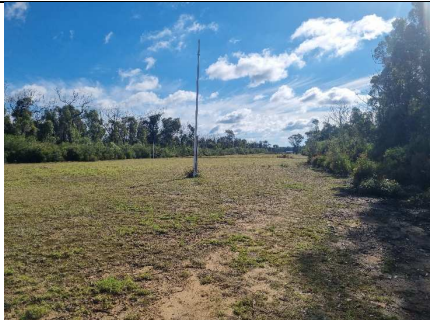
<p>Vegetative health 0-100m from target</p> <ul style="list-style-type: none"> • First 6-10m veg cover with more patchy areas (see below) • Rest of range grass cover good to greater than 70%

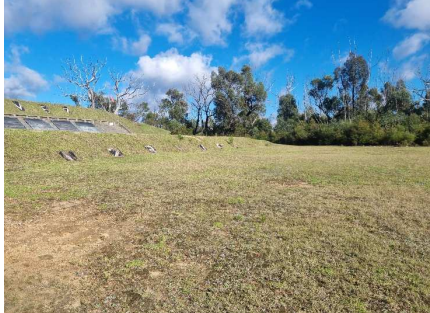
<p>Vegetative health first 6-10m from Mantlet</p> <ul style="list-style-type: none"> • 50-70% cover with patchy bare areas

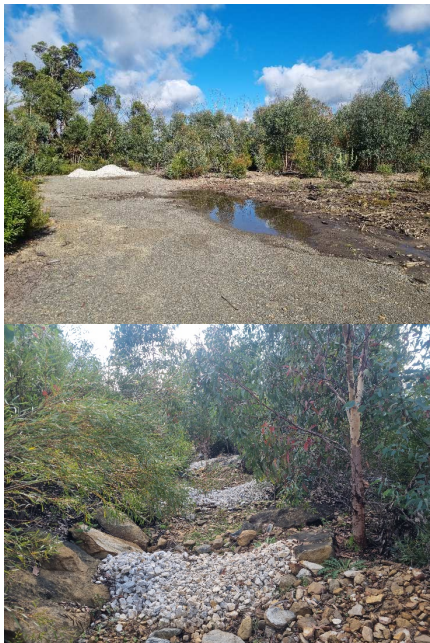
<p>Vegetative health rear of stop butt</p> <ul style="list-style-type: none"> • Vegetation establishing within channel • New limestone check structures have been constructed. Well-shaped per previous recommendations. • The upper check structure is solid and will hold back water • The lower checks are more free draining • Rear area is clear of waste
<p>Concrete Galley</p>

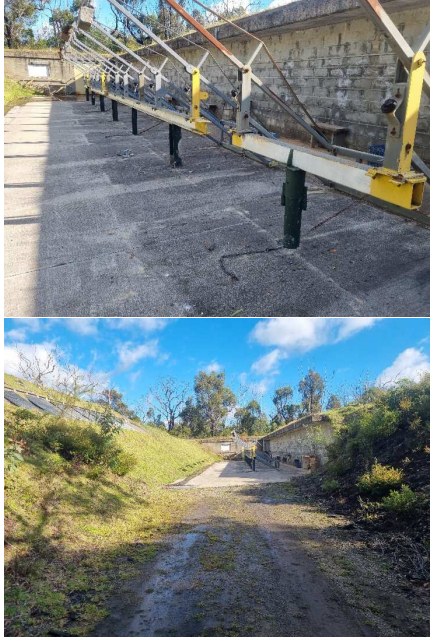
<p>The gallery is clear, no waste or bullet fragments evident.</p> <p>Limited sediment is accumulating within the swale drain at side of the concrete.</p> <p>This sediment is sampled.</p>

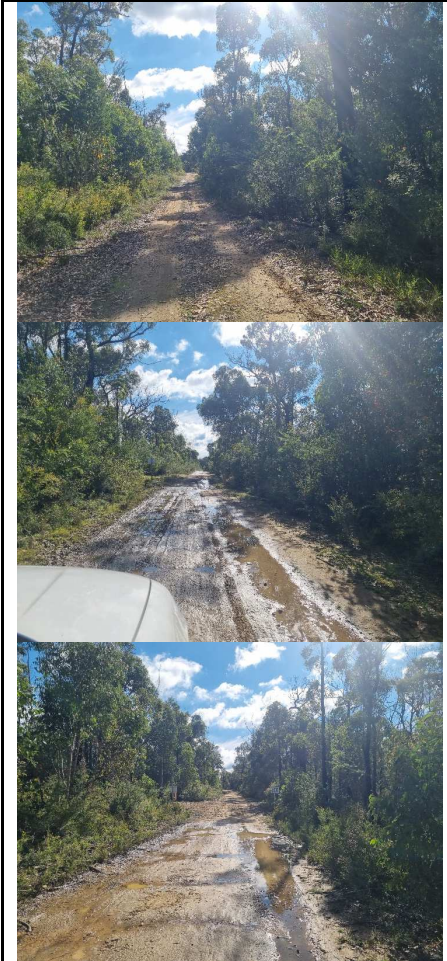
<p>Roads and Access tracks</p> <ul style="list-style-type: none">• Access track in good condition• Water is pooled in some areas however access is still suitable.• Minor cross erosion evident• No action recommended.

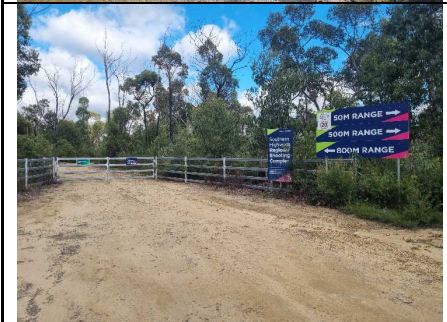
<p>Safety and signage</p> <ul style="list-style-type: none">• Signage is in place at the main gate

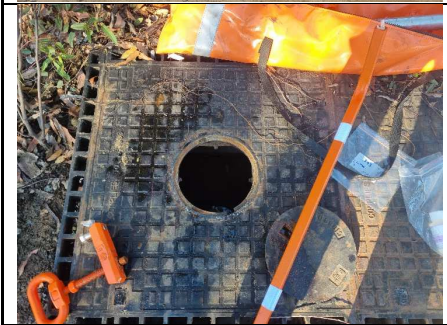
<p>Engineering controls: Lime treatment Process</p> <ul style="list-style-type: none">• The lime treatment process is a closed sealed unit.• Tools were available to open the unit so water could be sampled.• No sediment is within the sealed unit.
