SOUTHERN HIGHLANDS REGIONAL SHOOTING  
COMPLEX (SHRSC)

QUARTER 1 MONITORING REPORT

(FOR SAMPLING 18 NOV 2022)

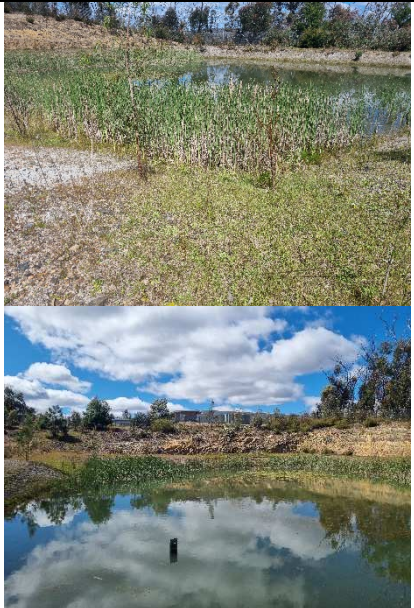
<b>Basins</b>	
<b>Basin 5 (at 50m range)</b>

<ul style="list-style-type: none"> <li>• The basin is full</li> <li>• Note scour near entrance has not progressed.</li> </ul>

<ul style="list-style-type: none"> <li>• Spillway and outlet area stable</li> </ul>
 	<p>Scour over batter at entrance to basin enclosure</p> <p>Does not seem to be progressing</p> <p>No further action required at this time.</p>
<p><b>Vegetation Health/Surface cover</b></p>	
 	<p>Range/Bay 1</p> <ul style="list-style-type: none"> <li>• Evidence Water pooling in central area – not serious</li> <li>• Note riling over batter of butt to South western side</li> </ul> <hr/> <p>Mound SE of Range/Bay1</p> <ul style="list-style-type: none"> <li>• Vegetation cover is good and approaching 100%- surface stable</li> </ul>

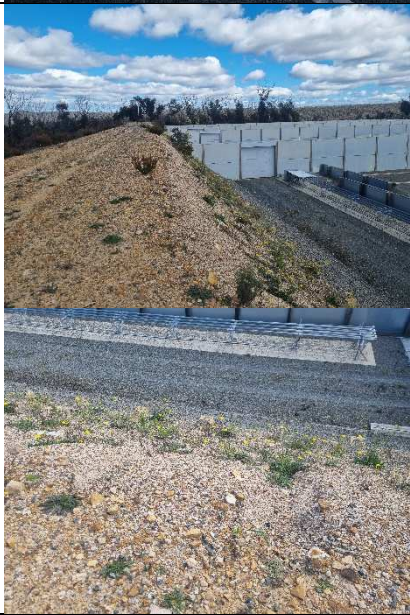
<p><b>Top of Stop butt at 50m</b></p> <ul style="list-style-type: none"> <li>• Some riling at front of batter – multiple locations</li> <li>• Occurs where water is pooling on top of butt formation and overflows over face</li> </ul> <p><b>Rework of top of the mound formation will be required to prevent surface water passing over the batters of the stop butt.</b></p> <p><b>This issue will be monitored to confirm if the issue progresses.</b></p>
<p><b>Vegetation external to the 50m Range</b></p>

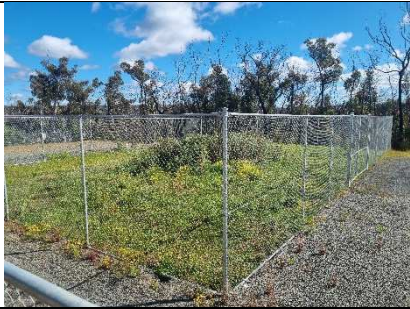
<ul style="list-style-type: none"> <li>• Weeds are establishing over the septic area –</li> <li>• <b>This will require management as part of the annual program.</b></li> </ul>

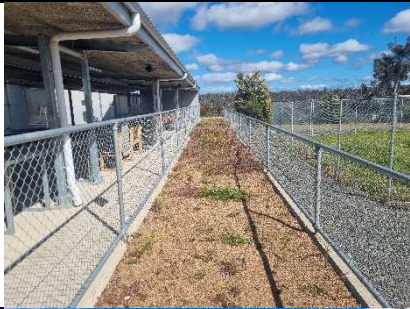
<ul style="list-style-type: none"> <li>• Surface weeds in path areas require management as part of the annual program.</li> </ul>

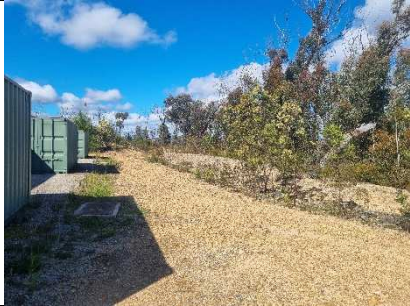
<ul style="list-style-type: none"> <li>• Vegetation is establishing in the drainage swales around the western side of the site.</li> <li>• This is not compromising the drainage function.</li> </ul>

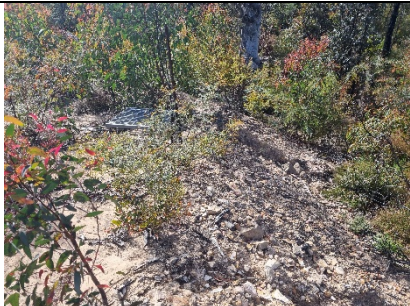
<p>Pit at South East corner of 50m stop butt</p> <ul style="list-style-type: none"> <li>• Pit is full of sediment and being bypassed</li> </ul> <p><b>Modification of this outlet area may be required.</b></p>

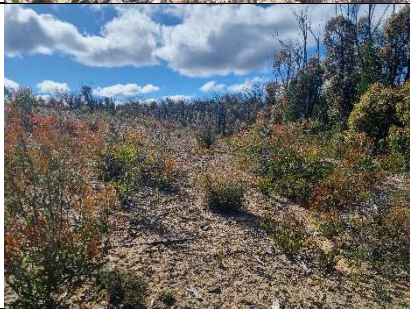
<ul style="list-style-type: none"> <li>• Drain to stormwater pit bare</li> <li>• Minor sediment loss evident</li> </ul> <p><b>Further stabilization of the back of the mound will be required to reduce the sediment load to the drainage outlets.</b></p>

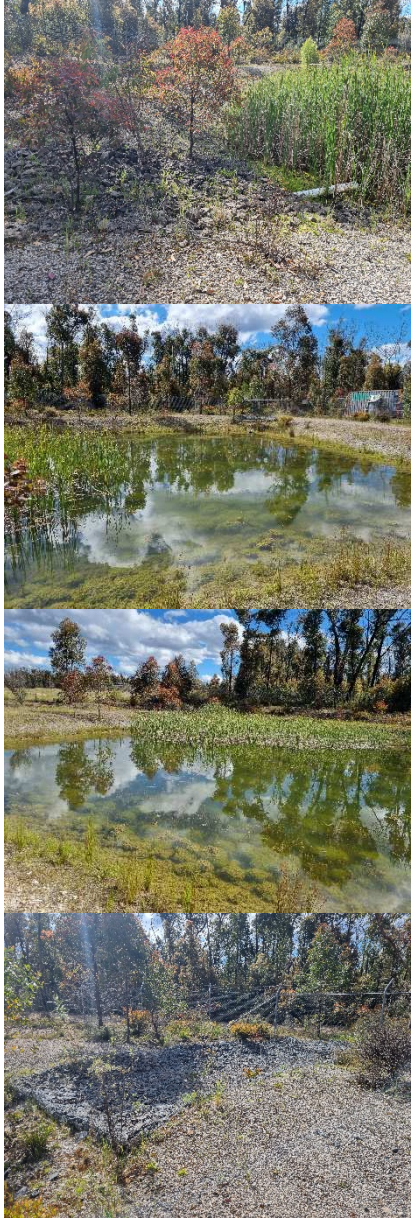
<b>Basins</b>	
<b>Basin 2 (500m west)</b>

<ul style="list-style-type: none"><li>• Basin is full to trickle/low flow level</li><li>• Inlet and outlet areas to basin are stable</li><li>• Water is very clear</li></ul>
<b>Basin 3 (500m east)</b>

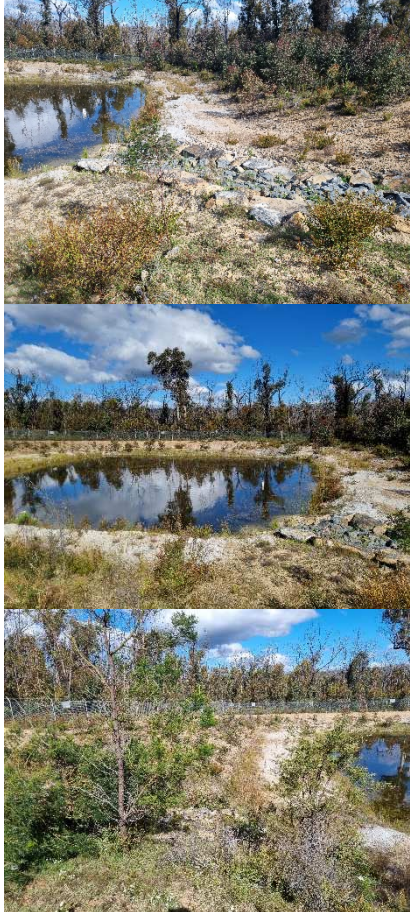
<ul style="list-style-type: none"> <li>• Basin is full to trickle/low flow level</li> <li>• Significant re work has been undertaken at the main (Southern) inlet of the basin with placement of rock</li> <li>• Water is passing out the side of the inlet control and is leading to scour adjacent to the inlet</li> </ul> <p><b>It is likely that re work of the inlet structure will be required</b></p> <ul style="list-style-type: none"> <li>• Vegetation is establishing around the secondary/northern inlet to the basin</li> <li>• This is not compromising its function</li> </ul> <ul style="list-style-type: none"> <li>• The outlet control is stable</li> <li>• The area below the outlet is stable</li> </ul>
<p><b>Vegetation Health Surface Cover</b>  <b>General comments to vegetation on 500m range</b></p> <ul style="list-style-type: none"> <li>• No significant erosion evident</li> <li>• Significant percentage of surface cover provided by moss and lichens and weeds</li> <li>• In several bays drainage is an issue – this will limit plant growth in the heavy or compacted soils</li> <li>• Absence of real topsoil is a limitation in long term. Also very low organic matter</li> </ul>

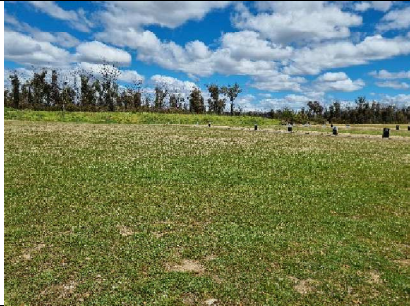
<p><b>Shooting Point 0m to Intermediate mound 50m</b></p> <ul style="list-style-type: none"> <li>• Vegetation cover &gt;70%</li> <li>• Some patchy areas closer to shooting point (northern end)</li> <li>• Nil erosion evident</li> <li>• Surface indicates that water is detained in the area</li> <li>• Thick cover of clover at time of inspection</li> </ul>

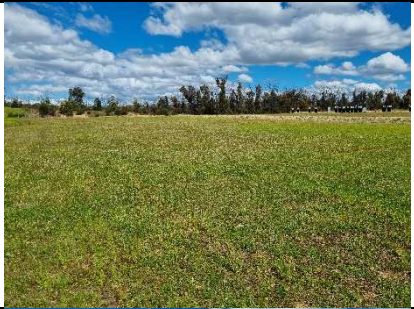
<p><b>Intermediate mound 50m to intermediate mound 100m</b></p> <ul style="list-style-type: none"> <li>• Vegetation cover &gt;70%</li> <li>• Clover cover</li> <li>• Nil erosion evident</li> <li>• Evidence ponding over central area</li> </ul>

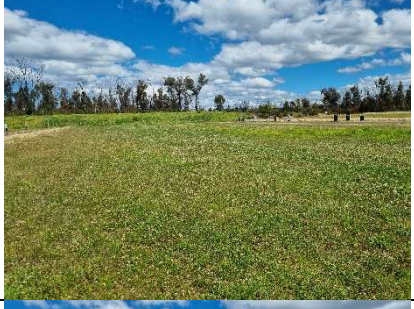
<p><b>Intermediate mound 100m to intermediate mound 150m</b></p> <ul style="list-style-type: none"> <li>• Vegetation cover &gt;70%</li> <li>• Clover cover</li> <li>• Nil erosion evident</li> <li>• Note that the slumping to landscape mound has been repaired and re landscaped</li> </ul>

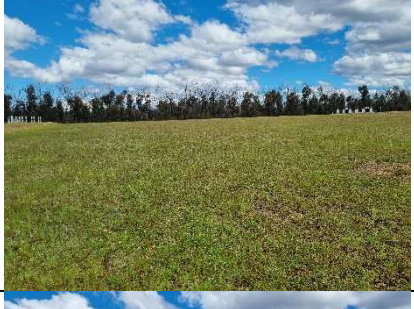
<p><b>Intermediate mound 150m to intermediate mound 200m</b></p> <ul style="list-style-type: none"> <li>• Vegetation cover &gt;70%</li> <li>• Clover cover</li> <li>• Nil erosion evident</li> <li>• Significant moss cover to provide surface cover</li> </ul>

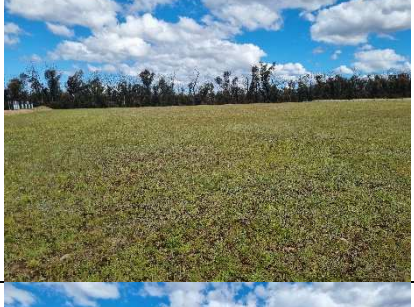
<p><b>Intermediate mound 200m to intermediate mound 300m</b></p> <ul style="list-style-type: none"> <li>• Vegetation cover &gt;70%</li> <li>• Clover cover</li> <li>• Nil erosion evident</li> <li>• Poor drainage at rear of target</li> </ul>

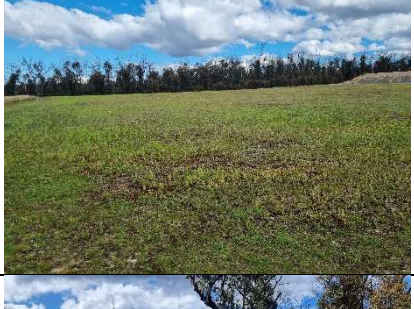
<p><b>Intermediate mound 300m to intermediate mound 385m</b></p> <ul style="list-style-type: none"> <li>• Vegetation cover &gt;70% +</li> <li>• Nil erosion evident</li> <li>• Mosses and Lichens</li> </ul>

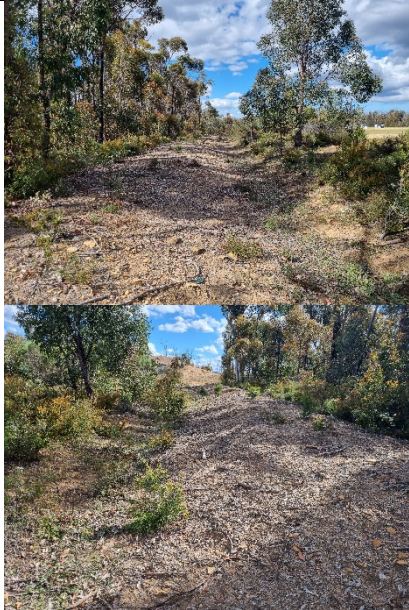
<p><b>New lay-down area located to north of basin2</b></p> <ul style="list-style-type: none"> <li>• Gravel surface</li> <li>• 4 shipping containers placed to replace storage lost in fire</li> <li>• No significant weeds over gravel</li> </ul>

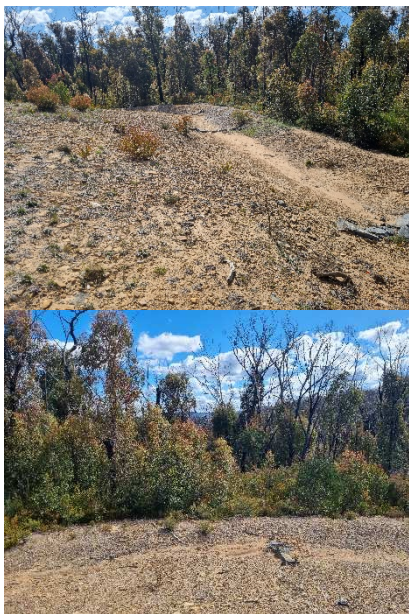
<ul style="list-style-type: none"><li>• Swale drain leading to south west corner of 500m stop butt</li><li>• Invert of drainage swales bare with some scour/sediment loss evident</li><li>• New rock check dams installed</li><li>• rock size too large &amp; no fabric installed causing water to be focused through with scour underneath</li></ul> <p><b>Recommend intermix smaller rock (75mm-150mm) into gaps of existing structures plus some smaller rock (diameter 25mm)</b></p>

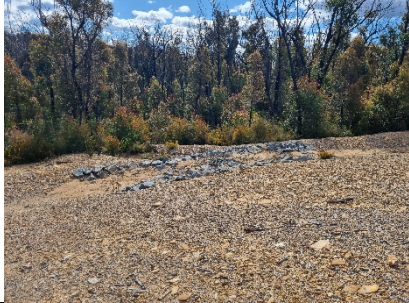
<p><b>Rock inlet to stormwater pit located western corner at rear of butt</b></p> <ul style="list-style-type: none"><li>• Sediment from drainage swale accumulating in rock work</li></ul>

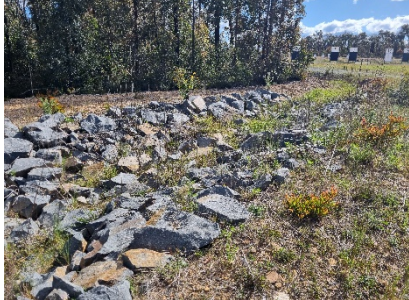
<p><b>New rock work at inlet to Basin 3 (500m East)</b></p> <ul style="list-style-type: none"><li>• Rock work is stable</li></ul>

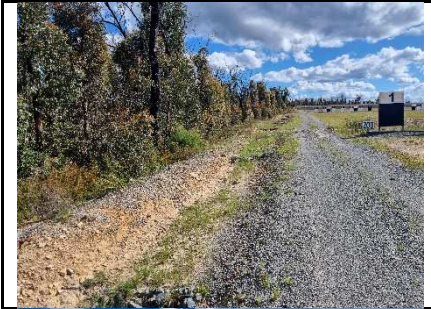
<p><b>Swale drains at 500m east</b></p> <ul style="list-style-type: none"><li>• Some sediment movement observed between the check structures.</li><li>• Grass is establishing over the sides and invert of the drain in some areas</li></ul>

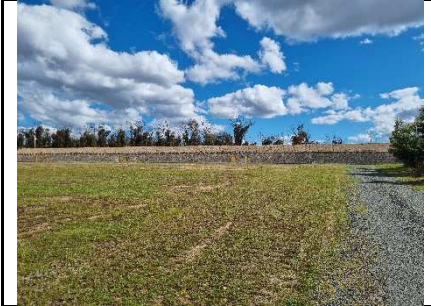
<p><b>Top of Stop butt at 500m</b></p> <ul style="list-style-type: none"><li>• Some riling at front of batter</li><li>• Occurs where water is pooling on top of butt formation and overflows over face</li></ul> <p><b>This may require re work in the future.</b></p>

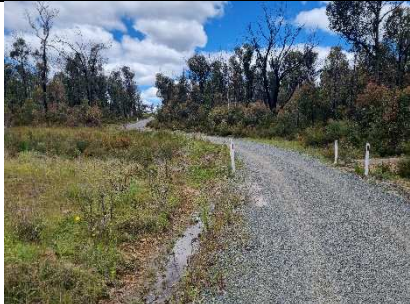
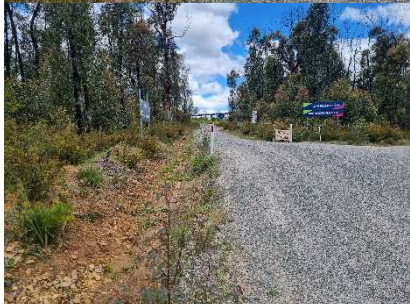
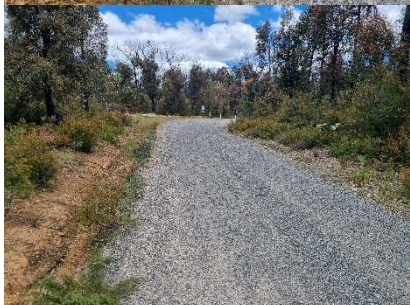
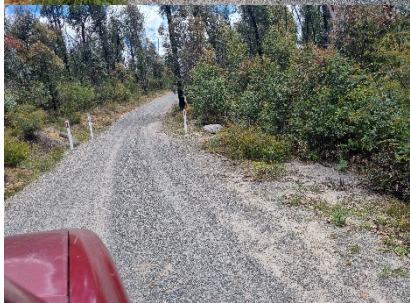
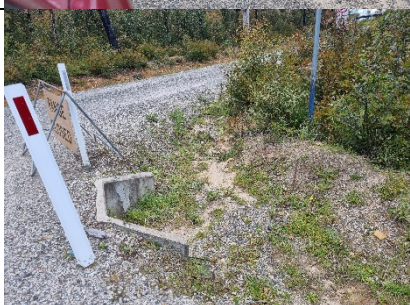
Engineering controls: Road Infrastructure and Drainage

- All road areas are stable
- Some minor erosion within invert of table drains

- Some sediment deposition within table drains and at culverts.

**Maintenance of these area should be scheduled**

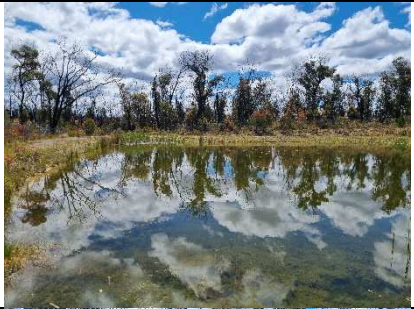
<b>Basin 1 (at future 200m range)</b>

<ul style="list-style-type: none"> <li>• Surrounds to basin are stable</li> <li>• Basin is full to low flow outlet pipe</li> <li>• Water is very clear</li> </ul>

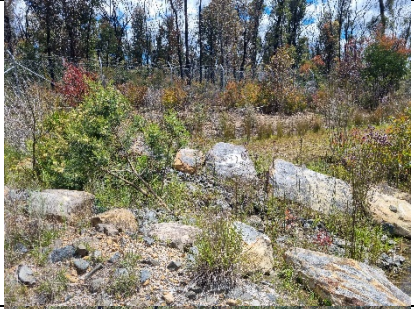
<ul style="list-style-type: none"> <li>• Rock work at the invert has been moved by flows</li> <li>• Geotextile has been exposed</li> </ul> <p><b>Additional works may be required in this area</b></p>

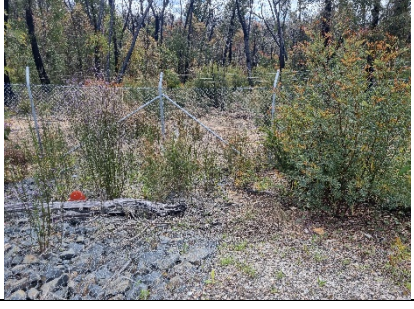
<ul style="list-style-type: none"> <li>• Outlet control/spillway is stable</li> </ul>

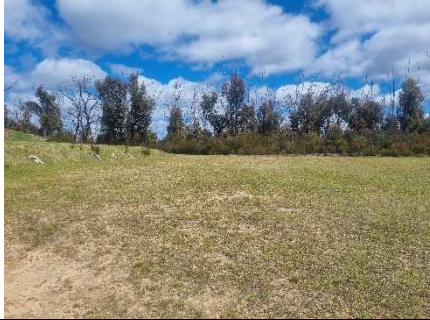
<p><b>Vegetative health 0-100m from target</b></p> <ul style="list-style-type: none"> <li>First 6-10m veg cover is more patchy (see below)</li> <li>Rest of range grass cover good (&gt;70%)</li> </ul>

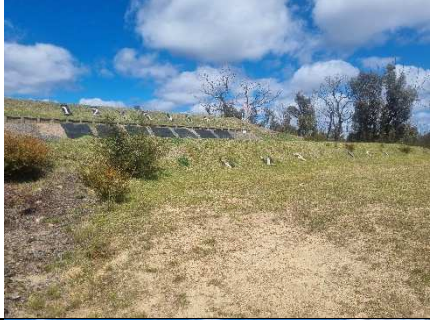
<p><b>Vegetative health first 6-10m from Mantlet</b></p> <ul style="list-style-type: none"> <li>50-70% cover with patchy bare areas</li> </ul>

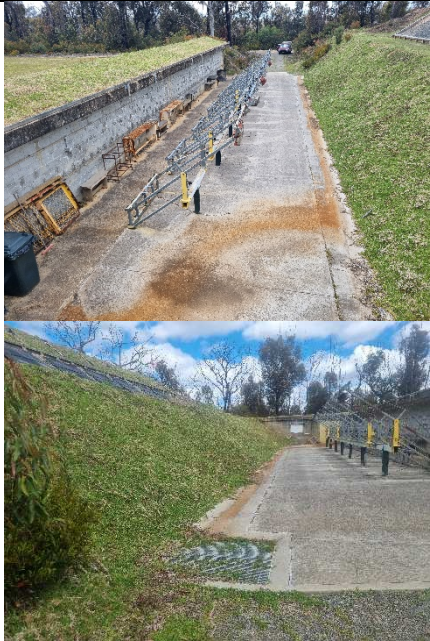
<p><b>Concrete Galley</b></p>

<ul style="list-style-type: none"> <li>• Sediment within swale at gallery</li> <li>• Otherwise swept clear.</li> </ul>
<p><b>Engineering controls: Road Infrastructure and Drainage</b></p>

323	Sediment accumulating within the swale – Gallery	6.3
<p>Sample 323 is accumulated sediment from adjacent areas. It is accumulated as a thin layer within the concrete swale and is regularly cleared/disposed off and swept as part of range maintenance.</p> <p><b>No action is recommended</b></p>		
331	Water - Pond side of 800	2.4
<p>Sample 331 returned a low pH of 2.4 Its basin does not receive runoff from any shot fall areas</p> <p>This value is not consistent with other observations for this location. it may be associated with a sampling error or break down or organic materials. The pH is included in all subsequent sampling exercises.</p> <p><b>No action recommended.</b></p>		
332	Water - Rear Channel 800 (upper)	10.1
<p>Sample 332 returned pH of 10.1 outside the target range of 6.5-8.5. This area is managed as not a shot fall area. (see the CSM for the 800m range provided as figure 6).</p> <p>This value is not consistent with other observations for this location as runoff from the local catchment is assumed to associated with the mulched surfaces adjacent and pH is typically Low.</p> <p><b>This result will be reviewed in following sampling events.</b></p> <p><b>No action at this time.</b></p>

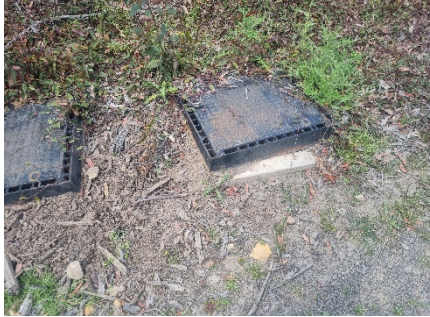
<p><b>Lime treatment process</b></p> <ul style="list-style-type: none"> <li>• <b>Western pit lit has been partially dislodged</b></li> <li>• <b>This was confirmed with the range manager</b></li> </ul>
