SOUTHERN HIGHLANDS REGIONAL SHOOTING
COMPLEX (SHRSC)

QUARTER 2 (2022-23) MONITORING REPORT

(FOR SAMPLING 9-10 FEB 2023)

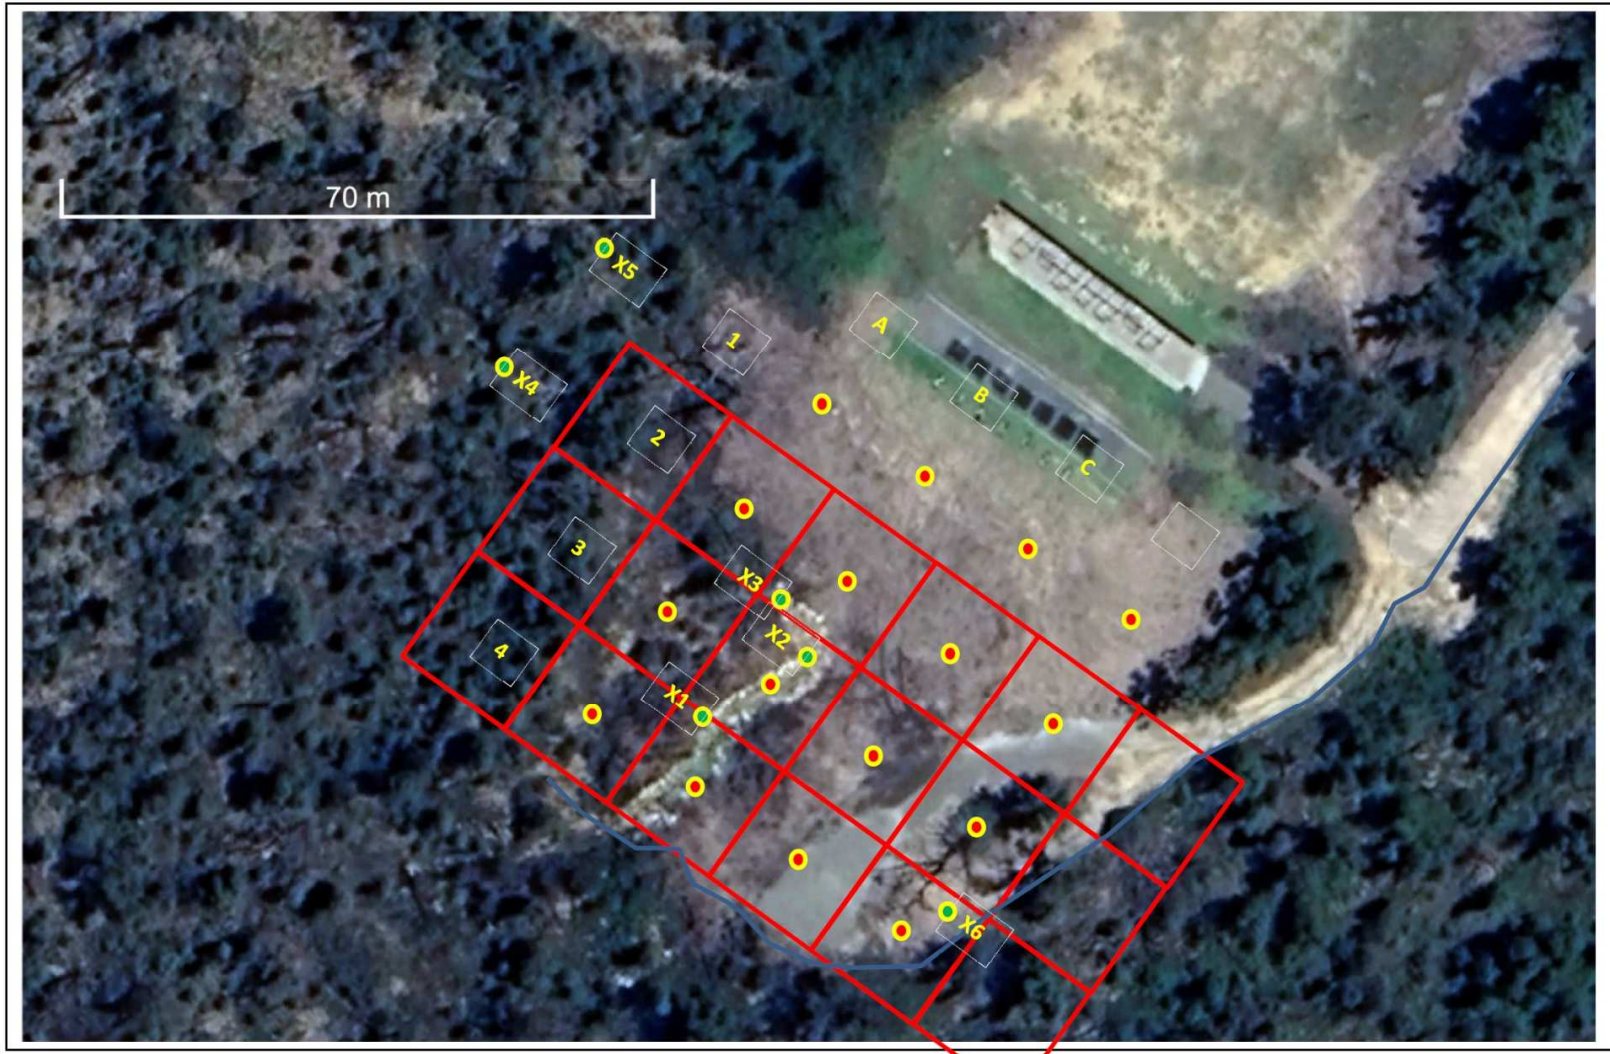
APPENDIX 2: ADDITIONAL SAMPLING REAR OF 800M STOP BUTT

- The catchment to the rear channel was broken up in a 4x4 15m grid with one sample taken at the centre of each grid square.
- Allowance was made for 6x targeted samples based on site observations. These were taken per below.

- X1 Soil from side of outlet channel
- X2 Sediment from invert of outlet channel - mid
- X3 Sediment from invert of outlet channel - upper
- X4 Bushland - west
- X5 Bushland west –reports to external catchment
- X6 Previous location of shipping containers – burnt in fires

Exceedances of other Criteria				
B1	<ul style="list-style-type: none"> • This sample returned a value for Copper and Zinc over the EIL from the WCMP criteria but under the HIL (C & D) Levels • This area is not within the primary or secondary shot fall area and does not report to the sealed lime treatment process • There is a concern that shots are progressing over the butt and landing at its rear. <p>Works have been recommended to provide additional protections and corrections within the outlet drainage from this area.</p>	Copper	2100	
		Zinc	210	
X1	<ul style="list-style-type: none"> • This sample returned a value for Lead over the HIL (C) level but under EIL from the WCMP criteria & the HIL (D) Level. • This area is not within the primary or secondary shot fall area and does not report to the sealed lime treatment process • There is a concern that shots are progressing over the butt and landing at its rear. <p>Works have been recommended to provide additional protections and corrections within the outlet drainage from this area.</p>	Lead	770

It is recommended that a series of shaped limestone check structures should be formed within the drainage swale to detain water and force drainage from the mulched area at the rear of the butt to pass through the limestone.
