SOUTHERN HIGHLANDS REGIONAL SHOOTING
COMPLEX (SHRSC)

2022-23 QUARTER 3 MONITORING REPORT

(FOR SAMPLING 20 APRIL 2023)

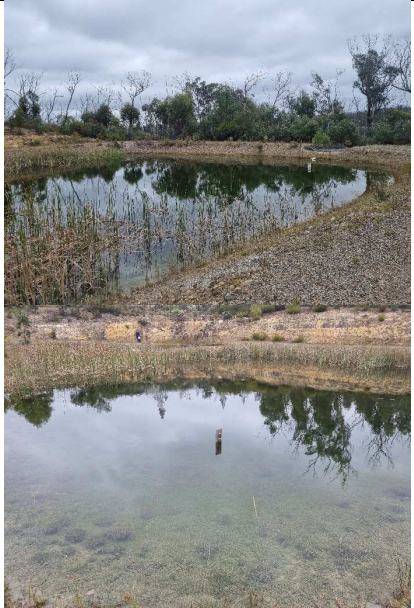
<ul style="list-style-type: none">• Basin full and clear

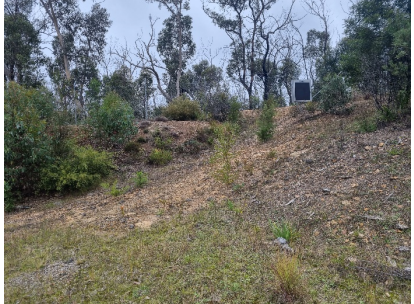
<ul style="list-style-type: none">• Previously observed scour near entrance does not appear to have progressed.

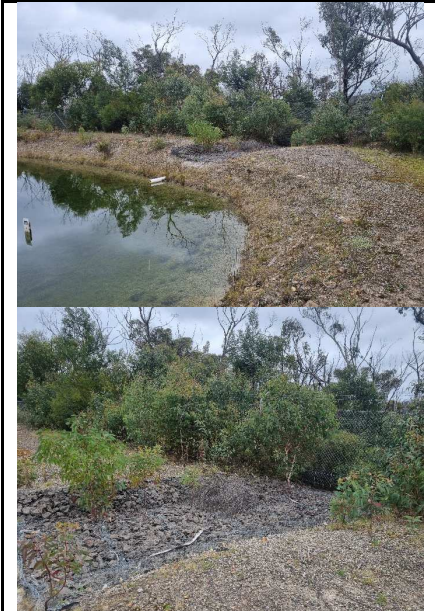
<ul style="list-style-type: none">• Spillway and outlet area stable• Woody plants are growing in the gabion outlet protection – these plants need to be controlled as they will degrade the baskets
Vegetation Health/Surface cover

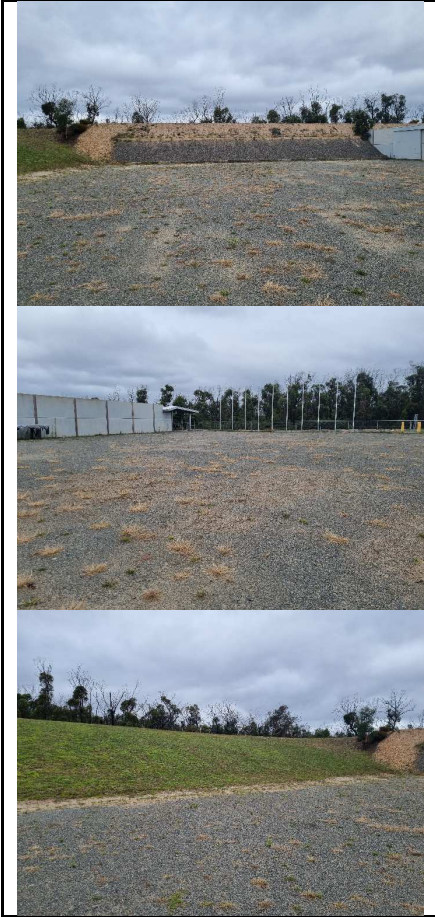
<ul style="list-style-type: none">• The Gravel & DGB surfaces Range 1 is stable• The Eastern mound to Range 1 is stable with cover greater than 70%• The butt to range 1 is stable• Some woody plants beginning to establish to the top of the butt.

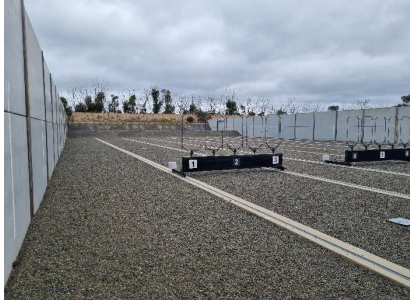
<p>Gravel surfaces Range 2</p> <ul style="list-style-type: none"> • erosion evident at the area from the top of the butt • Some weed growth is evident and appears to be actively controlled. <p>Woody plants beginning to establish to the top of the butt.</p>

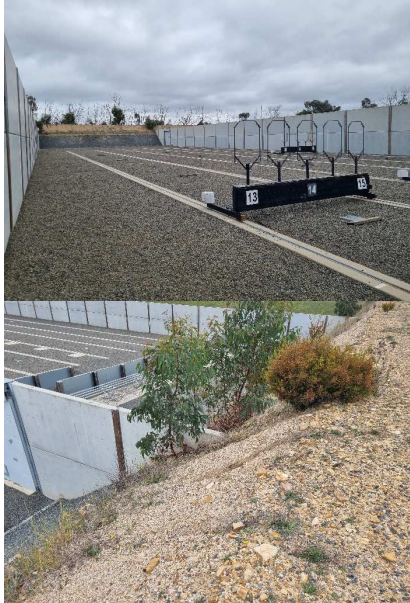
<p>Gravel surfaces Range 3</p> <ul style="list-style-type: none"> • erosion evident at the area from the top of the butt • Some weed growth is evident and appears to be actively controlled. <p>Woody plants beginning to establish to the top of the butt.</p>

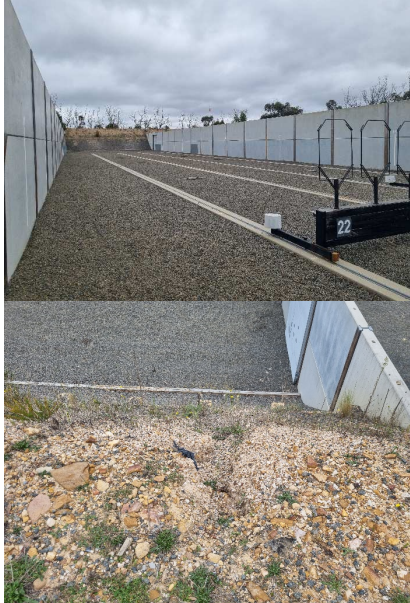
<p>Gravel surfaces Range 4</p> <ul style="list-style-type: none"> • Erosion evident at the area from the top of the butt • Some weed growth is evident and appears to be actively controlled. <p>Woody plants beginning to establish to the top of the butt.</p>

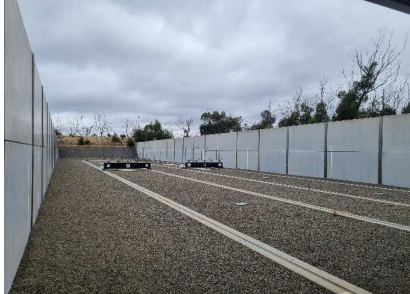
<p>Gravel surfaces Range 5</p> <ul style="list-style-type: none"> • Erosion evident at the area from the top of the butt • Some weed growth is evident and appears to be actively controlled. <p>Woody plants beginning to establish to the top of the butt.</p>

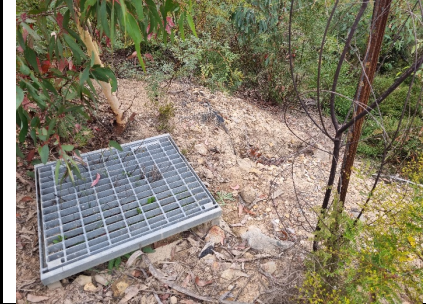
<ul style="list-style-type: none"> • Pit at South East corner of 50m stop butt • Pit is full of sediment and being bypassed <p>Modification of this outlet area may be required. It is recommended that that the pit be replaced with a rock and geotextile drop structure</p>

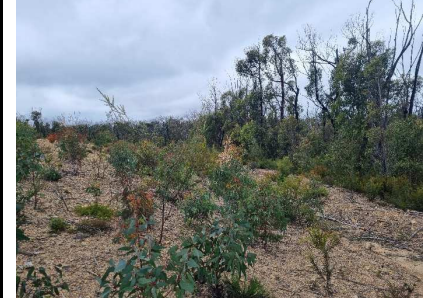
<ul style="list-style-type: none"> • The Drain to stormwater pit is bare • Minor sediment loss is evident • This is consistent with previous observations <p>Further stabilization of the back of the mound will be required to reduce the sediment load to the drainage outlets.</p> <p>This is consistent with previous observations</p>

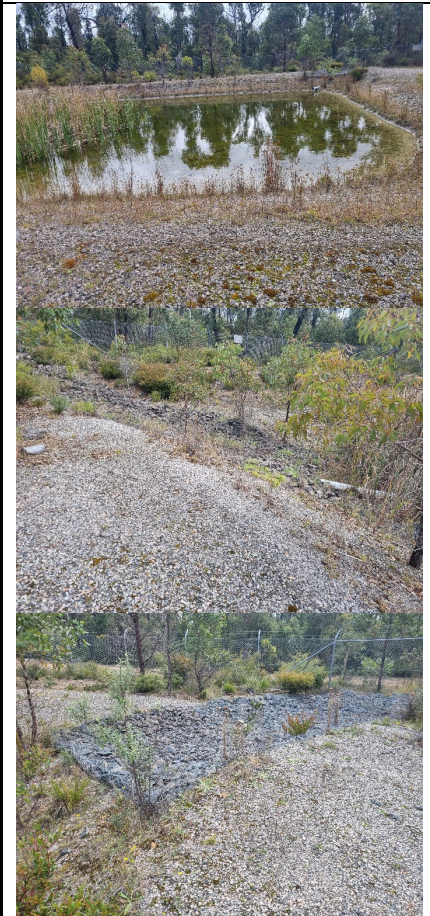
<ul style="list-style-type: none">• Basin is full to trickle/low flow level• Inlet and out let areas to basin are stable• The water is clear	
Basin 3 (500m east)

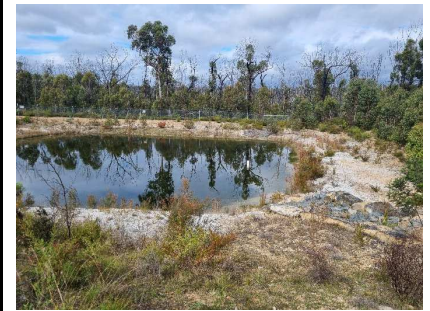
<ul style="list-style-type: none">• Basin is full to trickle/low flow level

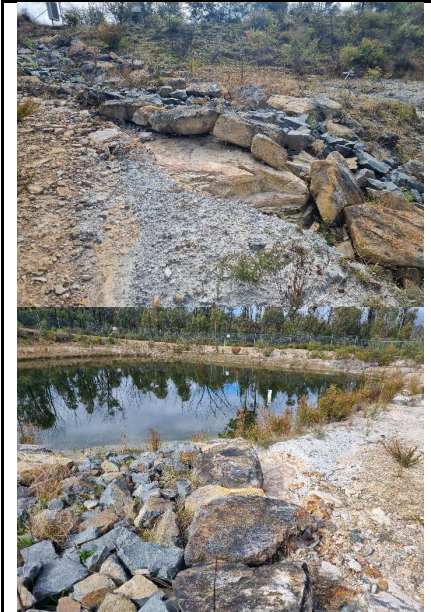
<p>Water is passing out the side of the primary inlet control and is leading to scour adjacent to the inlet and sediment material being moved to the surrounds of the basin inlet.</p> <p>It is likely that re work of the inlet structure will be required. Geotextile will be required within any re work of the invert to the control.</p>

2.	Basin 2 (500m west)	<p>Inlets and outlet areas are stable. No issues evident or required action.</p>
3.	Basin 3 (500m east)	<p>Significant erosion has occurred at the main (Southern) inlet of the basin with placement of rock. Water is passing out the side of the inlet control and is leading to scour adjacent to the inlet.</p> <p>Re-work the inlet structure will be required.</p> <p>It is recommended that re-work is undertaken to reshape the inlet channel to create a defined inflow. The new rock work should be under-laid with geotextile.</p> <p>The rock used should consist of well graded angular material. Geotextile will be required under the rock to create a stable inlet.</p> <p>Woody plants are establishing in the outlet of the basin – these will need to be controlled as part of scheduled maintenance.</p>

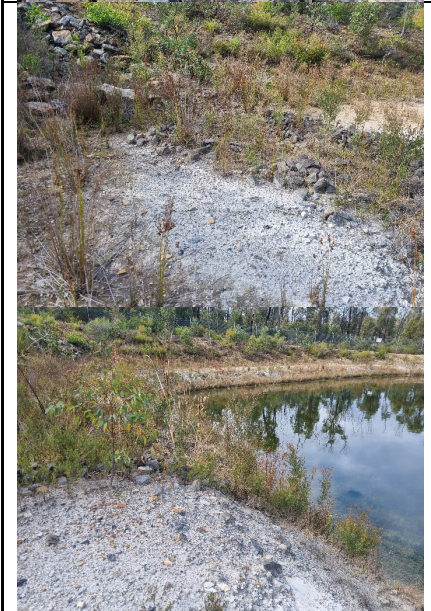
<p>The secondary inlets are stable with surface erosion not progressing</p>

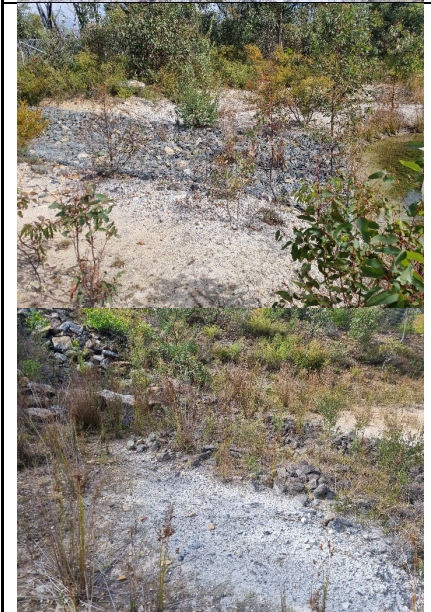
<p>The outlet control is stable.</p> <p>Some woody plants are establishing within the gabions . These will require treatment before the growth impacts the baskets</p> <p>The area below the outlet is stable.</p>

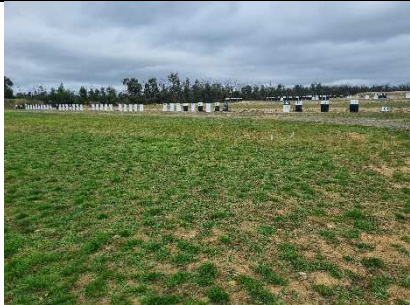
<p>Shooting Point 0m to Intermediate mound 50m</p> <ul style="list-style-type: none"> Ground cover good – greater than 90% Nil erosion evident

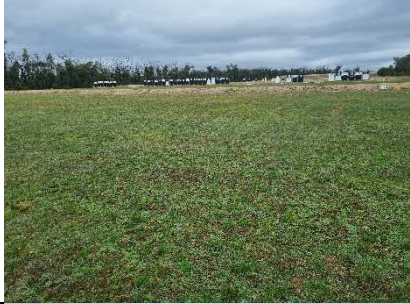
<p>Intermediate mound 50m to intermediate mound 100m</p> <ul style="list-style-type: none"> Ground cover good – greater than 90% Grasses and lichens Some bare patches Nil erosion evident Some ponding evident/wet spot in the central areas 	
 	<p>Intermediate mound 100m to intermediate mound 150m</p> <ul style="list-style-type: none"> Ground cover good – greater than 90% Grasses and lichens Nil erosion evident

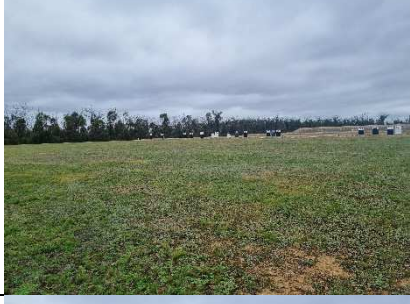
<p>Intermediate mound 150m to intermediate mound 200m</p> <ul style="list-style-type: none"> Ground cover good – greater than 80% Grasses and lichens Nil erosion evident

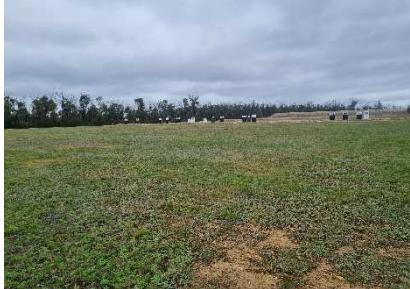
<p>Intermediate mound 200m to intermediate mound 300m</p> <ul style="list-style-type: none"> Ground cover good – greater than 80% Grasses and lichens Some bare patches Nil erosion evident

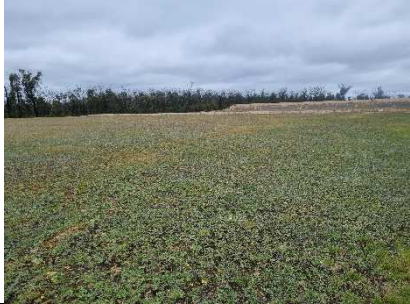
<p>Intermediate mound 300m to intermediate mound 385m</p> <ul style="list-style-type: none"> • Ground cover good – to 100% • Grasses and lichens • Nil erosion evident

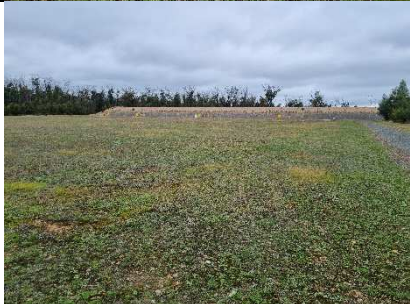
<p>Intermediate mound 385m to 500m Butt</p> <ul style="list-style-type: none"> • Ground cover good – greater than 80% • Bare areas/patchy areas at the southern end of the range • Grasses and lichens • Nil erosion evident 	
	<p>Gravel lay down area located to north of basin 2</p> <p>Gravel surface stable. Limited weed growth is evident.</p>

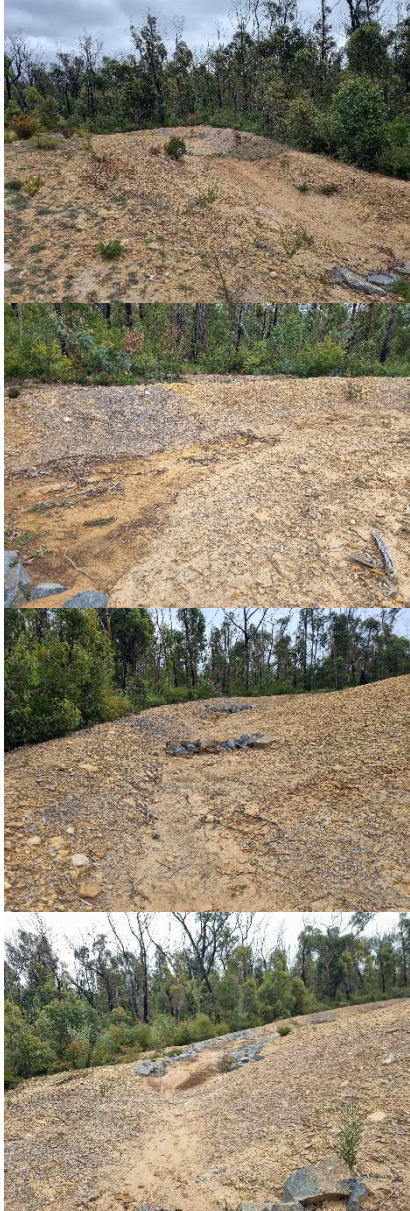
<p>Swale drain leading to south west corner of 500m stop butt</p> <ul style="list-style-type: none"> • Invert of drainage swales bare, with some scour/sediment loss evident • Rock check dams installed <p>Recommend intermix smaller rock (75mm-150mm) into gaps of existing structures plus some smaller rock (diameter 25mm)</p>

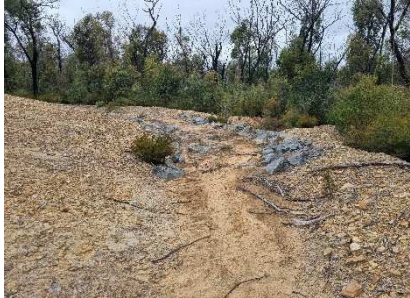
<p>Stormwater pit located at rear western corner of stop butt</p> <ul style="list-style-type: none"> • surrounds of pit protected with rockwork • pit and surrounds are full of sediment. The previous outlet and control is bypassed.

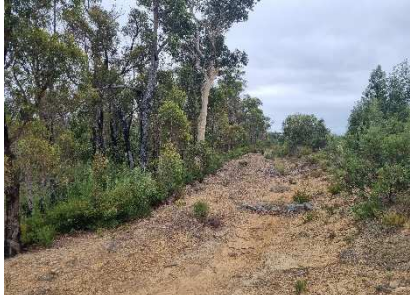
<p>Swale drains at 500m West</p> <ul style="list-style-type: none"> • Installed rock checks with diameter 75-100mm • Invert between check dams is acceptably stable.

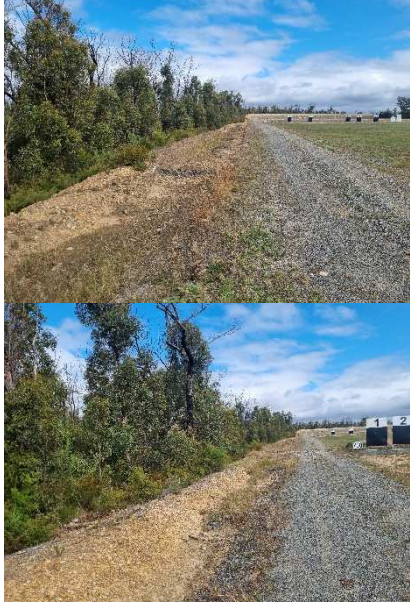
<p>Swale drains at 500m east</p> <ul style="list-style-type: none"> • Installed rock checks with diameter 75-100mm • Invert between check dams beginning to stabilise with grass. • Sediment is accumulating behind the numerous check measures • In some cases the check measures require maintenance and reinstatement • In some areas the accumulated sediment has filled the swale to the point that the capacity is threatened and there is risk that water will flood out of the swale to the east. <p>Clearing of sediment and reinstatement of controls and swale capacity is required.</p>

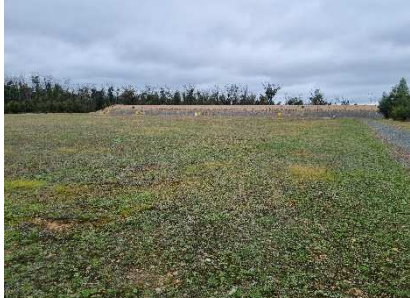
<p>Top of Stop butt at 500m</p> <ul style="list-style-type: none"> • Some riling at front of batter • This riling occurs where water is pooling on top of butt formation and overflows over face • Some vegetation is establishing above the bullet catcher. This vegetation will need to be managed as part of scheduled maintenance.

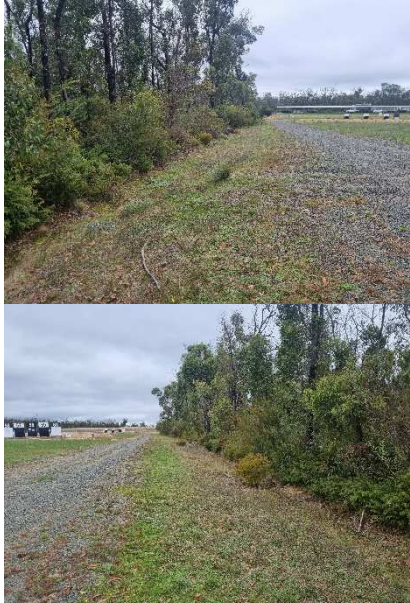
<p>Side track drainage 500m</p> <ul style="list-style-type: none"> • Some riling and localised erosion is occurring from intermediate mounds directing waters to the east and west • These have been repaired in some areas with placement of gravel and aggregate. • Ongoing maintenance of these areas will be required as part of annual programmed works 	
<p>Engineering controls: Road Infrastructure and Drainage</p>

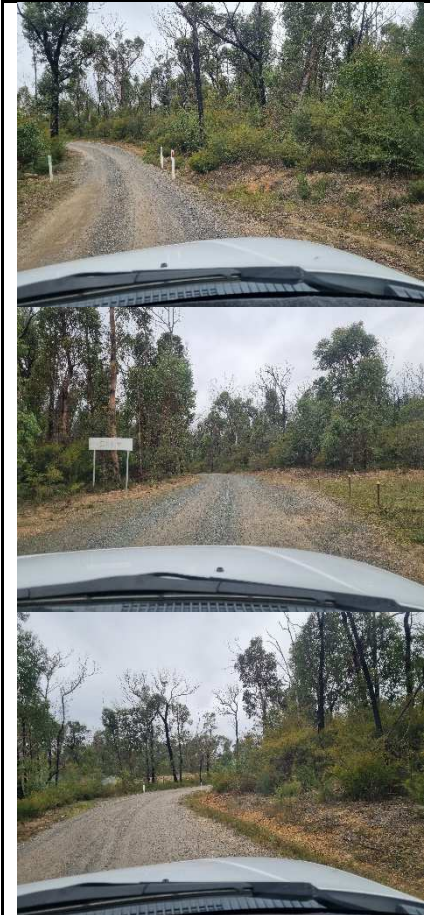
- All road areas are stable
- Culvert crossings are maintained.

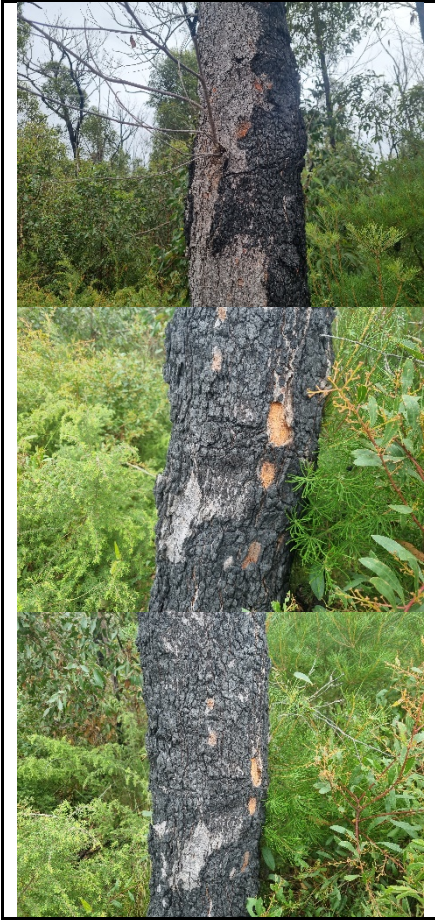
<p>The eastern and western interface between the range and the bushland was walked.</p> <p>No evidence of shot loss was seen at this interface. Several instances exist where burnt bark was removed in patches however this does not appear to be associated with bullet strike and normal post fire shedding.</p>

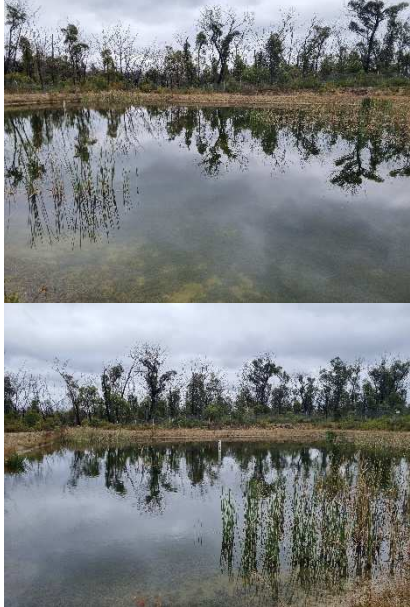
<ul style="list-style-type: none"> • Surrounds to basin are stable • Basin is full to low flow outlet pipe • Water is very clear

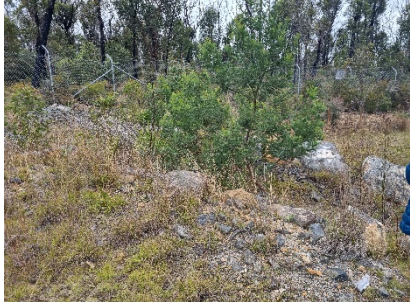
<ul style="list-style-type: none"> • Rock work at the invert has been moved by flows • Geotextile has been exposed • Some woody plants are establishing in the inlet channel. <p>Additional works may be required in this area to control the woody plants before they disturb the channel protections.</p>

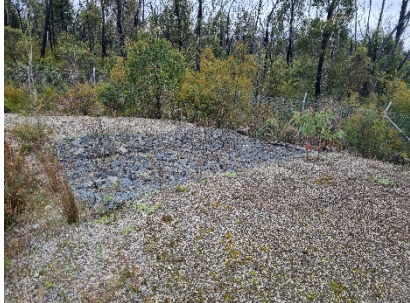
<ul style="list-style-type: none"> • Outlet control/spillway is stable • Previously observed “erosion” or movement of material below basin outlet has not progressed. No further action recommended at this time. 	
Basin 4 (at car park)

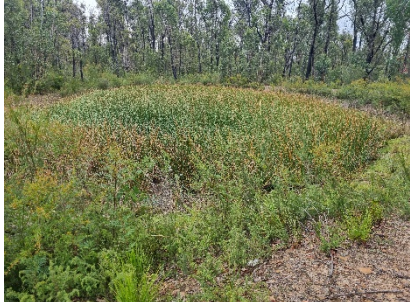
<ul style="list-style-type: none"> • Basin inlet and outlet stable • Basin full of reeds • Water level is low/dry

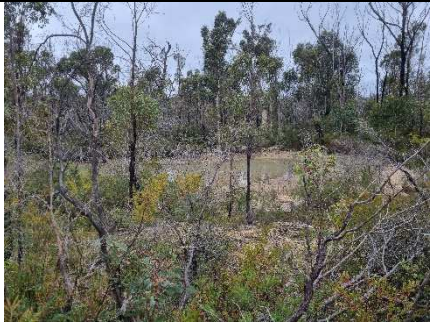
<p>Basin 7 - Bushland Pond</p> <ul style="list-style-type: none"> The pond water level is very low. The water is turbid. 	
Vegetation Health

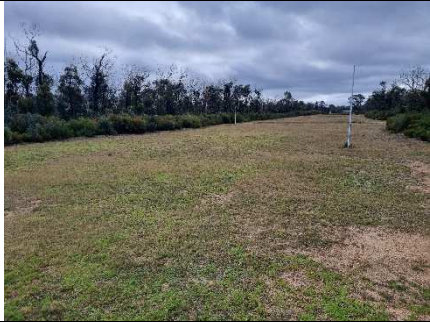
<p>Vegetative health 0-100m from target</p> <ul style="list-style-type: none"> First 6-10m veg cover with more patchy areas (see below) Rest of range grass cover good to greater than 70%

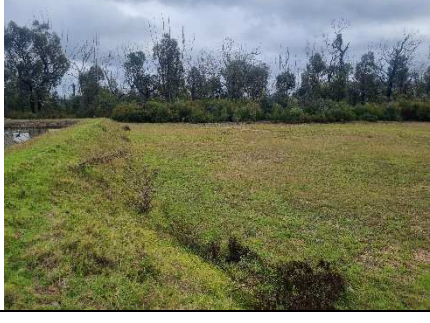
<p>Vegetative health first 6-10m from Mantlet</p> <ul style="list-style-type: none"> 50-70% cover with patchy bare areas

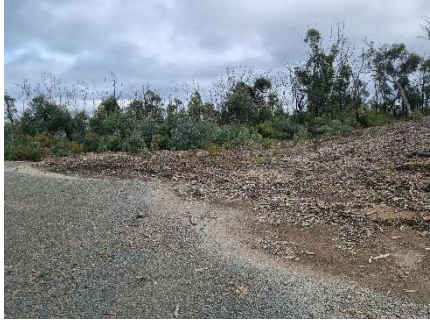
<p>Vegetative health rear of stop butt</p> <ul style="list-style-type: none"> Vegetation establishing within channel Rear area is clear of waste

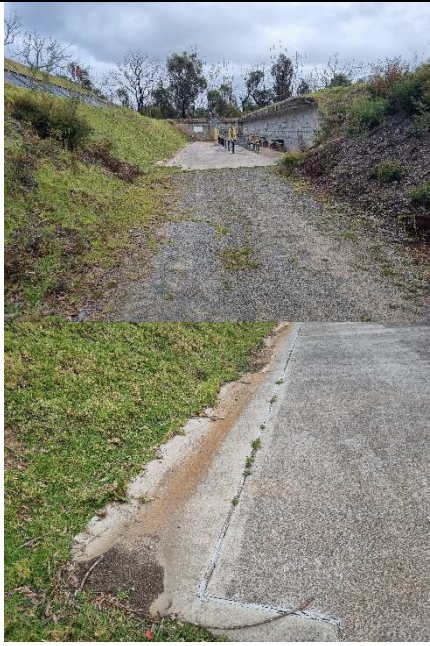
<p>The gallery is clear, no waste or bullet fragments evident.</p> <p>Limited sediment is accumulating within the swale drain at side of the concrete.</p> <p>This sediment is sampled.</p>	
Engineering controls: Road Infrastructure and Drainage

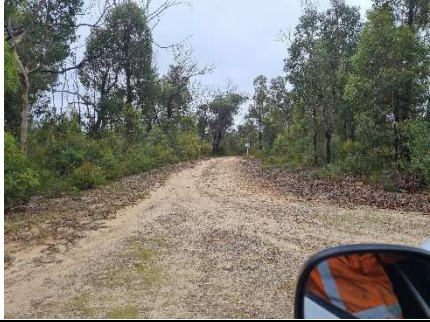
<p>Roads and Access tracks</p> <ul style="list-style-type: none"> • Access track in good condition • Water is pooled in some areas however access is still suitable. • Minor cross erosion evident • No action recommended. 	
		<p>Safety and signage</p> <ul style="list-style-type: none"> • Signage is in place at the main gate
<p>No Photo</p>	<p>Engineering controls: Lime treatment Process</p> <ul style="list-style-type: none"> • The lime treatment process is a closed sealed unit. • Tools were not available to open the unit so water could be sampled.
