Asbestos and Hazardous Materials Reinspection Assessment

Point Wolstoncroft Sports and Recreational Centre

03/02/2023

754-SYDEN311850 - Point Wolstoncroft Sports and Recreational Centre - HMRR - 17012023

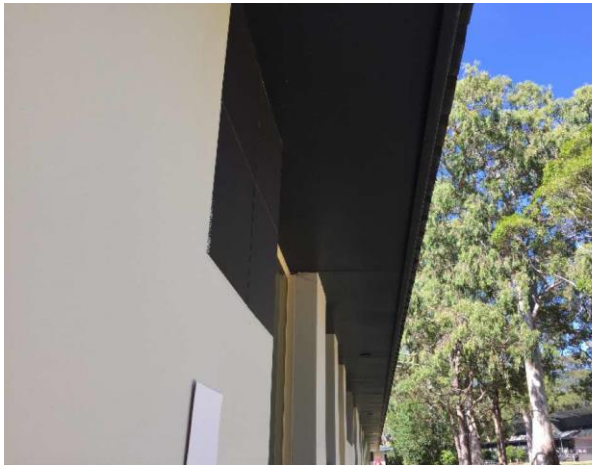
Line ID 1: External, GF, Acacia Lodge, Eaves Throughout, Fibre Cement Sheetting - No Asbestos Detected

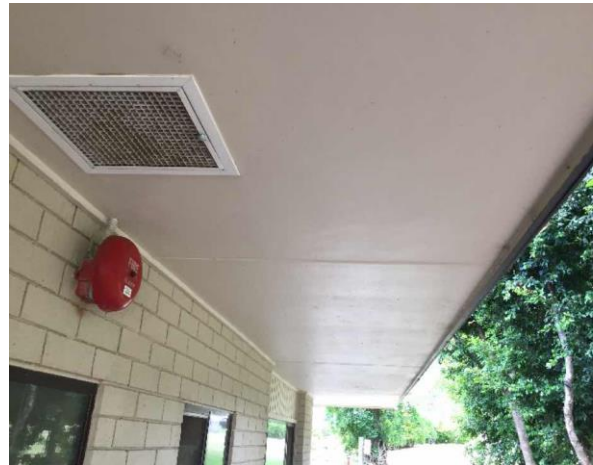
Line ID 2: External, GF, Administration/Office Building, Eaves, Fibre Cement Sheetting - No Asbestos Detected

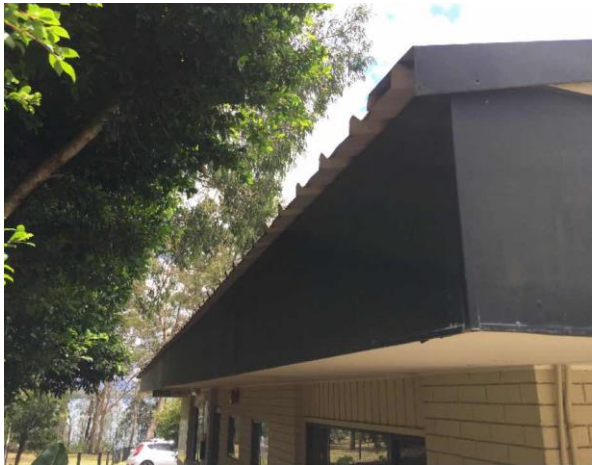
Line ID 3: External, GF, Administration/Office Building, Perimeter, Fascia Panels, Fibre Cement Sheetting - No Asbestos Detected

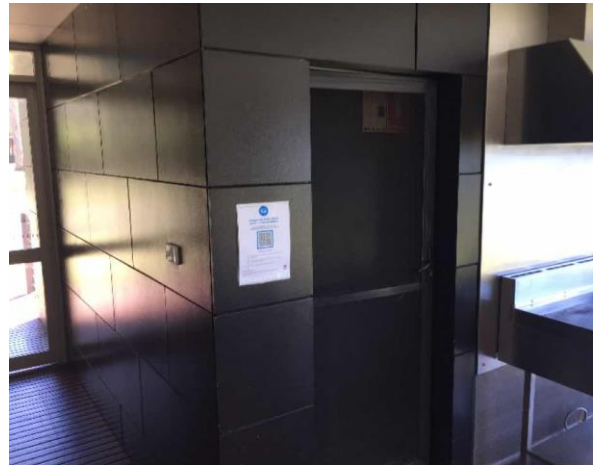
Line ID 4: External, GF, Banksia Lodge, All Walls of Kitchen to Northern Elevation, Compressed Cement Sheetting - No Asbestos Detected

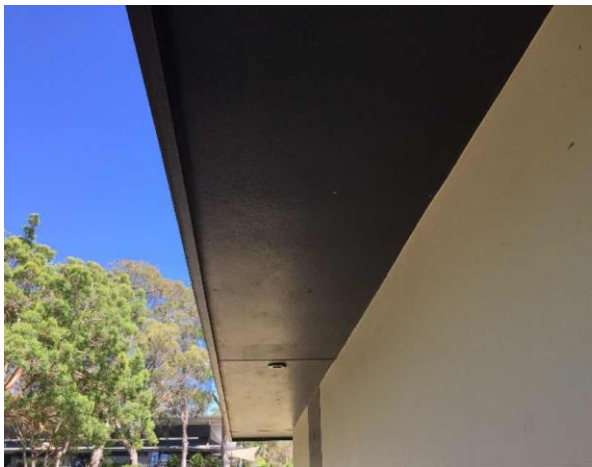
Line ID 5: External, GF, Banksia Lodge, Eaves Throughout, Fibre Cement Sheetting - No Asbestos Detected

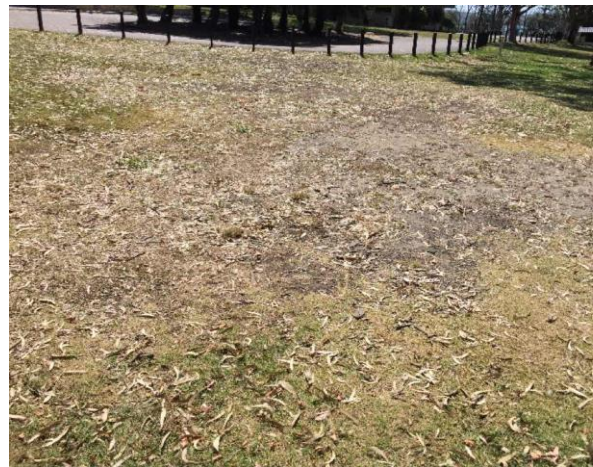
Line ID 6: External, GF, Basketball Court Area, Debris to Ground Surface and Beneath Ground, Fibre Cement Sheet - Removed

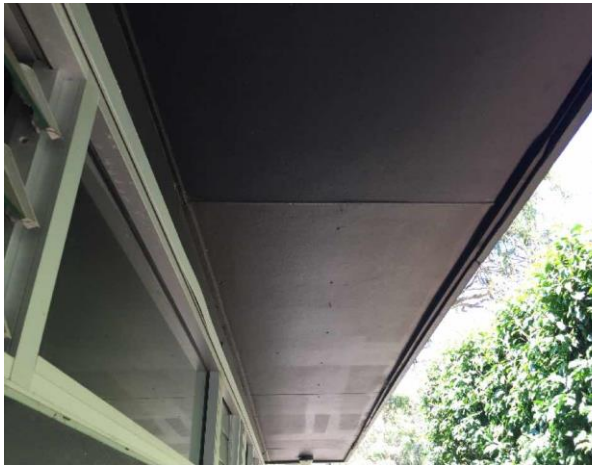
Line ID 7: External, GF, Bluegum Lodge, Eaves Throughout, Fibre Cement Sheetting - No Asbestos Detected

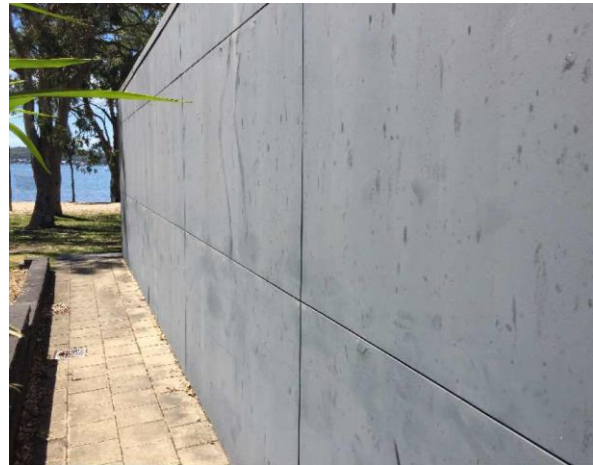
Line ID 8: External, GF, Bluegum Lodge, Northern Elevation Wall, Compressed Cement Sheetting - No Asbestos Detected

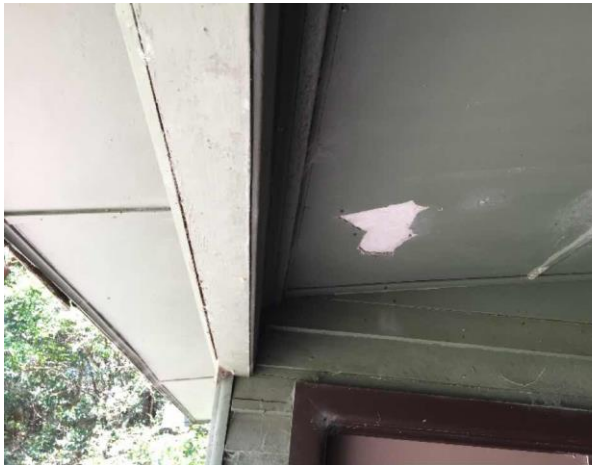
Line ID 9: External, GF, Bush Craft Building, Eaves and Porch Ceiling, Fibre Cement Sheetting - Chrysotile & Amosite Asbestos Detected

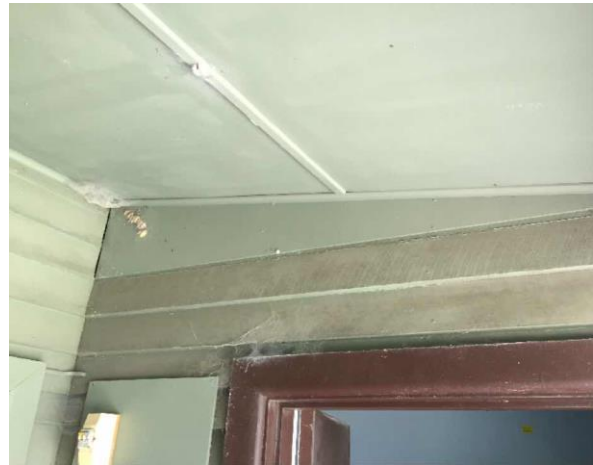
Line ID 10: External, GF, Bush Craft Building, Infill Panels to Upper Porch Walls, Fibre Cement Sheetting - Chrysotile & Amosite Asbestos Detected

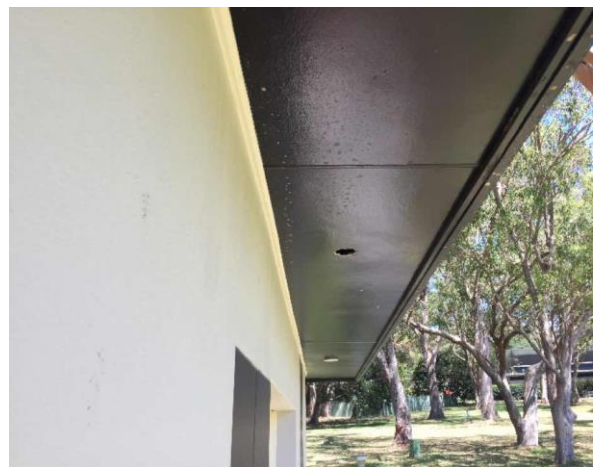
Line ID 12: External, GF, Casuarina Lodge, Eaves Throughout, Fibre Cement Sheetting - No Asbestos Detected

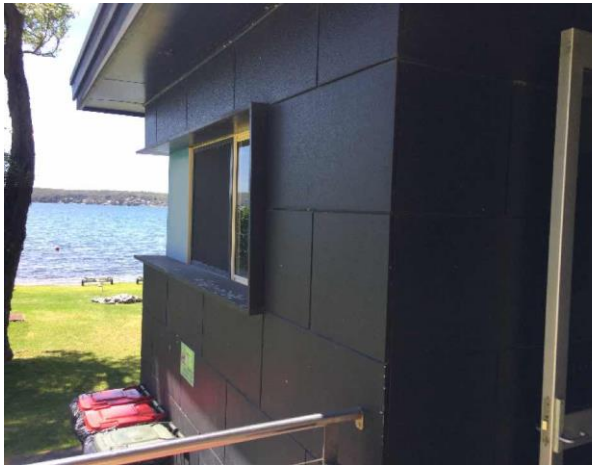
Line ID 13: External, GF, Casuarina Lodge, Kitchen, Wall Cladding, Compressed Cement Sheetting - No Asbestos Detected

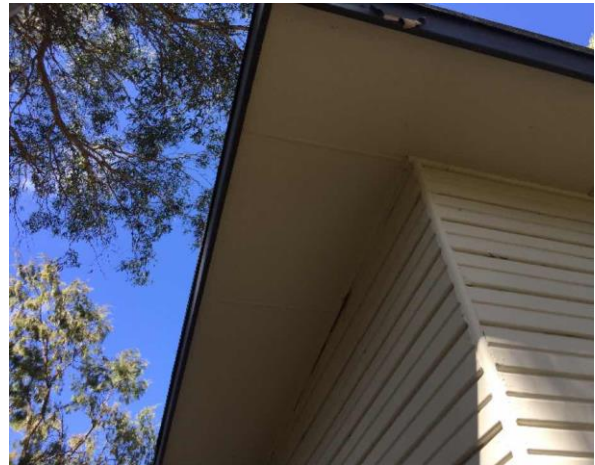
Line ID 14: External, GF, Conference Lodge, Eaves, Fibre Cement Sheetting - Chrysotile & Amosite Asbestos Detected

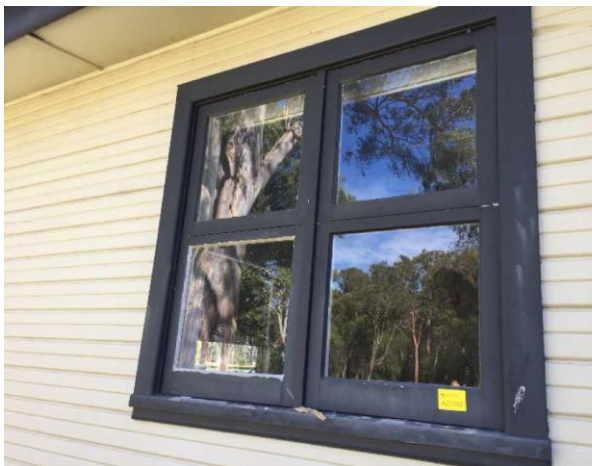
Line ID 15: External, GF, Conference Lodge, Original Windows Throughout, Window Caulking - No Asbestos Detected

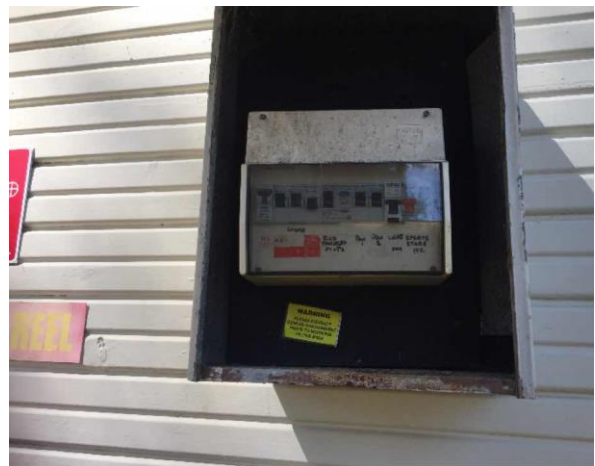
Line ID 16: External, GF, Conference Lodge, Southern Wall With Electrical Box, Bituminous Backing Board - Chrysotile Asbestos Detected

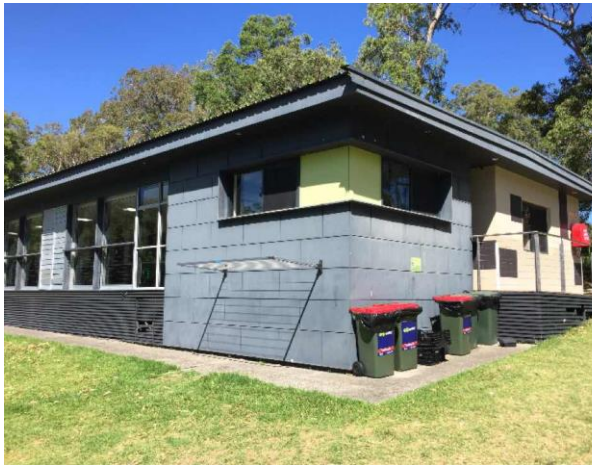
Line ID 19: External, GF, Geebung Lodge, Kitchen Walls, Compressed Cement Sheetting - No Asbestos Detected

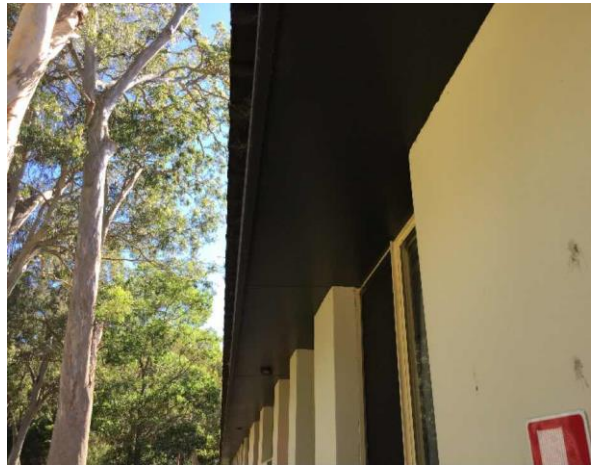
Line ID 20: External, GF, Grevillea Lodge, Eaves Throughout, Fibre Cement Sheetting - No Asbestos Detected

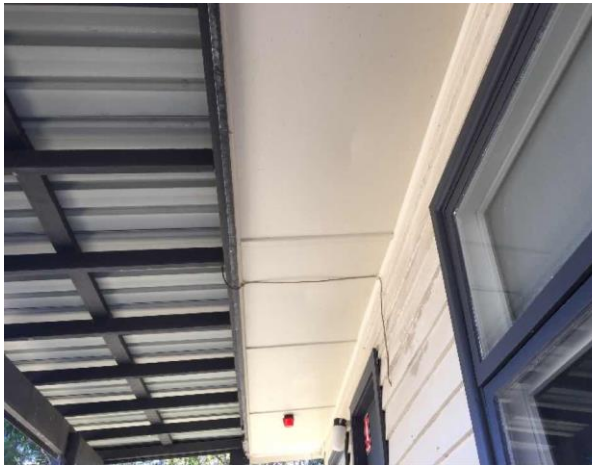
Line ID 21: External, GF, Gum Nut Lodge, Eaves Throughout, Fibre Cement Sheetting - Chrysotile & Amosite Asbestos Detected

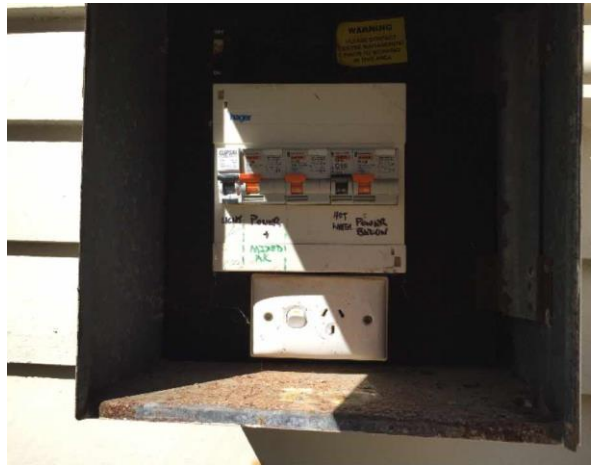
Line ID 22: External, GF, Gum Nut Lodge, Electrical Box to South Wall, Bituminous Backing Board - Chrysotile Asbestos Detected

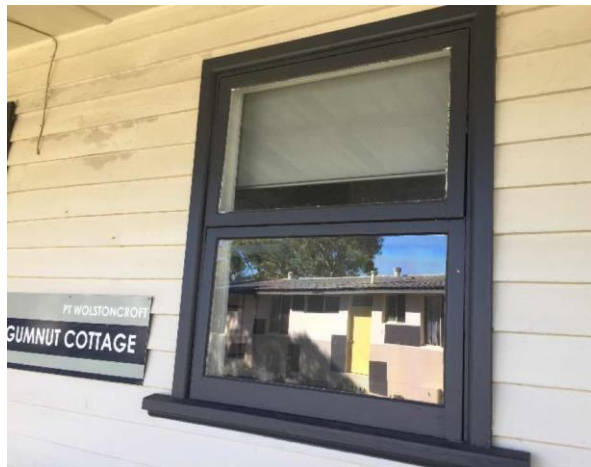
Line ID 24: External, GF, Gum Nut Lodge, Wooden Windows Throughout, Window Caulking - No Asbestos Detected

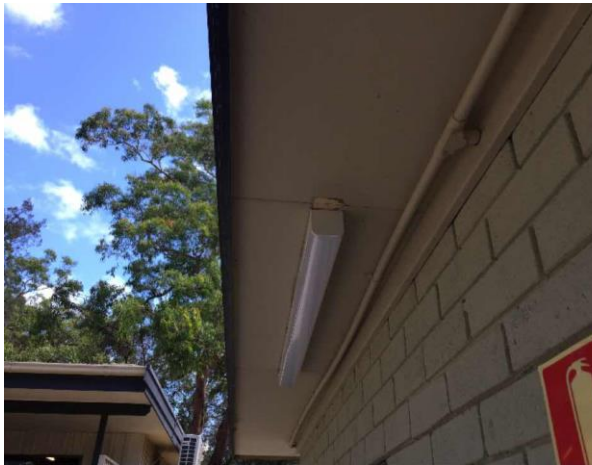
Line ID 25: External, GF, Holiday Units (1-8) Laundry, Eaves, Fibre Cement Sheetting - No Asbestos Detected

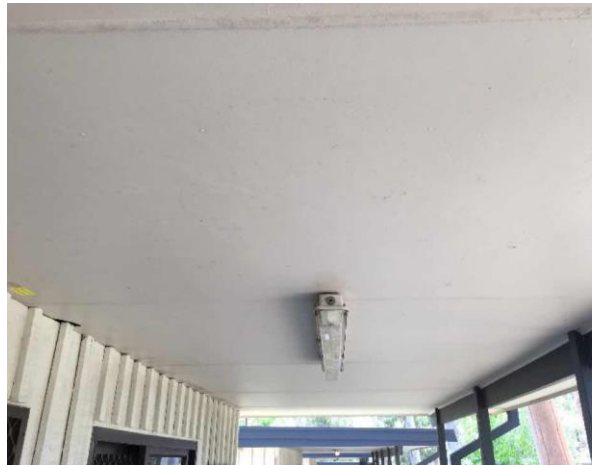
Line ID 26: External, GF, Holiday Units 1-8 (All Identical In Design), Eaves and Awnings, Fibre Cement Sheetting - No Asbestos Detected

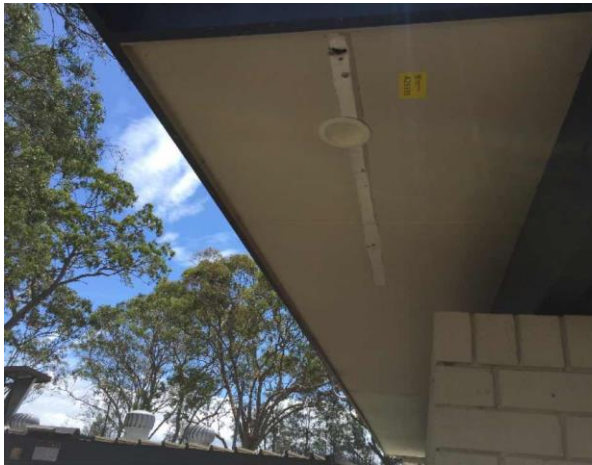
Line ID 27: External, GF, Pool House, Pool Store & Toilet Block, Eaves Throughout, Fibre Cement Sheetting - No Asbestos Detected

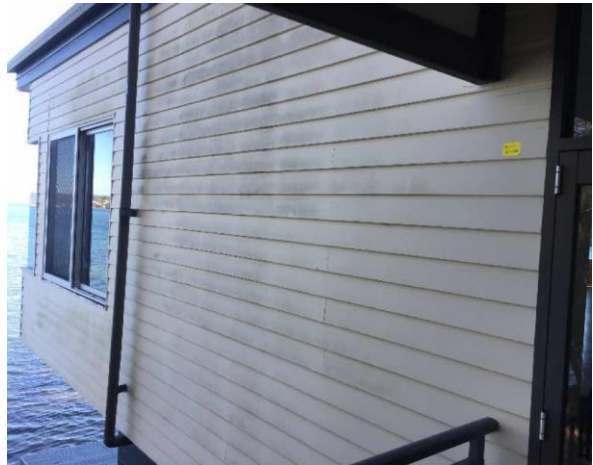
Line ID 28: External, GF, Recreational Hall, Cladding to All Elevations, Compressed Cement Sheetting - No Asbestos Detected

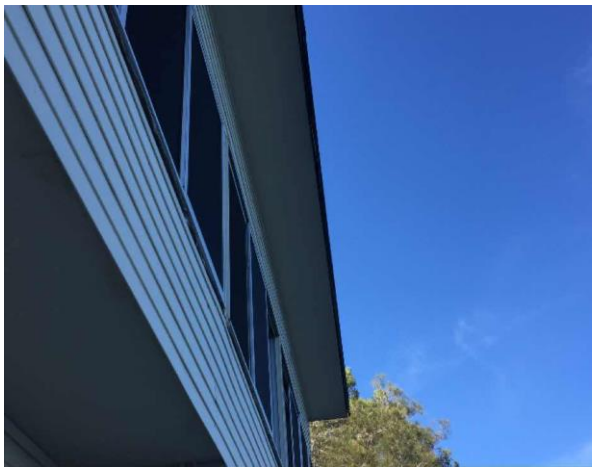
Line ID 29: External, GF, Recreational Hall, Eaves to Eastern and Western Elevations, Fibre Cement Sheetting - Chrysotile Asbestos Detected

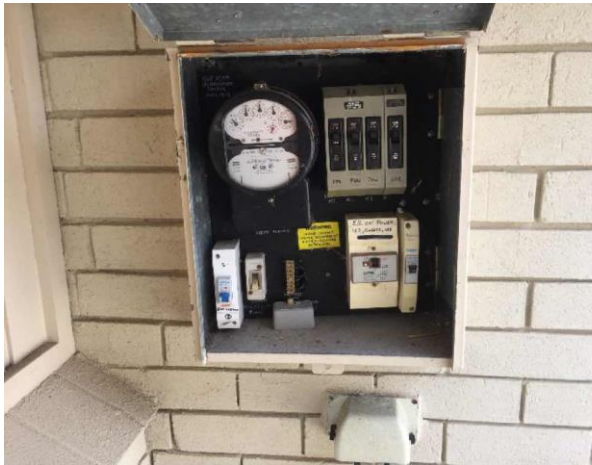
Line ID 31: External, GF, Residence 1, Electrical Box to South-eastern Corner, Bituminous Backing Board - Chrysotile Asbestos Detected

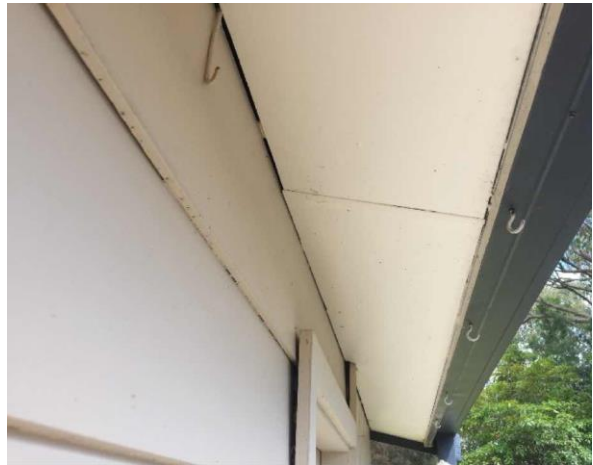
Line ID 32: External, GF, Residence 1 (Waratah House & Garage), Garage Eaves, Fibre Cement Sheeting - No Asbestos Detected

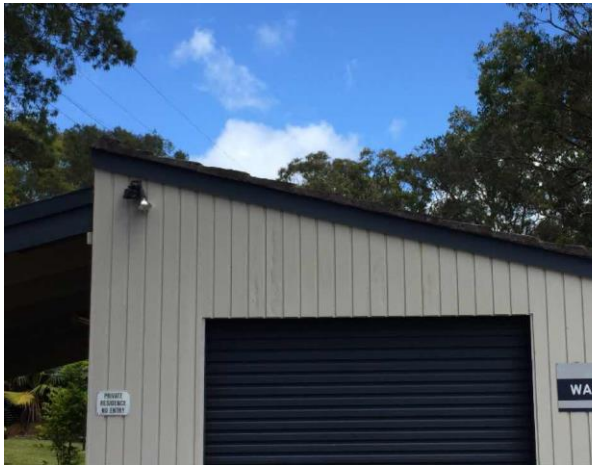
Line ID 33: External, GF, Residence 1 (Waratah House & Garage), Garage, Under Roof Tiles, Compressed Cement Sheeting - Chrysotile Asbestos Detected

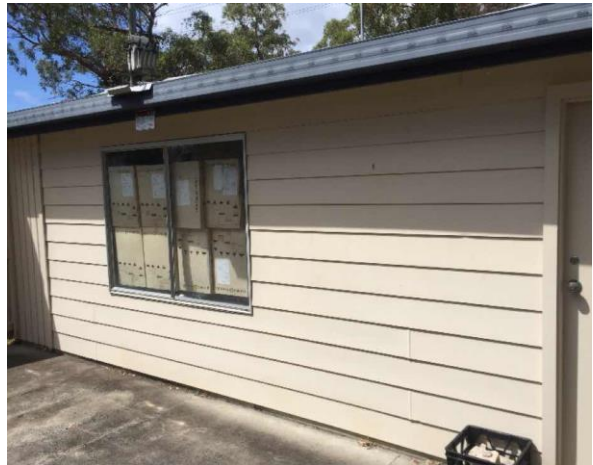
Line ID 34: External, GF, Residence 1 (Waratah House & Garage), Garage, Weatherboard Cladding, Compressed Cement Sheeting - No Asbestos Detected

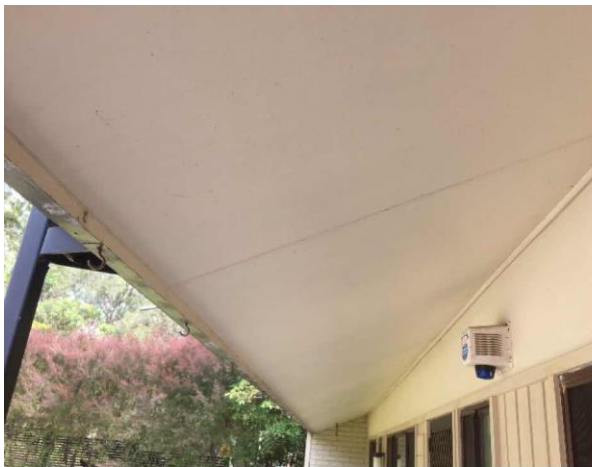
Line ID 35: External, GF, Residence 1 (Waratah House & Garage), Northern and Southern Awnings, Fibre Cement Sheeting - No Asbestos Detected

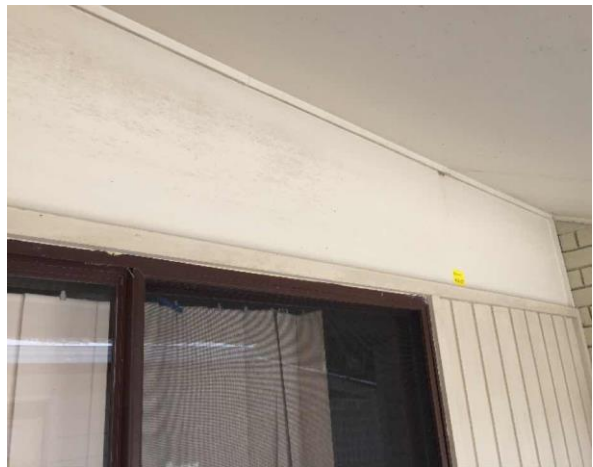
Line ID 36: External, GF, Residence 1 (Waratah House & Garage), Northern and Southern Elevations, Upper 1/4 Wall, Fibre Cement Sheeting - Chrysotile Asbestos Detected

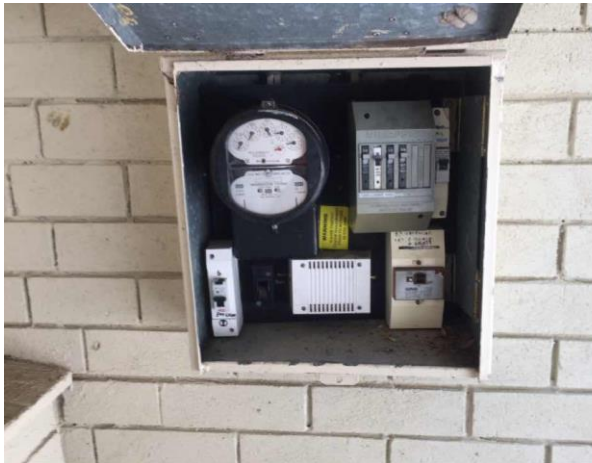
Line ID 37: External, GF, Residence 2, Electrical Box to South-eastern Corner, Bituminous Backing Board - Chrysotile Asbestos Detected

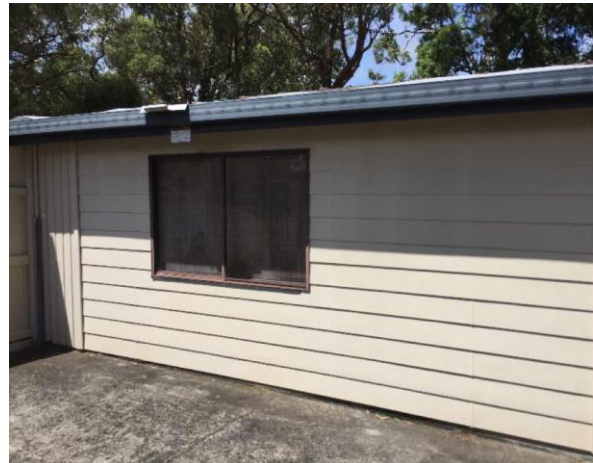
Line ID 38: External, GF, Residence 2 (Wattle House & Garage), Garage Weatherboard Cladding, Compressed Cement Sheetting - No Asbestos Detected

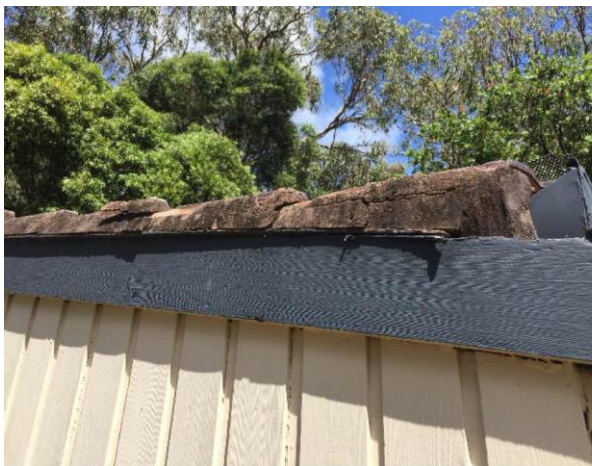
Line ID 39: External, GF, Residence 2 (Wattle House & Garage), House and Garage, Under Roof Tiles, Compressed Cement Sheetting - Chrysotile Asbestos Detected

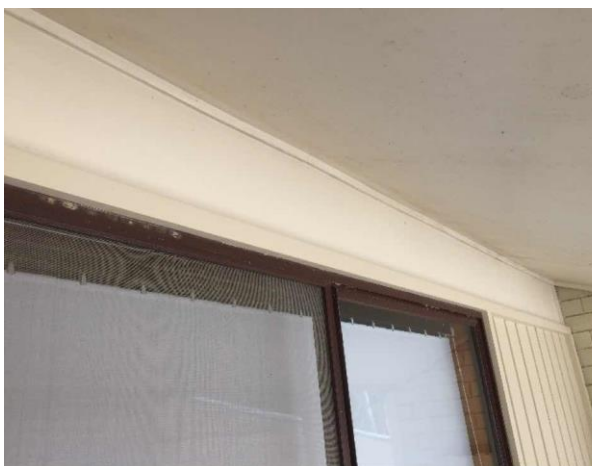
Line ID 41: External, GF, Residence, Northern and Southern Elevations, Upper 1/4 of Walls, Fibre Cement Sheetting - Chrysotile Asbestos Detected

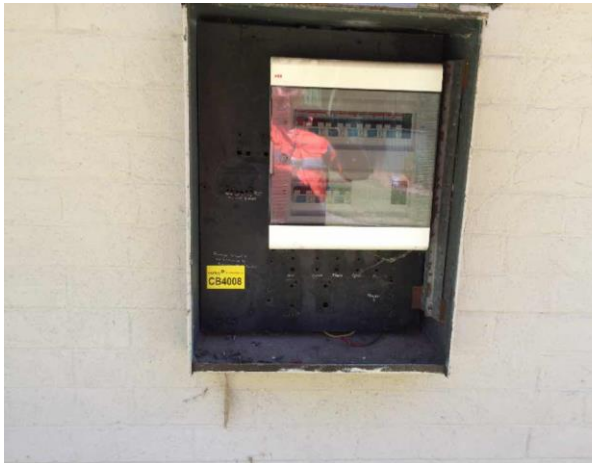
Line ID 43: External, GF, Residence 3 and Garage, Southern Elevation Within Fuse Box, Bituminous Backing Board - Chrysotile Asbestos Detected

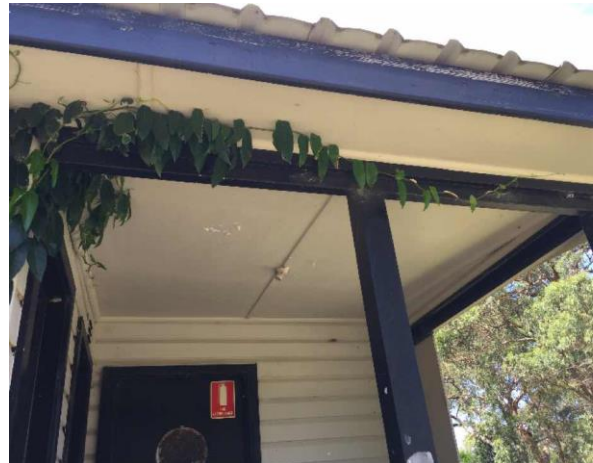
Line ID 44: External, GF, Ropes Course Store Building/Toilet, Eaves and Porch Ceiling, Fibre Cement Sheeting - Chrysotile & Amosite Asbestos Detected

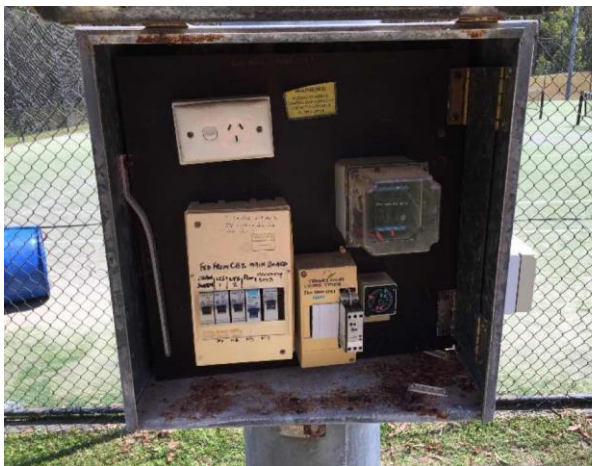
Line ID 45: External, GF, Ropes Course Store Building/Toilet, Light Pole Adjacent Tennis Court, Electrical Fuse Box , Bituminous Backing Board - Suspected Asbestos

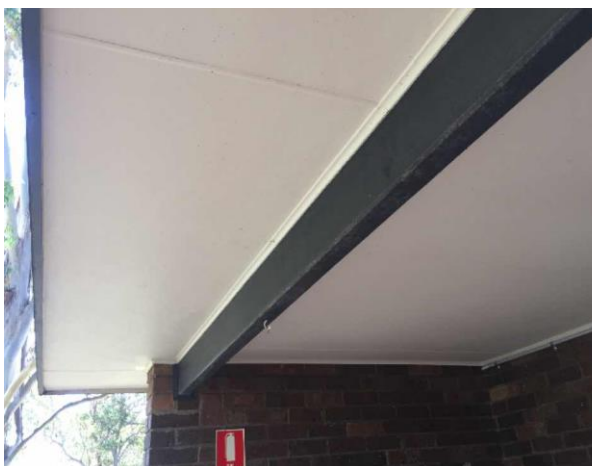
Line ID 47: External, GF, Staff Residence, Eaves and Awning, Fibre Cement Sheeting - No Asbestos Detected

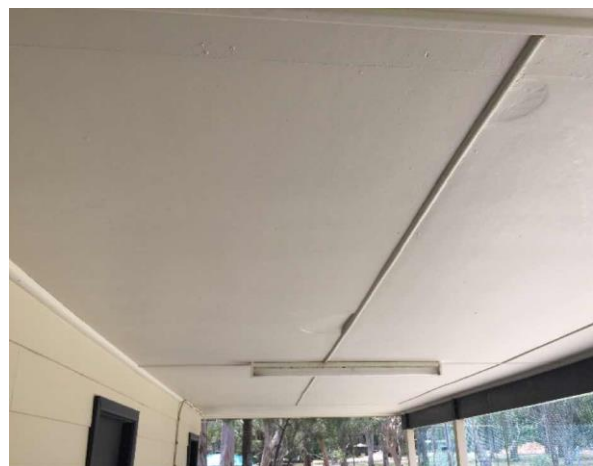
Line ID 48: External, GF, Tennis Court Amenities Block (North), Awning and Eaves (All Elevations), Fibre Cement Sheeting - Chrysotile Asbestos Detected

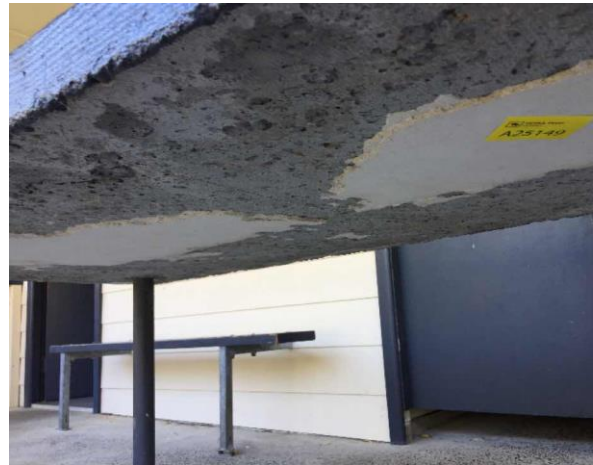
Line ID 50: External, GF, Tennis Court Amenities Block (North), Underside of Concrete Table, Fibre Cement Sheetting - Chrysotile Asbestos Detected

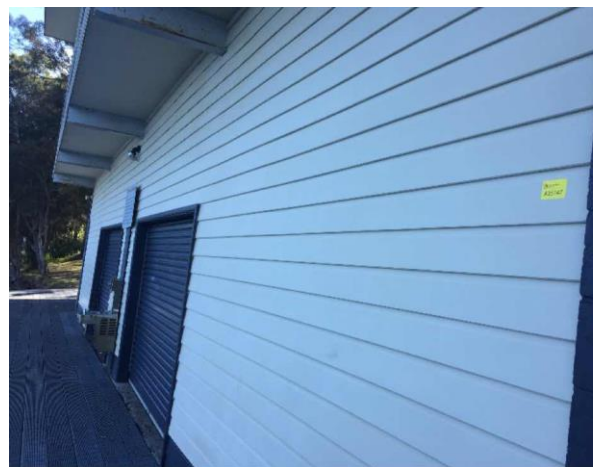
Line ID 54: External, Basement, The Boat Shed, Cladding to Western Wall, Compressed Cement Sheetting - Chrysotile Asbestos Detected

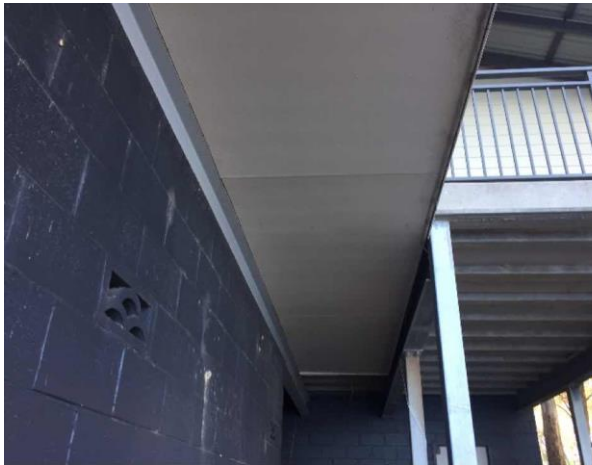
Line ID 55: External, Basement, The Boat Shed, Eaves to Northern, Southern and Western Elevations, Fibre Cement Sheeting - Chrysotile Asbestos Detected

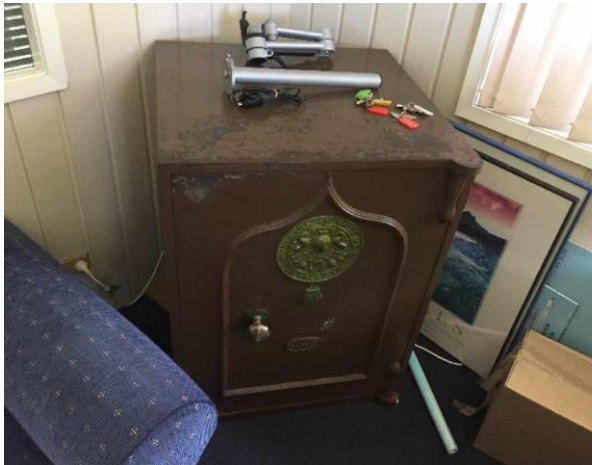
Line ID 57: Internal, GF, Administration/Office Building, Office, Safe, Internal Insulation - Suspected Asbestos

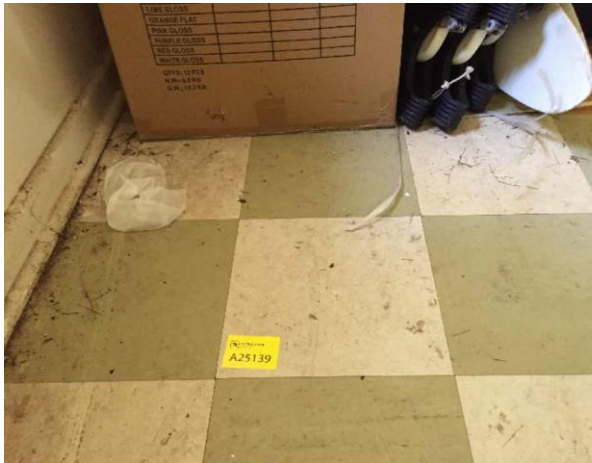
Line ID 67: Internal, GF, Bush Craft Building, Eastern Room, Light Grey Vinyl Floor Tiles - Chrysotile Asbestos Detected

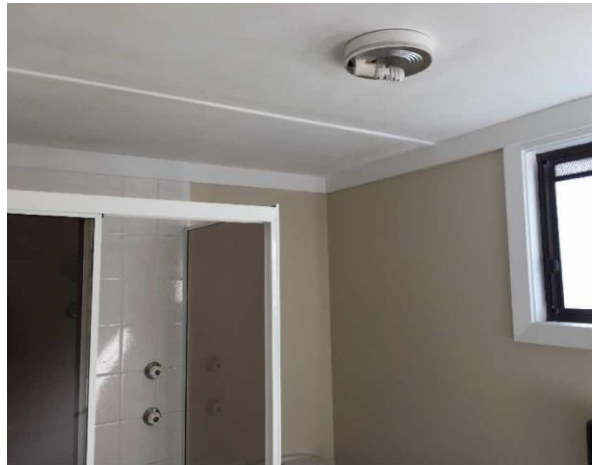
Line ID 74: Internal, GF, Gum Nut Lodge, Bathroom Walls and Ceiling, Fibre Cement Sheeting - Chrysotile & Amosite Asbestos Detected

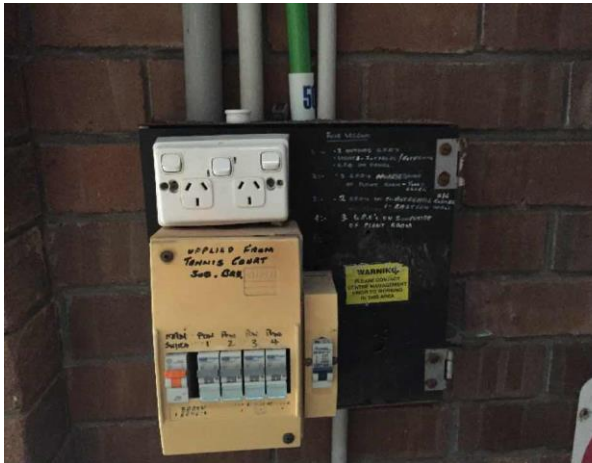
Line ID 79: Internal, GF, Pool House, Pool Store & Toilet Block, Western Wall of Pump House, Bituminous Backing Board - Suspected Asbestos

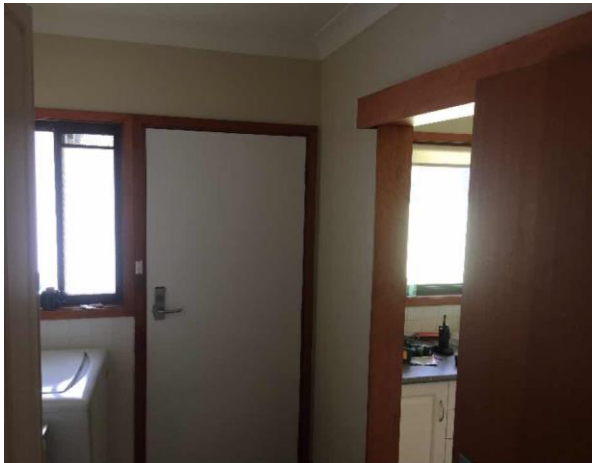
Line ID 81: Internal, GF, Residence 1 (Waratah House & Garage), Laundry, Toilet and Shower Walls, Fibre Cement Sheetting - Chrysotile Asbestos Detected

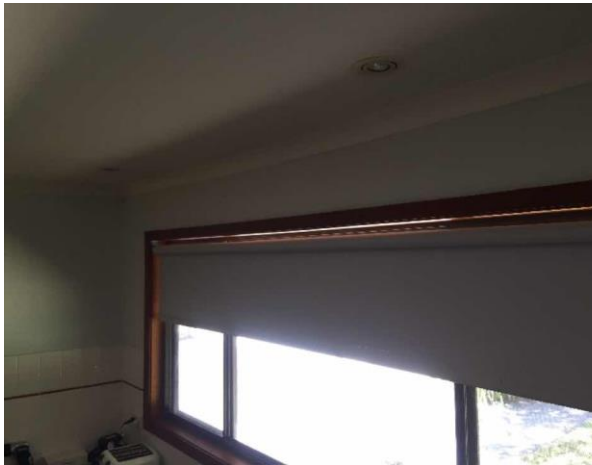
Line ID 85: Internal, GF, Residence 3 and Garage, Bathroom Ceiling, Fibre Cement Sheeting - Chrysotile, Amosite and Crocidolite Asbestos Detected

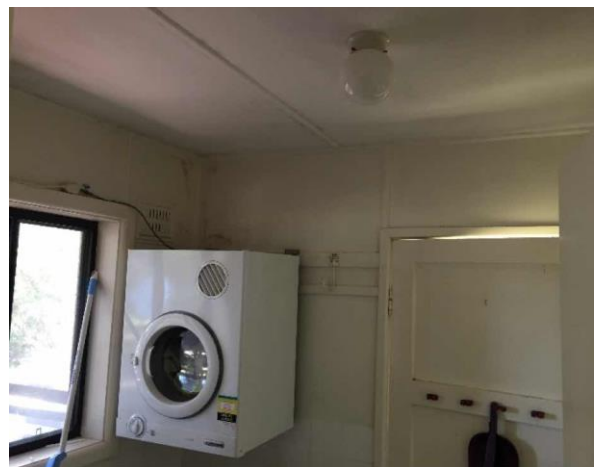
Line ID 89: Internal, GF, Residence 3 and Garage, Laundry Walls and Ceiling, Fibre Cement Sheeting - Chrysotile, Amosite and Crocidolite Asbestos Detected

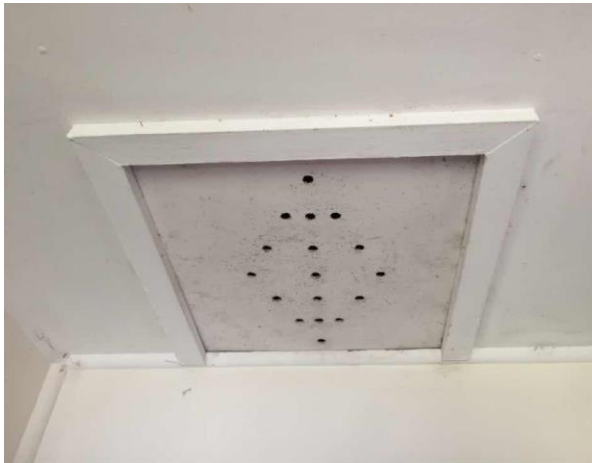
Line ID 90: Internal, GF, Residence 3 and Garage, Manhole Cover Within Laundry, Fibre Cement Sheetting - Chrysotile Asbestos Detected

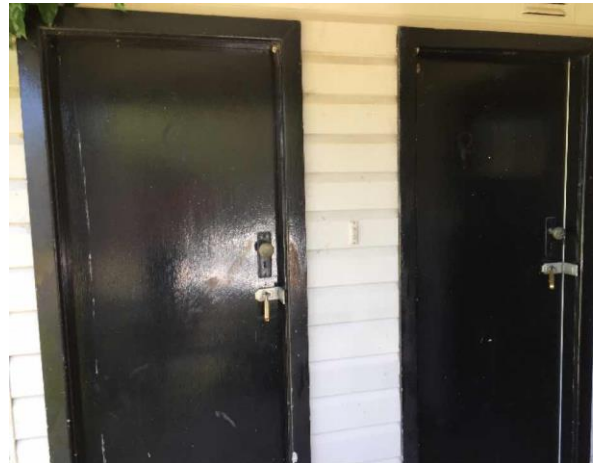
Line ID 91: Internal, GF, Ropes Course Store Building/Toilet, Toilet and Shower Room Ceilings, Fibre Cement Sheetting - Chrysotile & Amosite Asbestos Detected

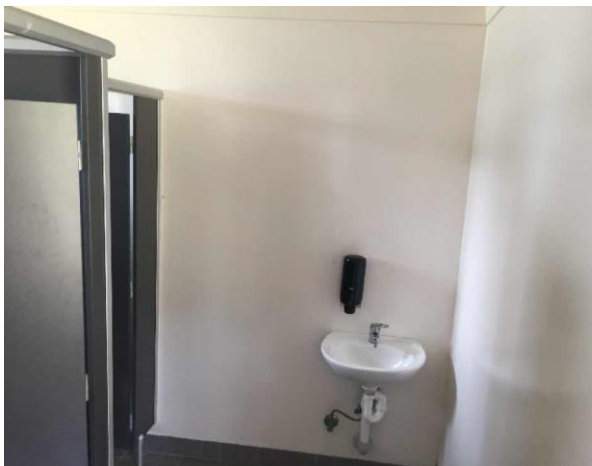
Line ID 92: Internal, GF, Tennis Court Amenities Block (North), Storeroom, Male and Female Toilets, Walls, Fibre Cement Sheetting - Chrysotile Asbestos Detected

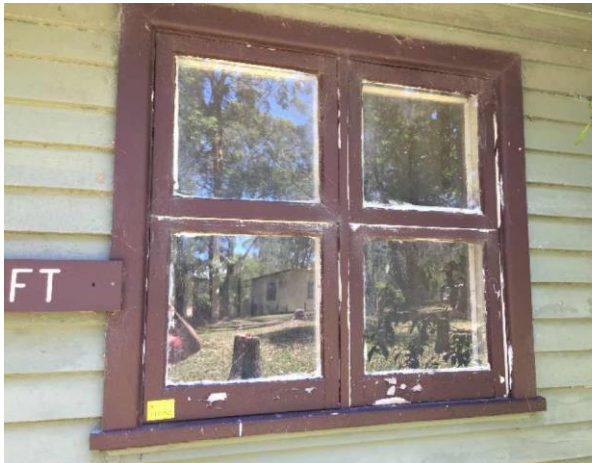
Line ID 96: External, GF, Bush Craft Building, Window and Door Frames, Brown (Dark) Paint - Lead Detected (0.19% w/w)

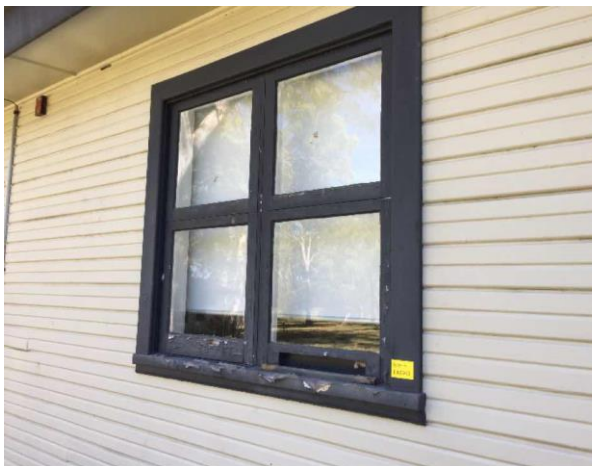
Line ID 98: External, GF, Conference Lodge, Windows and Trim Throughout, Grey (Dark) Paint - Lead Detected (1.9% w/w)

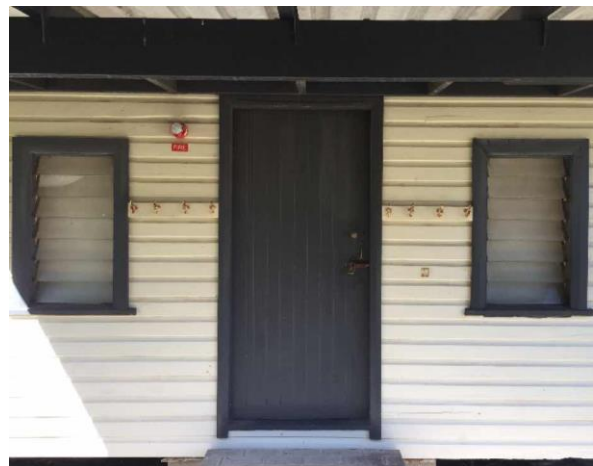
Line ID 99: External, GF, Equipment Store Building, Door, Window Frames and Trim, Grey (Dark) Paint - Lead Detected (1.9% w/w)

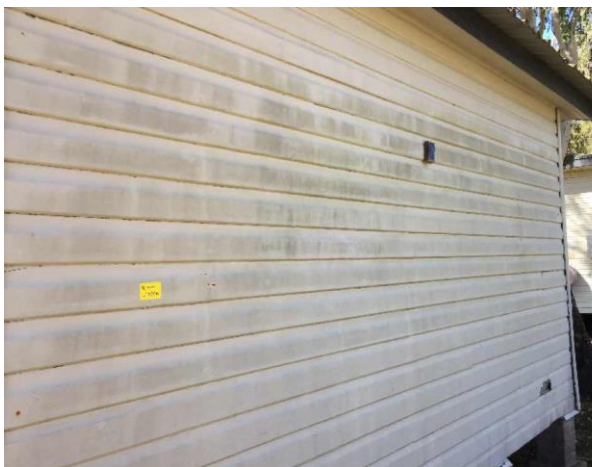
Line ID 100: External, GF, Equipment Store Building, Walls, Beige Paint - Lead Detected (7.1% w/w)

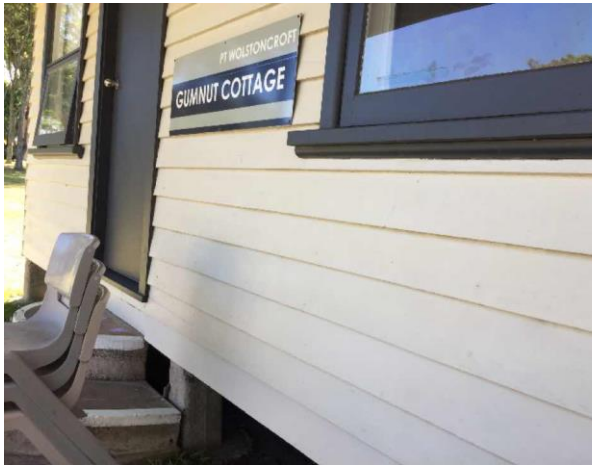
Line ID 102: External, GF, Gum Nut Lodge, Walls Throughout, Beige Paint - Lead Detected (7.1% w/w)

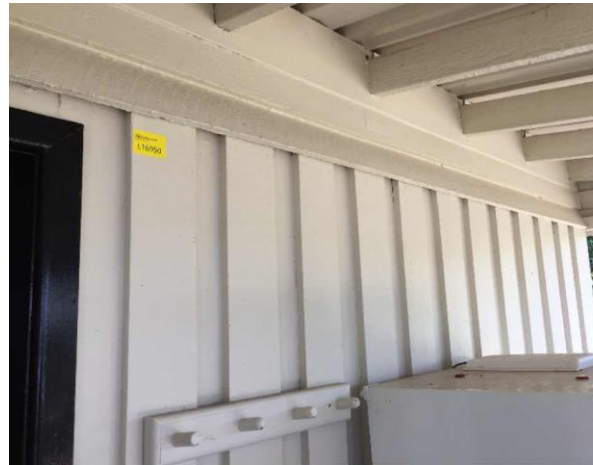
Line ID 103: External, GF, Hakea Lodges 1-3, Walls Throughout, Beige Paint - Lead Detected (<0.005% w/w)

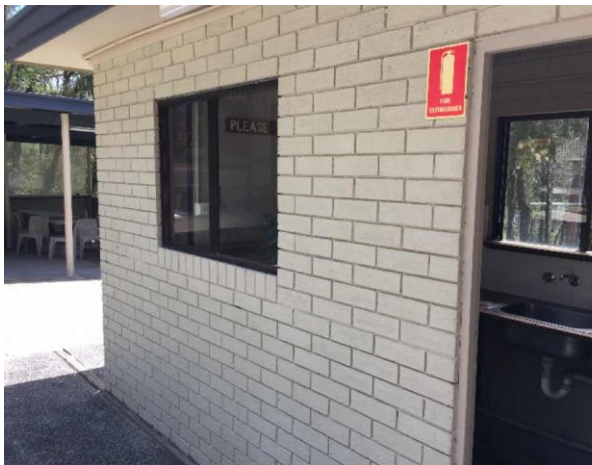
Line ID 104: External, GF, Holiday Units (1-8) Laundry, Walls, Grey Paint - Lead Detected (0.02% w/w)

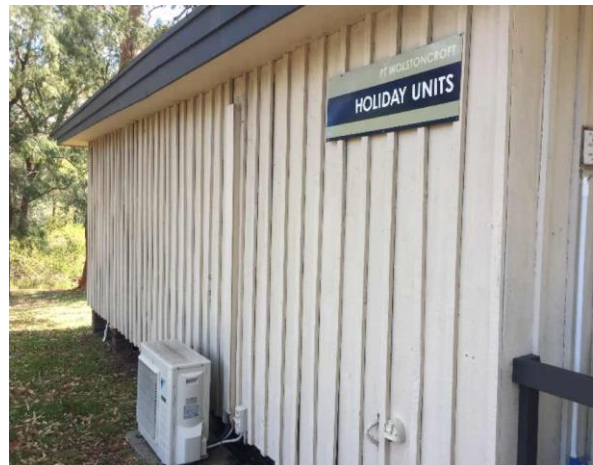
Line ID 105: External, GF, Holiday Units 1-8 (All Identical In Design), Walls Throughout, Beige Paint - Lead Detected (<0.005% w/w)

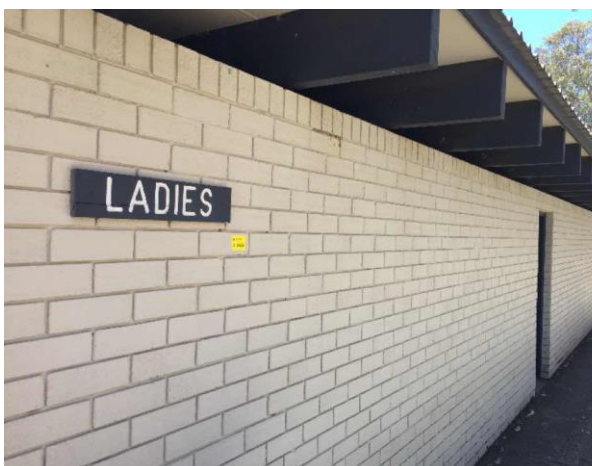
Line ID 106: External, GF, Pool House, Pool Store & Toilet Block, Walls Throughout, Beige Paint - Lead Detected (<0.005% w/w)

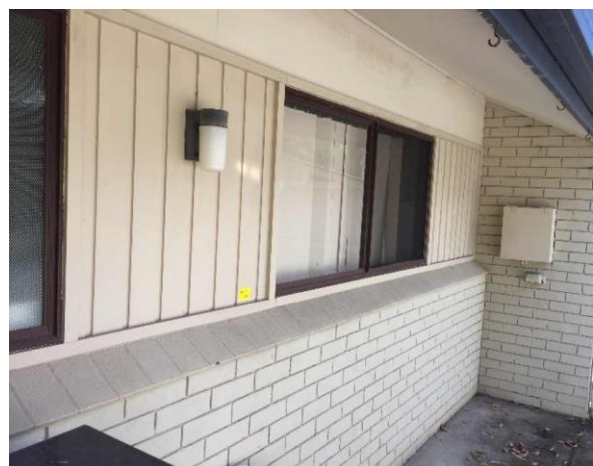
Line ID 107: External, GF, Residence 1 (Waratah House & Garage), House and Garage Walls, Beige Paint - Lead Detected (0.005% w/w)

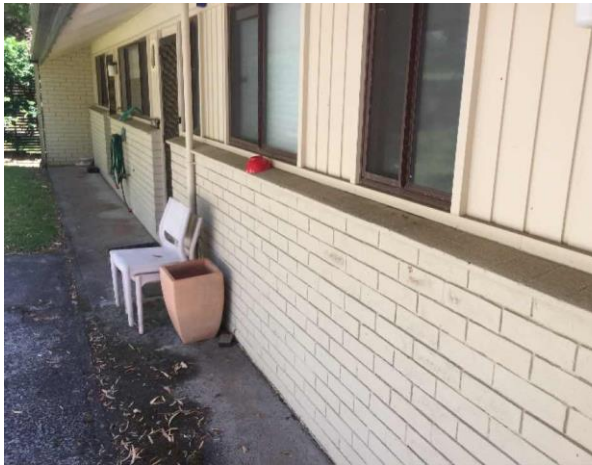
Line ID 108: External, GF, Residence 2 (Wattle House & Garage), House and Garage Walls, Beige Paint - Lead Detected (0.005% w/w)

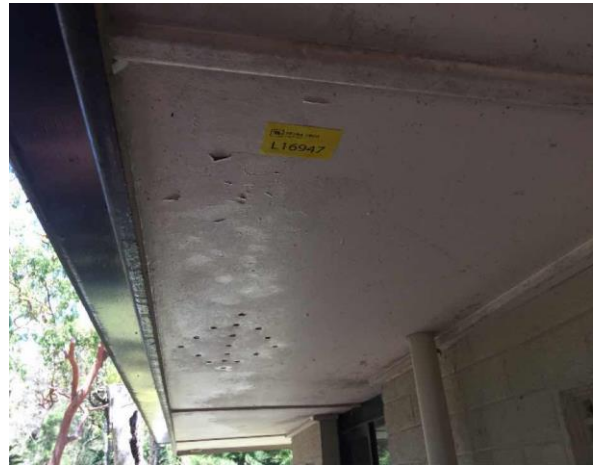
Line ID 109: External, GF, Residence 3 and Garage, Eaves to House and Garage, White Paint - Lead Detected (0.46% w/w)

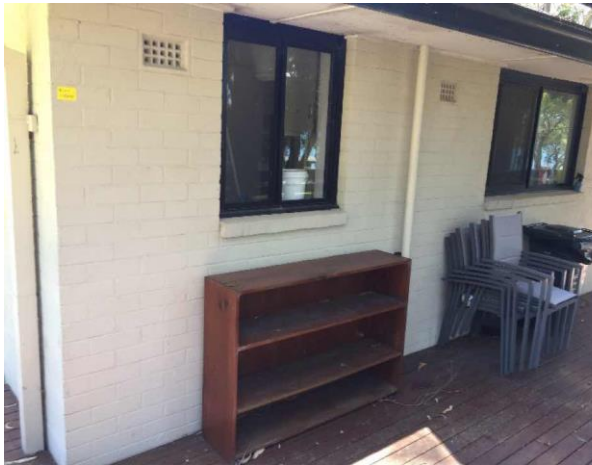
Line ID 110: External, GF, Residence 3 and Garage, Walls to House and Garage, Beige Paint - Lead Detected (0.008% w/w)

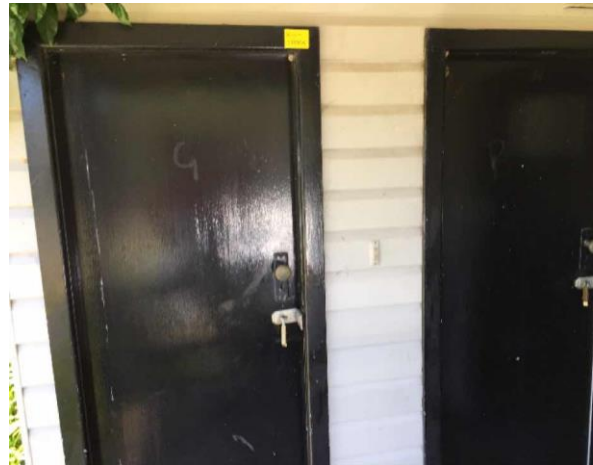
Line ID 111: External, GF, Ropes Course Store Building/Toilet, Hand-railing, Doors, Window and Door Frames, Black Paint - Lead Detected (0.20% w/w)

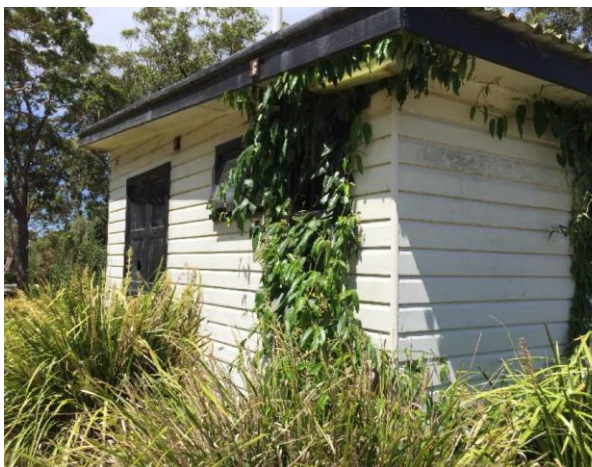
Line ID 112: External, GF, Ropes Course Store Building/Toilet, Walls, Beige Paint - Lead Detected (<0.005% w/w)

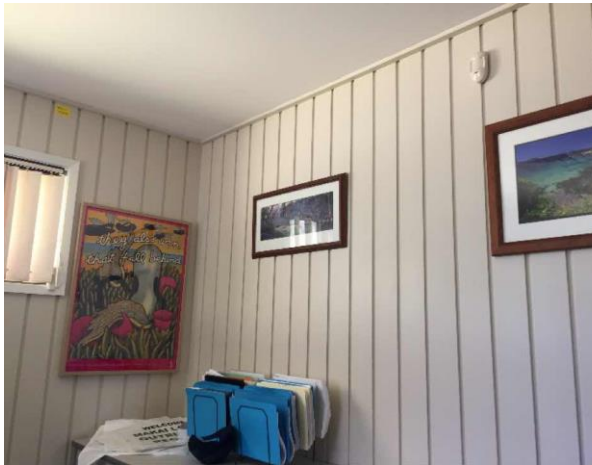
Line ID 114: Internal, GF, Administration/Office Building, Walls Throughout, Cream Paint - Lead Detected (0.02% w/w)

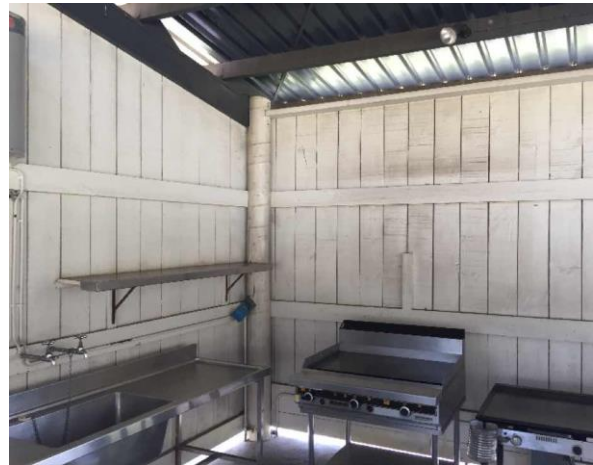
Line ID 115: Internal, GF, Barbeque Area, Walls Throughout, Beige Paint - Lead Detected (<0.005% w/w)

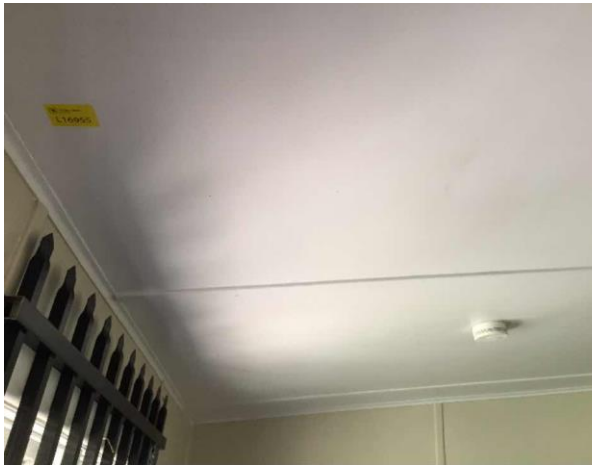
Line ID 116: Internal, GF, Bush Craft Building, Ceilings and Window Frames, White Paint - Lead Detected (5.8% w/w)

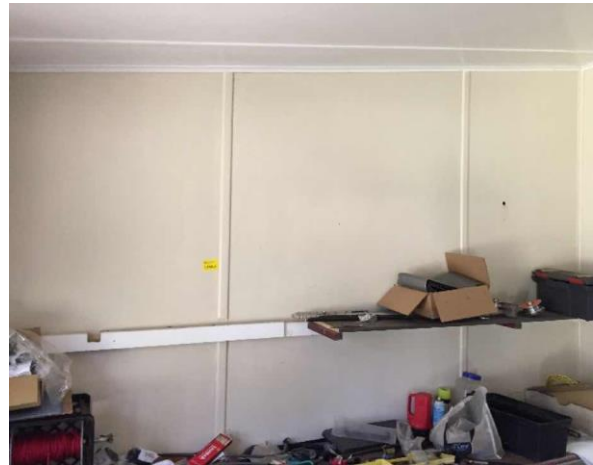
Line ID 117: Internal, GF, Bush Craft Building, Walls to Eastern Room, Beige Paint - Lead Detected (0.079% w/w)

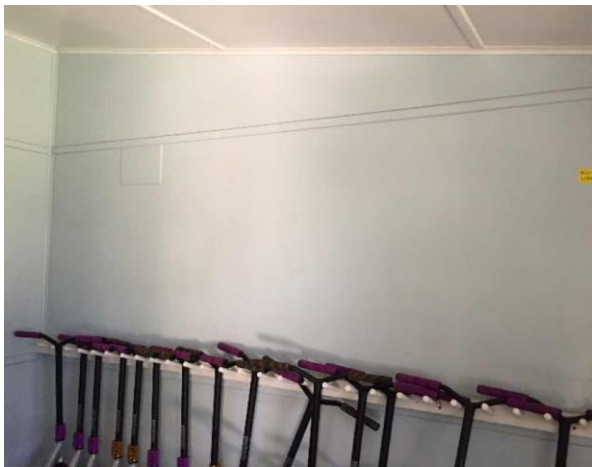
Line ID 118: Internal, GF, Bush Craft Building, Walls to Western Room, Blue Paint - Lead Detected (0.14% w/w)

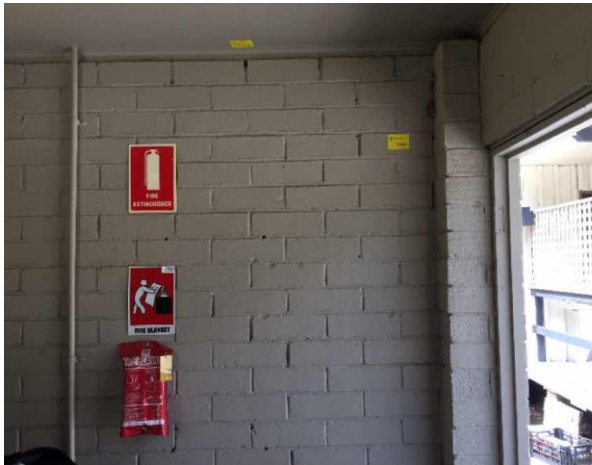
Line ID 120: Internal, GF, Holiday Units (1-8) Laundry, Walls and Ceiling, Grey Paint - Lead Detected (0.02% w/w)
