Asbestos and Hazardous Materials Reinspection Assessment

Point Wolstoncroft Sports and Recreational Centre

03/02/2023

754-SYDEN311850 - Point Wolstoncroft Sports and Recreational Centre - HMRR - 17012023

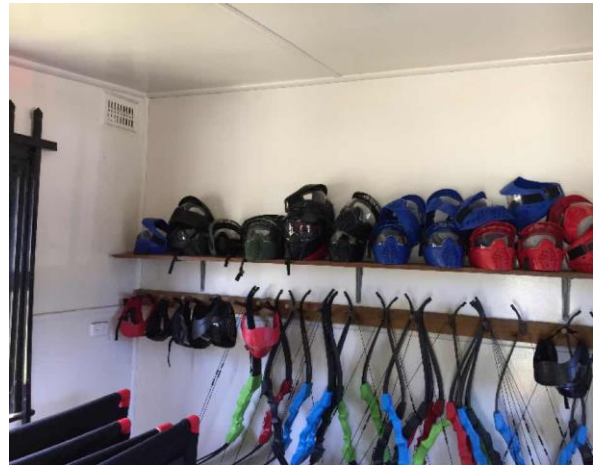
Line ID 121: Internal, GF, Ropes Course Store Building/Toilet, Walls and Ceilings Throughout, Beige Paint - Lead Detected (0.006% w/w)

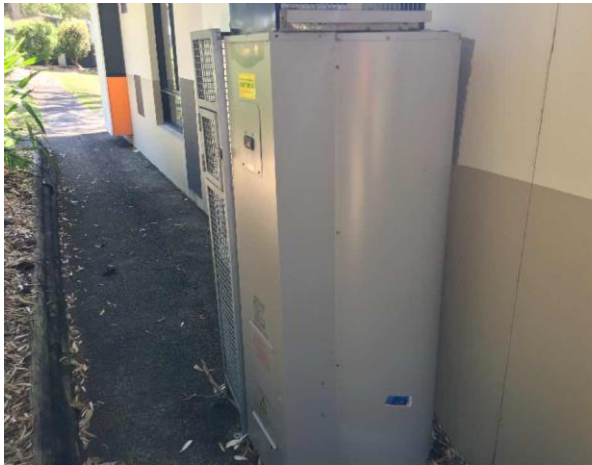
Line ID 122: External, GF, Banksia Lodge, Western Elevation, Hot Water Tank, Internal Insulation - Suspected SMF

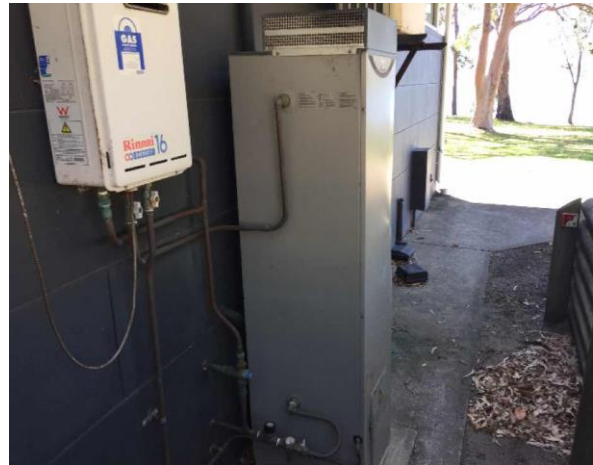
Line ID 123: External, GF, Bluegum Lodge, Southern Elevation, Hot Water Tank, Internal Insulation - Suspected SMF

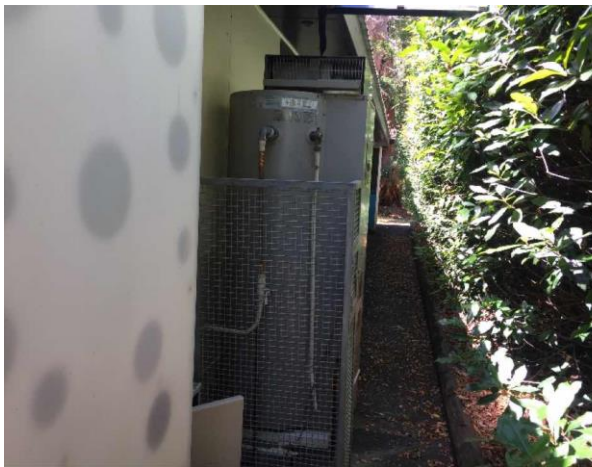
Line ID 124: External, GF, Casuarina Lodge, Western Wall, Hot Water Tank, Internal Insulation - Suspected SMF

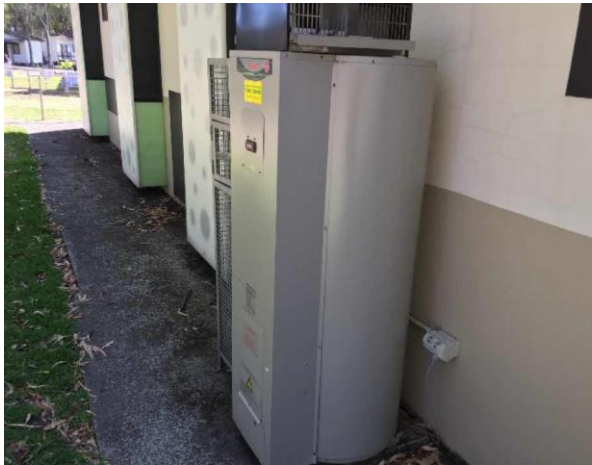
Line ID 126: External, GF, Geebung Lodge, Western Elevation, Hot Water Tank, Internal Insulation - Suspected SMF

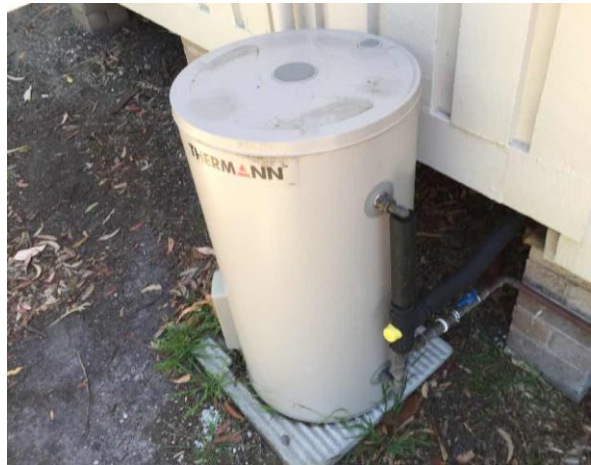
Line ID 127: External, GF, Hakea Lodges 1-3, Hot Water Tanks, Internal Insulation - Suspected SMF

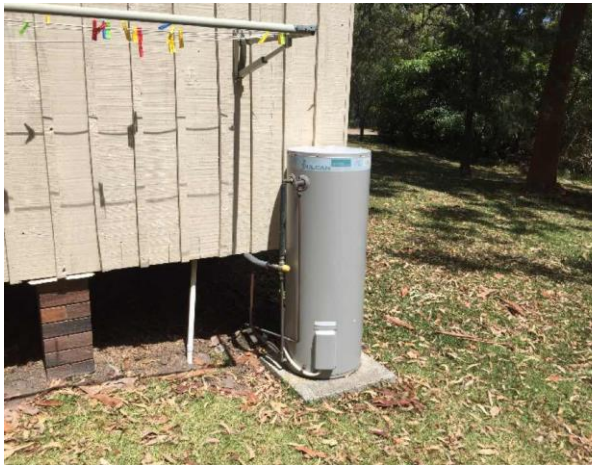
Line ID 128: External, GF, Holiday Units 1-8 (All Identical In Design), Hot Water Tanks, Internal Insulation - Suspected SMF

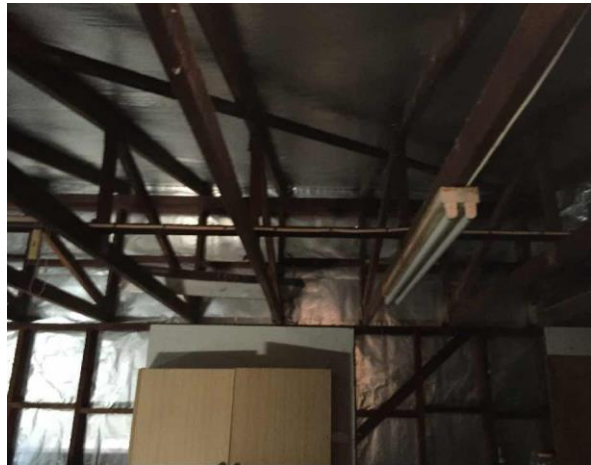
Line ID 129: External, GF, Residence 1 (Waratah House & Garage), Garage, Ceiling and Walls, Sarking Insulation - Suspected SMF

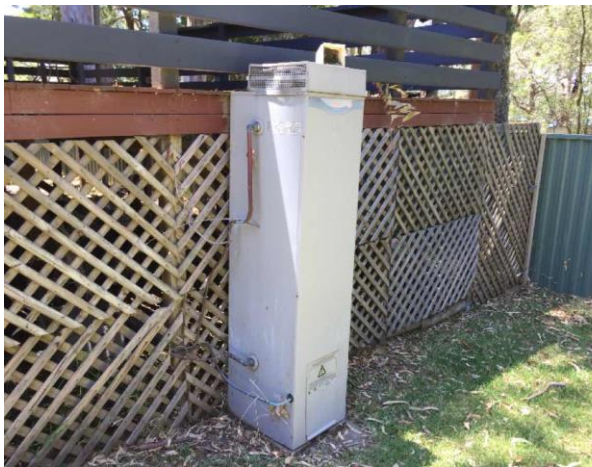
Line ID 130: External, GF, Residence 3 and Garage, South-eastern Corner, Hot Water Tank, Internal Insulation - Suspected SMF

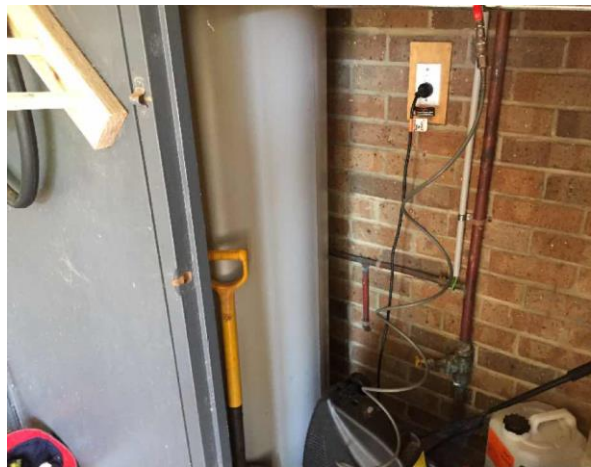
Line ID 131: External, GF, Staff Residence, Within Porch Cupboard, Hot Water Tank, Internal Insulation - Suspected SMF

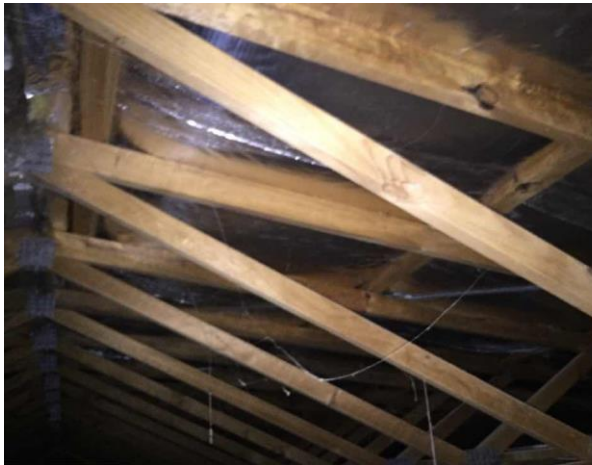
Line ID 132: Internal, GF, Acacia Lodge, Underside of Roof, Sarking Insulation - Suspected SMF

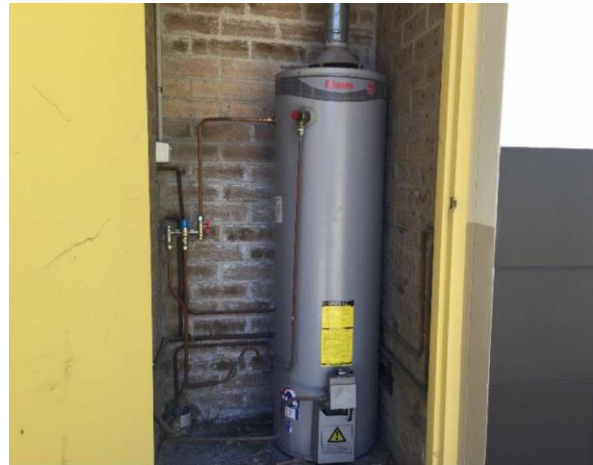
Line ID 133: Internal, GF, Acacia Lodge, Western Elevation Cupboards, Hot Water Tanks , Internal Insulation - Suspected SMF

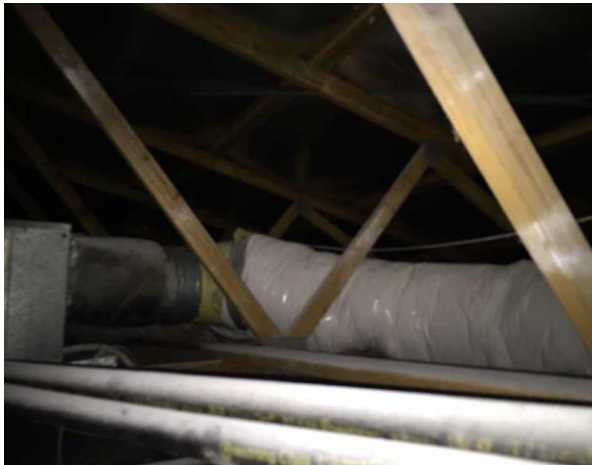
Line ID 134: Internal, GF, Administration/Office Building, Ceiling Space, Air Conditioning Ductwork, Insulation Material - Suspected SMF

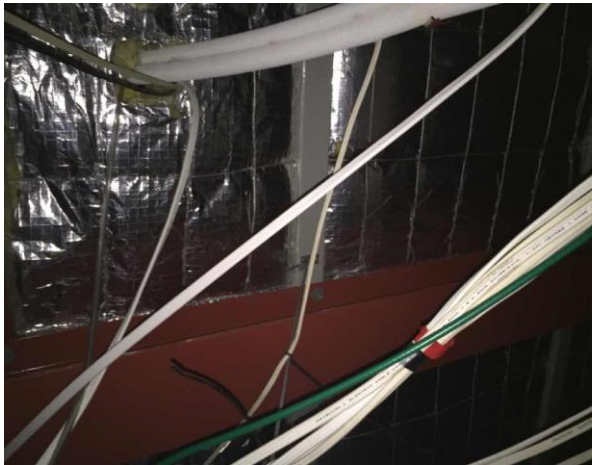
Line ID 139: Internal, GF, Dining Hall, Underside of Roof, Sarking Insulation - Suspected SMF

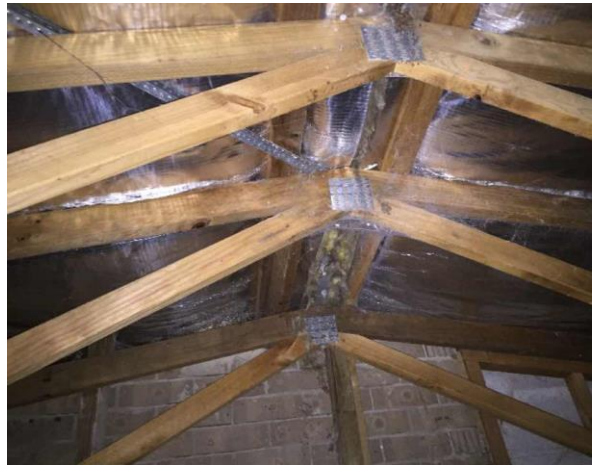
Line ID 140: Internal, GF, Geebung Lodge, Underside of Roof, Sarking Insulation - Suspected SMF

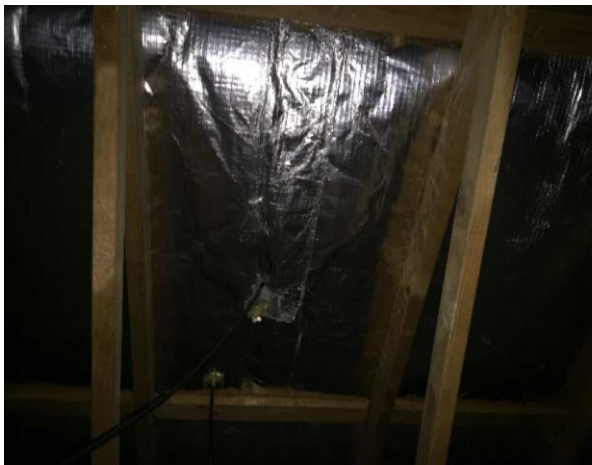
Line ID 141: Internal, GF, Grevillea Lodge, Underside of Roof, Sarking Insulation - Suspected SMF

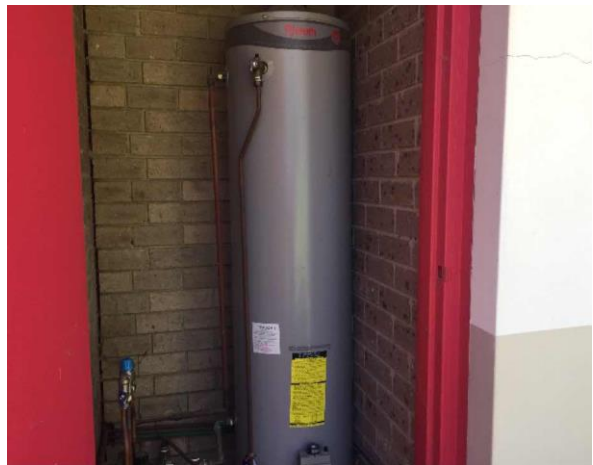
Line ID 142: Internal, GF, Grevillea Lodge, Western Wall Cupboards, Hot Water Tanks, Internal Insulation - Suspected SMF

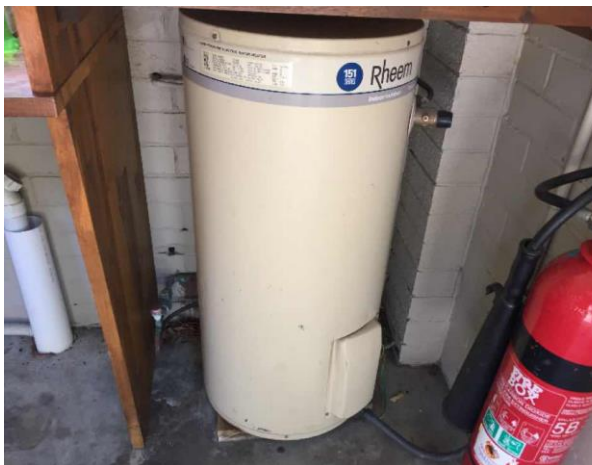
Line ID 143: Internal, GF, Holiday Units (1-8) Laundry, Hot Water Tank, Internal Insulation - Suspected SMF

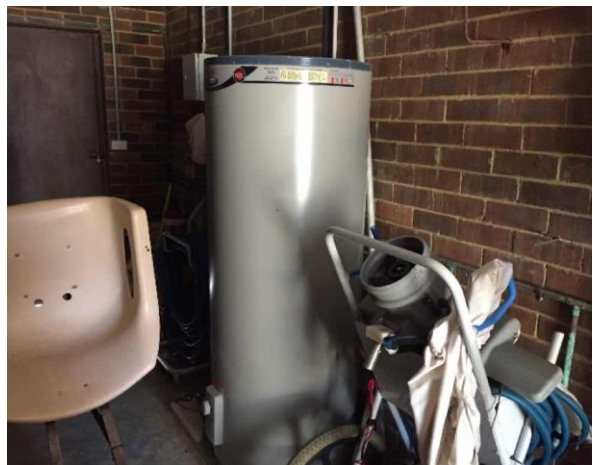
Line ID 144: Internal, GF, Pool House, Pool Store & Toilet Block, Cleaners Room, Hot Water Tank, Internal Insulation - Suspected SMF

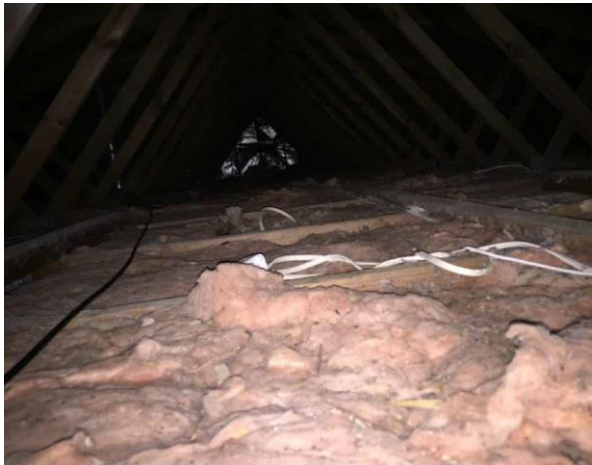
Line ID 145: Internal, GF, Residence 1 (Waratah House & Garage), House, Floor of Ceiling Void, Insulation Batts - Suspected SMF

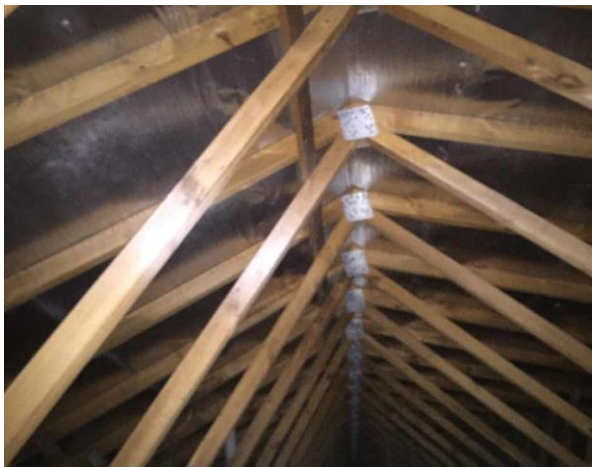
Line ID 148: Internal, GF, Residence 2 (Wattle House & Garage), House, Floor of Ceiling Void, Insulation Batts - Suspected SMF

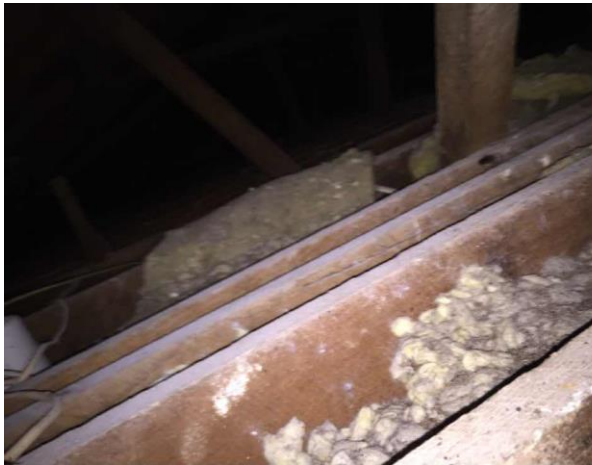
Line ID 150: Internal, GF, Residence 2 (Wattle House & Garage), Laundry, Hot Water Tank, Internal Insulation - Suspected SMF

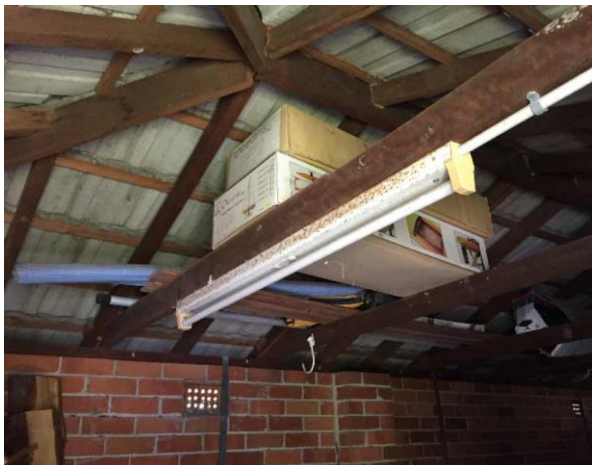
Line ID 152: Internal, GF, Equipment Store Building, Fluorescent Lights, Capacitor(s) - PCB Capacitor

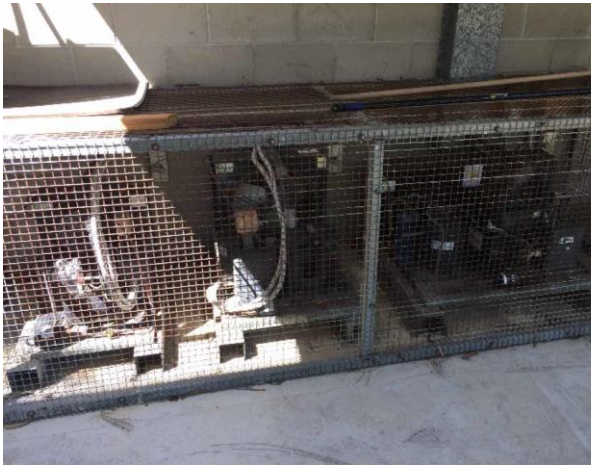
Line ID 156: External, GF, Conference Lodge, Beneath Building, Air Conditioning Unit, R410A Hydrofluorocarbon (HFC) - Non ODS Refrigerant

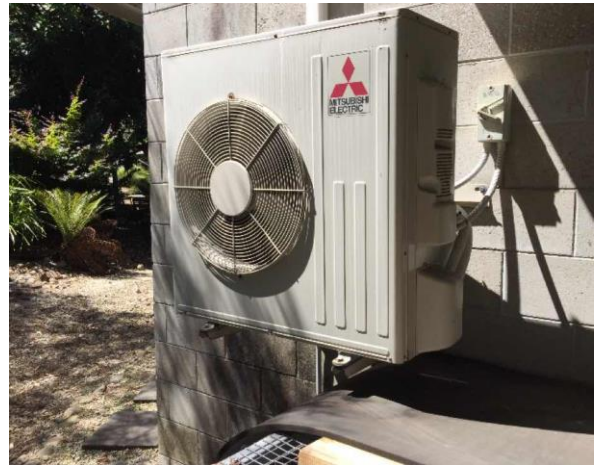
Line ID 157: External, GF, Dining Hall, Chiller Units, R404A Refrigerant - Non ODS Refrigerant

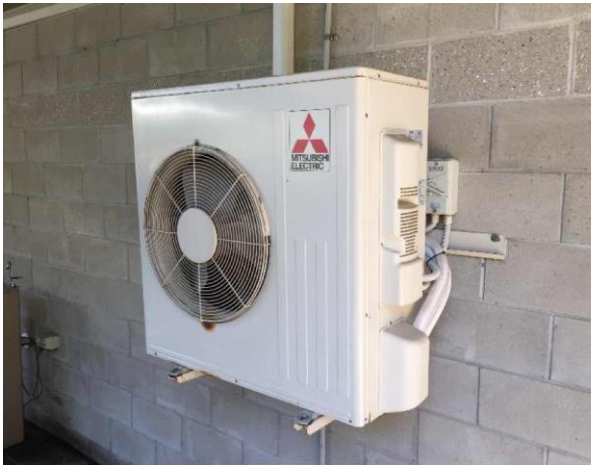
Line ID 158: External, GF, Dining Hall, Southern Elevation, Air Conditioning Unit, R410A Hydrofluorocarbon (HFC) - Non ODS Refrigerant

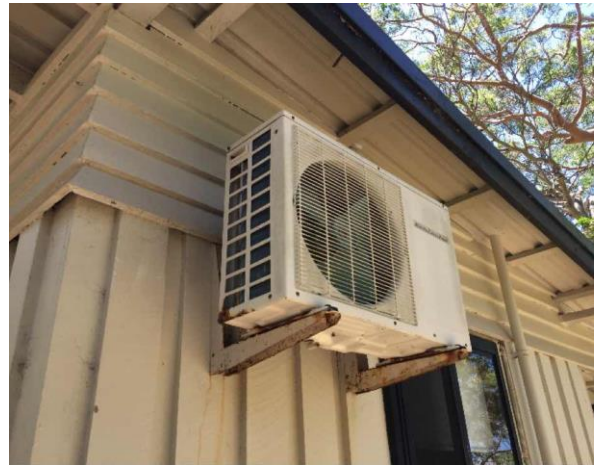
Line ID 159: External, GF, Dining Hall, Western Wall, Air Conditioning Unit, R410A Hydrofluorocarbon (HFC) - Non ODS Refrigerant

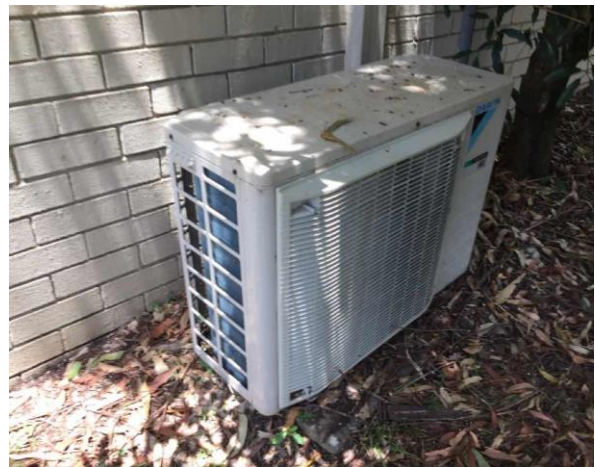
Line ID 161: External, GF, Holiday Units 1-8 (All Identical In Design), Air Conditioning Units, R410A Hydrofluorocarbon (HFC) - Non ODS Refrigerant

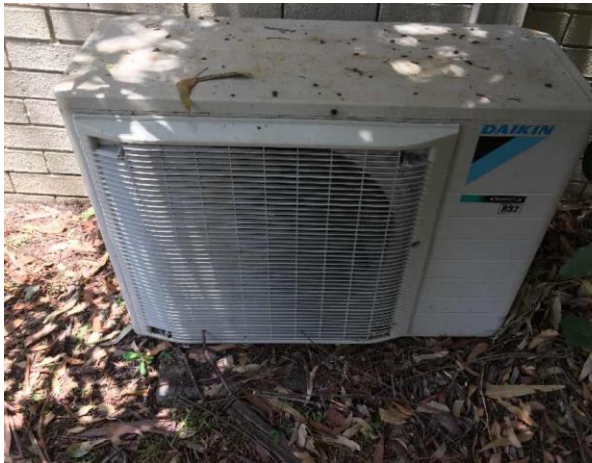
Line ID 162: External, GF, Residence 1 (Waratah House & Garage), Eastern Wall, Air Conditioning Unit, R32 Refrigerant - Non ODS Refrigerant

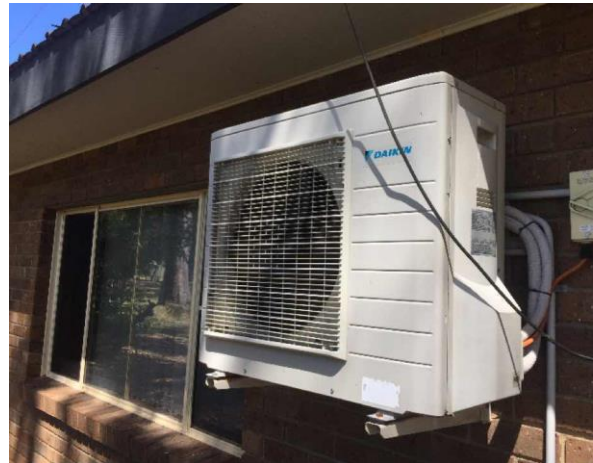
Line ID 163: External, GF, Residence 2 (Wattle House & Garage), Eastern Wall, Air Conditioning Unit, R32 Refrigerant - Non ODS Refrigerant

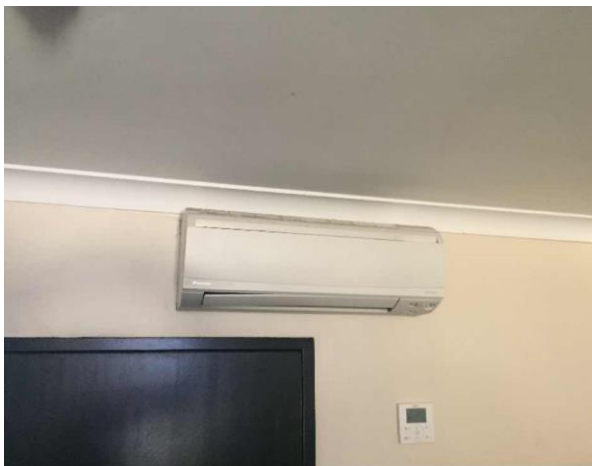
Line ID 164: External, GF, Staff Residence, Northern Wall, Air Conditioning Unit, R410A Hydrofluorocarbon (HFC) - Non ODS Refrigerant

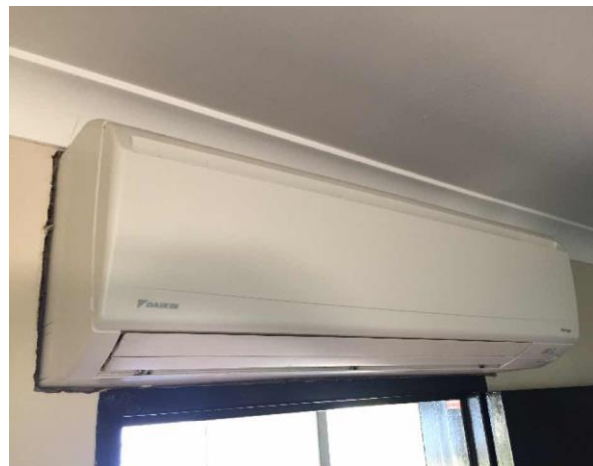
Line ID 165: Internal, GF, Acacia Lodge, Air Conditioning Units, R410A Hydrofluorocarbon (HFC) - Non ODS Refrigerant

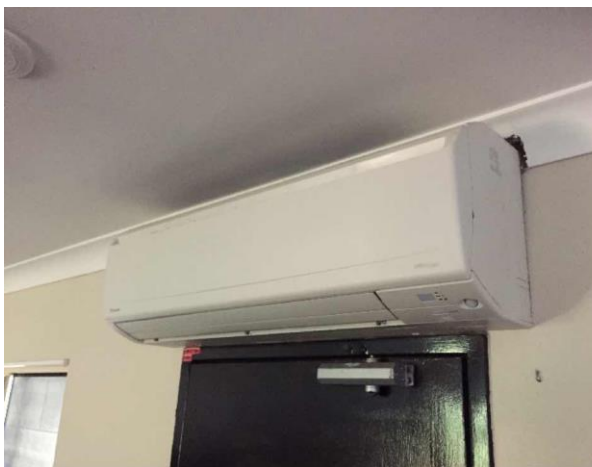
Line ID 166: Internal, GF, Banksia Lodge, Air Conditioning Units, R410A Hydrofluorocarbon (HFC) - Non ODS Refrigerant

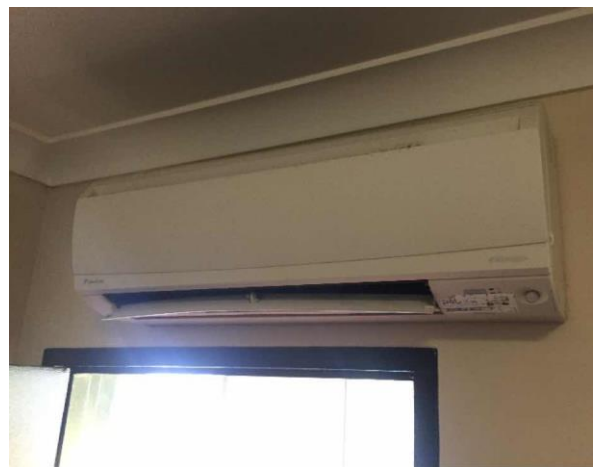
Line ID 167: Internal, GF, Casuarina Lodge, Air Conditioning Units, R410A Hydrofluorocarbon (HFC) - Non ODS Refrigerant

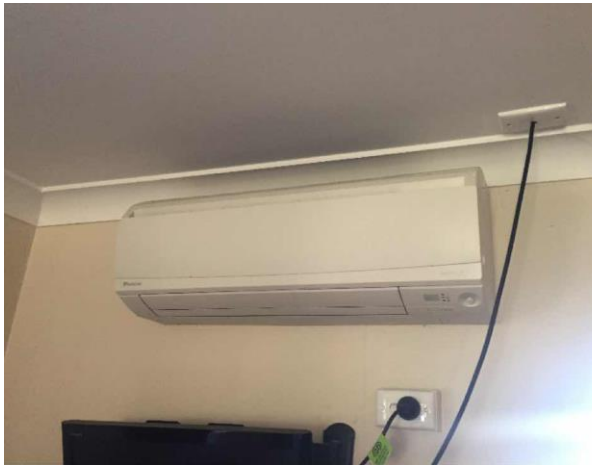
Line ID 168: Internal, GF, Geebung Lodge, Air Conditioning Units, R410A Hydrofluorocarbon (HFC) - Non ODS Refrigerant

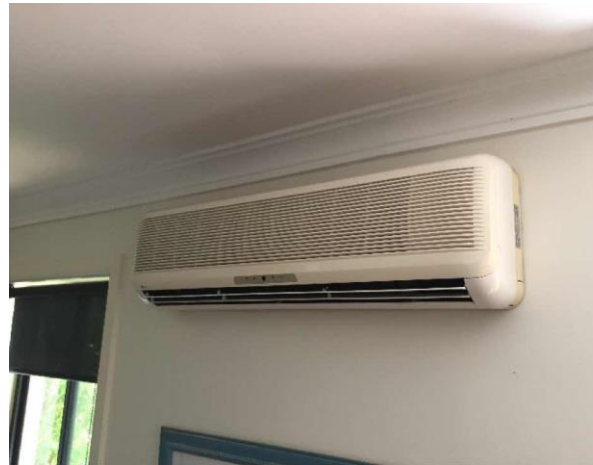
Line ID 169: Internal, GF, Grevillea Lodge, Air Conditioning Units, R410A Hydrofluorocarbon (HFC) - Non ODS Refrigerant
