Asbestos and Hazardous Materials Reinspection Assessment

Sydney International Equestrian Centre

28/03/2023

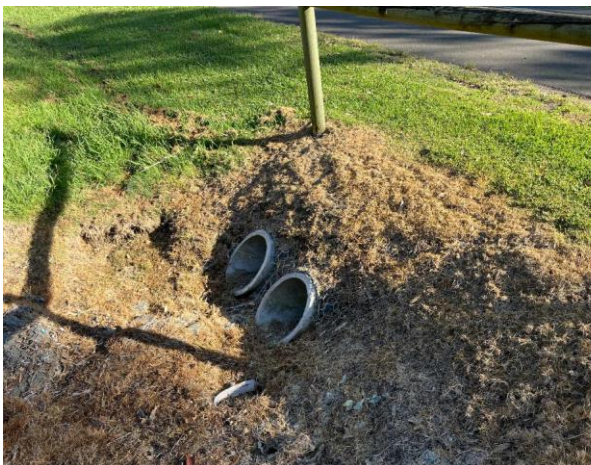
Line ID 4: External, Grounds Throughout, North Side of Cabins, Drainage Pipes, Moulded Fibre Cement - No Asbestos Detected

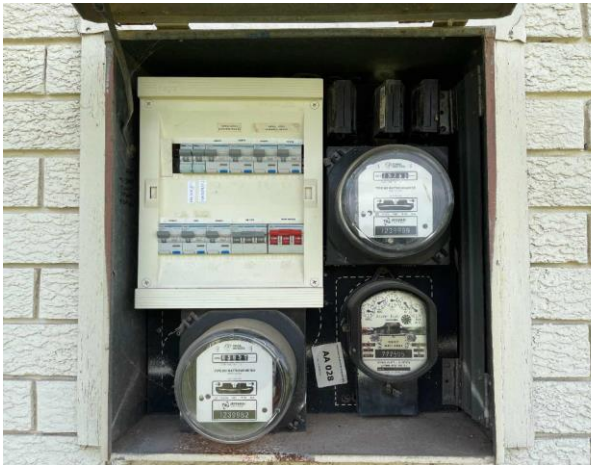
Line ID 13: External, House, Perimeter, Meter Box, Bituminous Backing Board - Suspected Asbestos

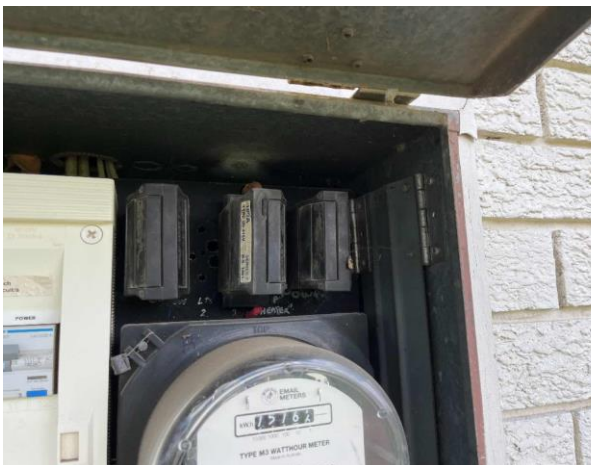
Line ID 16: External, House, Perimeter, Switchboard, HRC Fuses - Suspected Asbestos

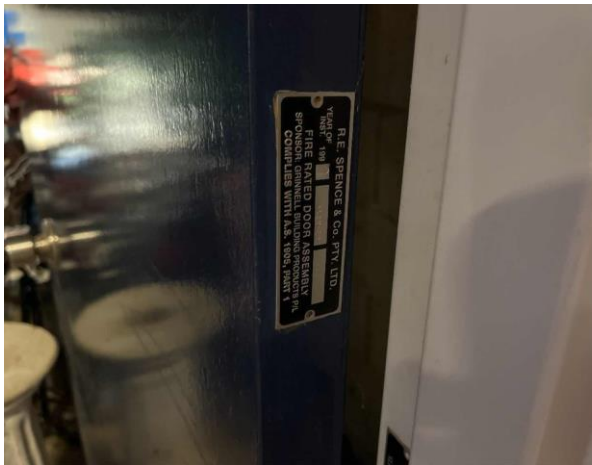
Line ID 32.1: Internal, Main Arena 1, Eastern Storage Area, Door to E.05, E.04 and E.03, Fire Door Core - Suspected Asbestos

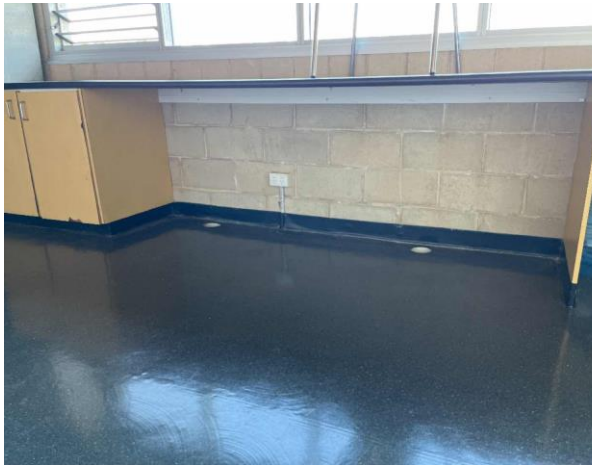
Line ID 35: Internal, Main Arena 1, Eastern Storage Area, E.03 Skirting, Black Vinyl Sheet - No Asbestos Detected

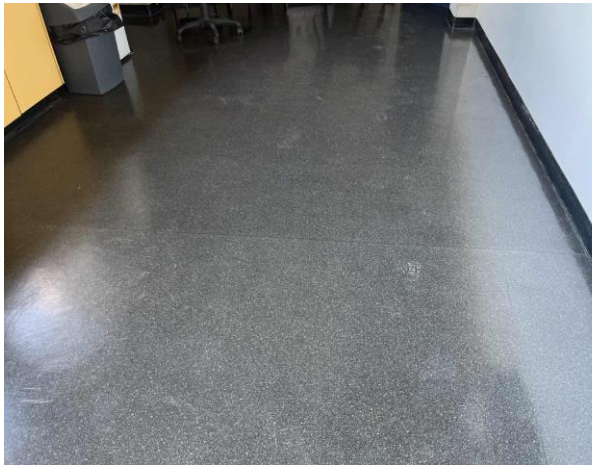
Line ID 37: Internal, Main Arena 1, Western Storage Area, F.03 Floor Covering, Black Vinyl Sheet - No Asbestos Detected

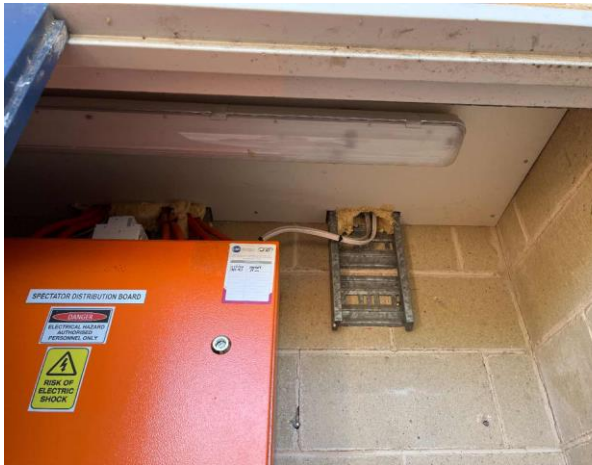
Line ID 41: Internal, Main Arena 1 West Amenities, C.09 Distribution Board, Ceiling, Fibre Cement Sheeting - No Asbestos Detected

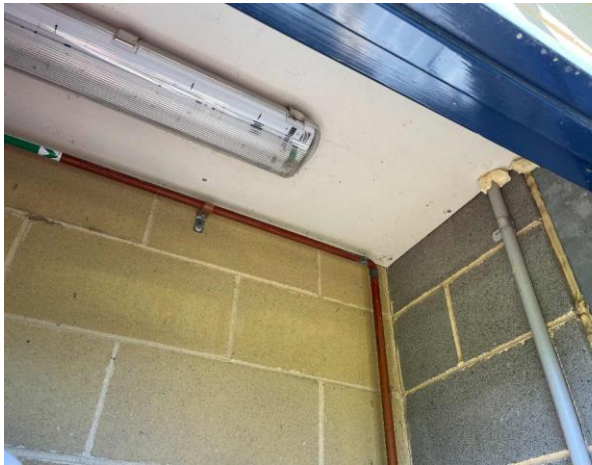
Line ID 43: Internal, Northern Amenities, Store Room, Ceiling, Fibre Cement Sheet - No Asbestos Detected

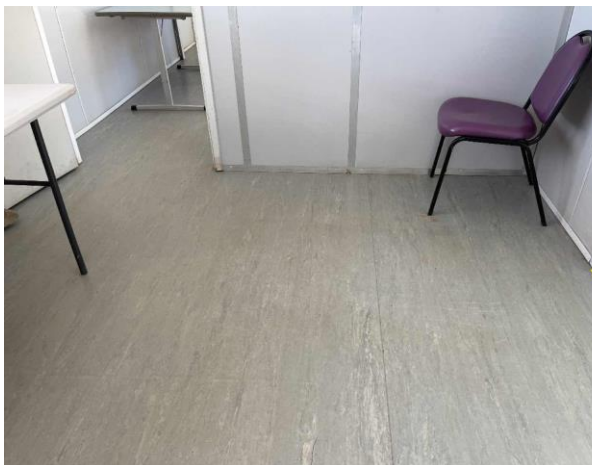
Line ID 45: Internal, Riders Retreat, Event Office, Floor Covering, Blue Vinyl Sheet - No Asbestos Detected

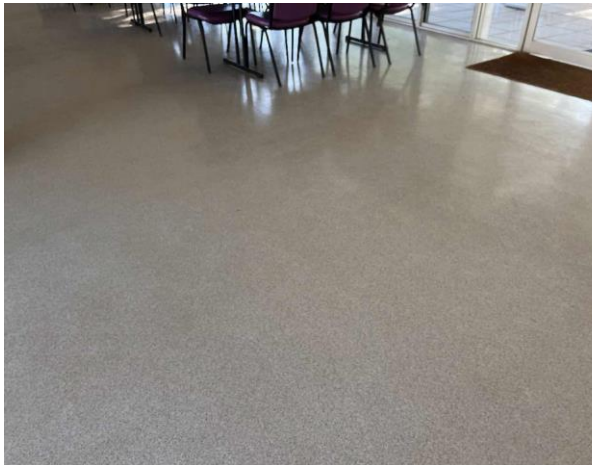
Line ID 47: Internal, Riders Retreat, Throughout, Floor Covering, Blue Vinyl Sheet - No Asbestos Detected

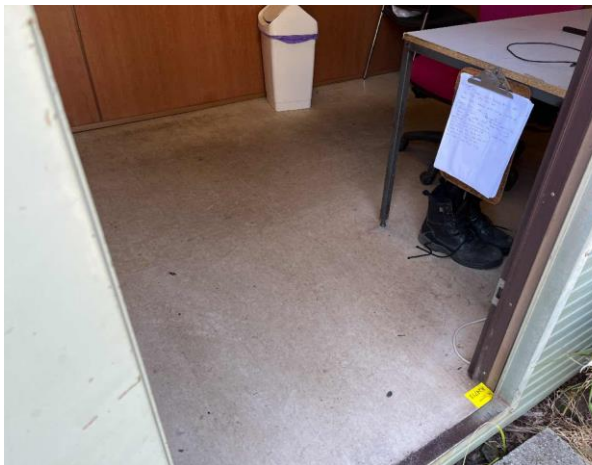
Line ID 49: Internal, Security Office, Throughout, Floor Covering, Grey Vinyl Sheet - No Asbestos Detected

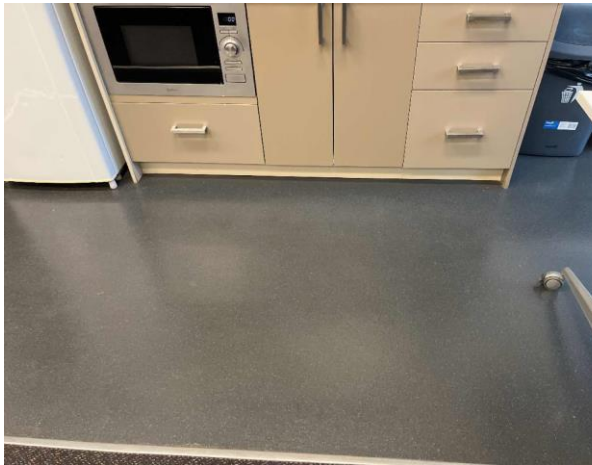
Line ID 53: Internal, Venue Office, Conference Room, Kitchen Area, Floor Covering, Grey Vinyl Sheet - No Asbestos Detected

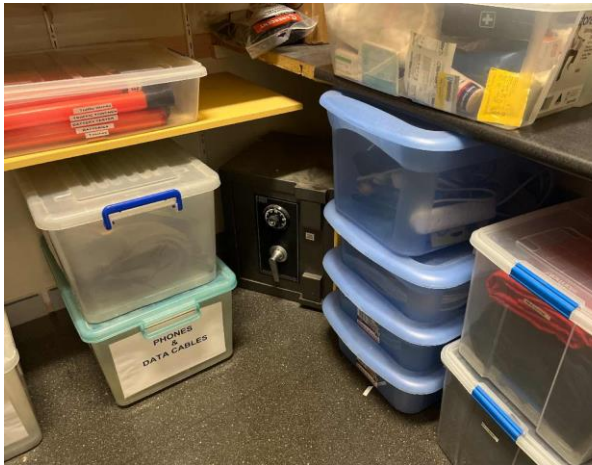
Line ID 58: Internal, Venue Office, Office A.05, Safe, Internal Insulation - Suspected Asbestos

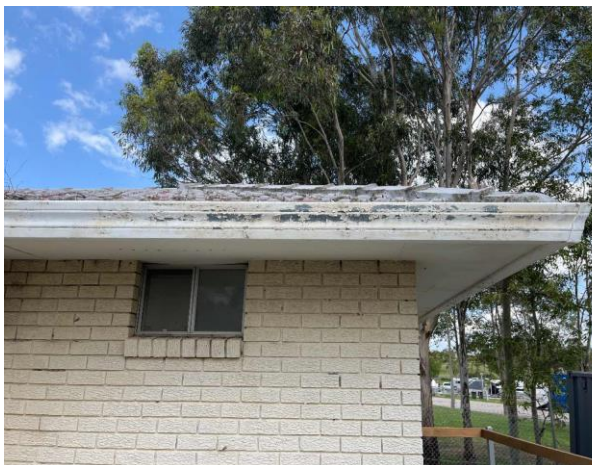
Line ID 63: External, House, Perimeter, Gutters, White Paint - Lead Detected (0.12% w/w)

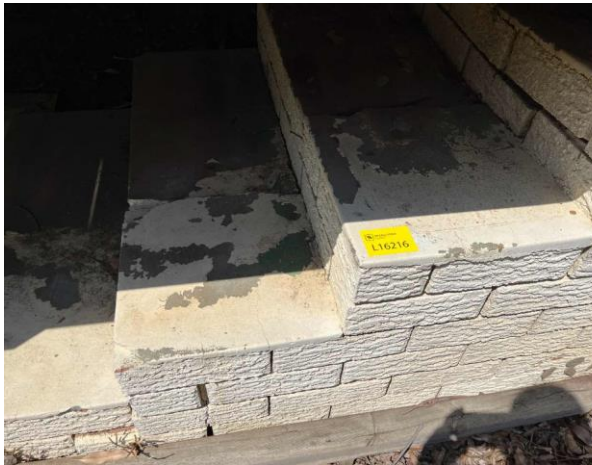
Line ID 64.1: External, House, Perimeter, Walls and Old Stairs, Cream Paint - Lead Detected (<0.005% w/w)

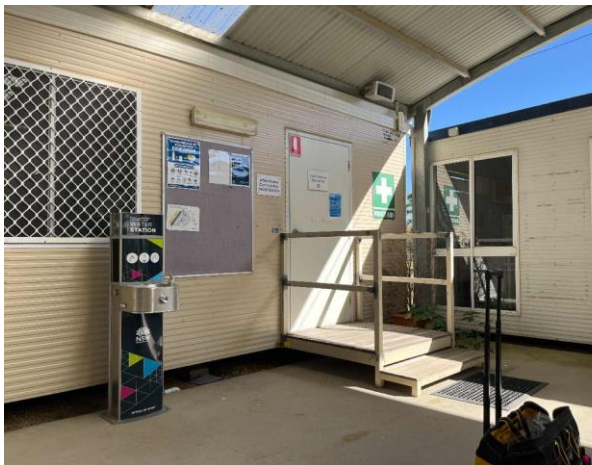
Line ID 66: External, Riders Retreat, First Aid Room, Walls and Handrails, Cream Paint - Lead Detected (<0.005% w/w)

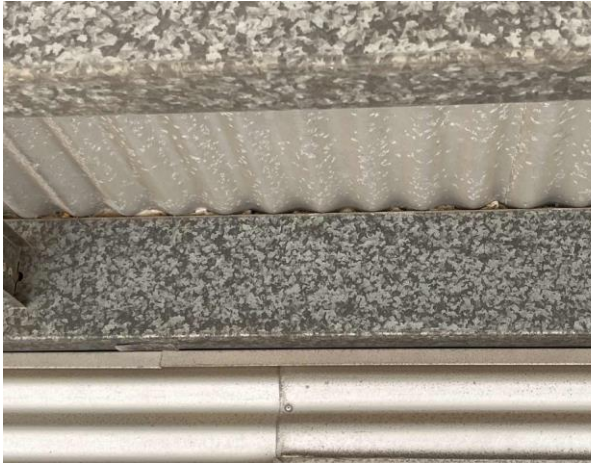
Line ID 72: Internal, Indoor Arena, Judges Office, Ceiling Void, Insulation Material - Suspected SMF

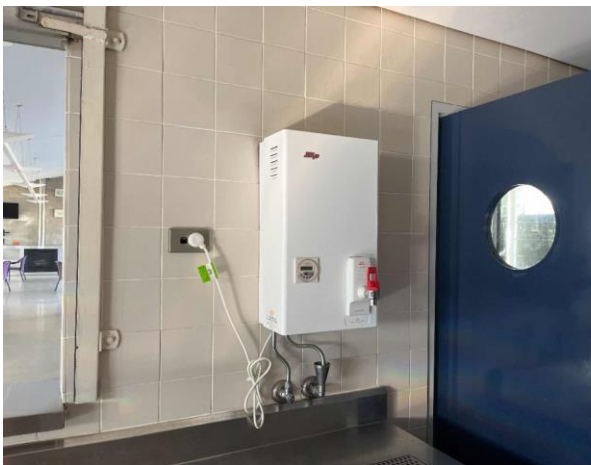
Line ID 77: Internal, Riders Retreat, Kitchen, Hot Water Boiler, Internal Insulation - Suspected SMF

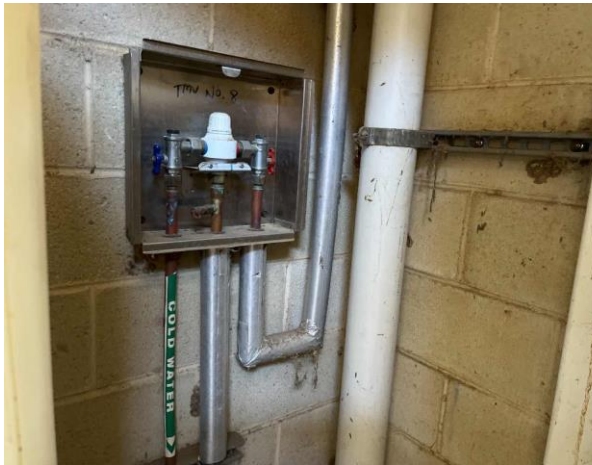
Line ID 80: Internal, Stables, Amenities, HWS Cupboards, Pipework, Insulation Material - Suspected SMF

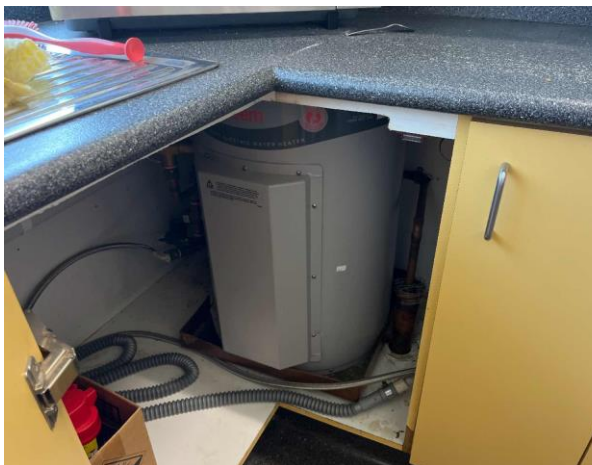
Line ID 85: Internal, Venue Office, Kitchen, Hot Water Heater, Internal Insulation - Suspected SMF

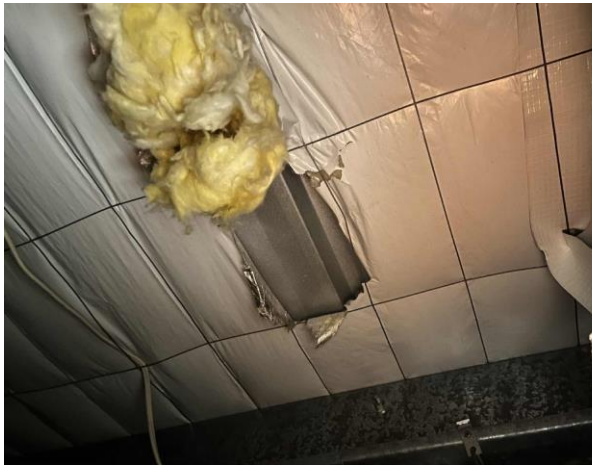
Line ID 87: Internal, Venue Office, Throughout, Ceiling Space, Sarking Insulation - Suspected SMF

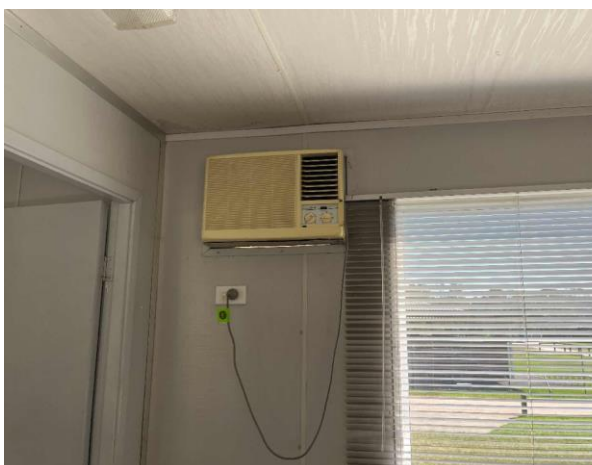
Line ID 92: Internal, Riders Retreat, Event Office, TECO AC Unit, Unknown Refrigerant - Suspected ODS

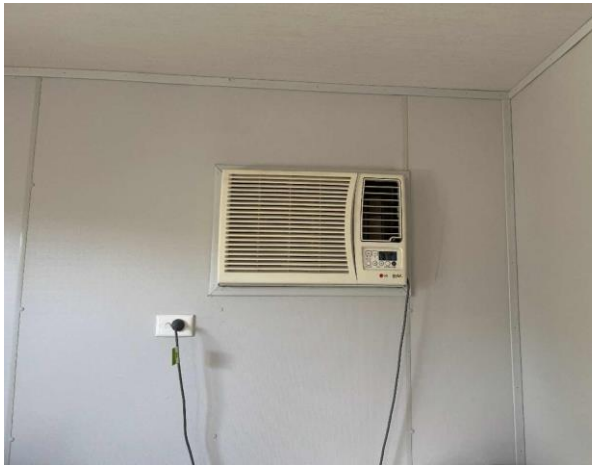
Line ID 93: Internal, Riders Retreat, First Aid Room, LG AC Unit, Unknown Refrigerant - Suspected ODS

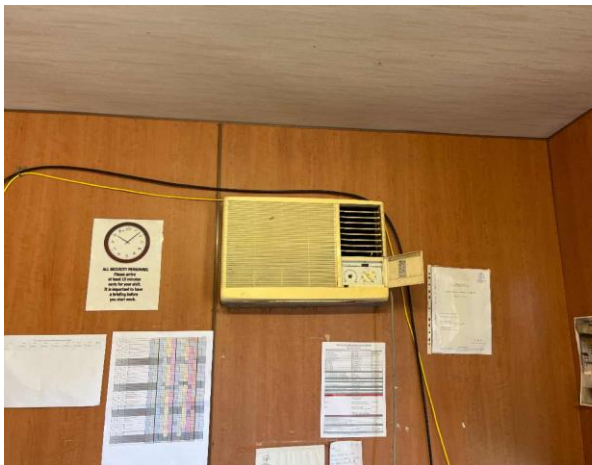
Line ID 95: Internal, Security Office, Throughout, TECO AC Unit, Unknown Refrigerant - Suspected ODS
