# Asbestos and Hazardous Materials Reinspection Assessment

Sydney International Regatta Centre

28/03/2023

754-SYDEN311850 - Sydney International Regatta Centre - HMRR - 01032023

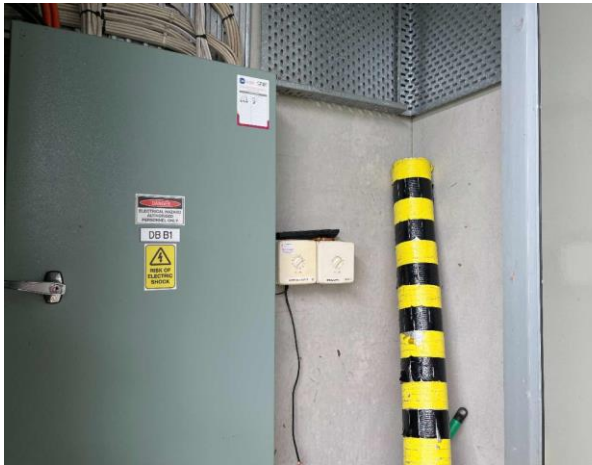
Line ID 1: External, Boatsheds, Meter Rooms, Walls, Fibre Cement Sheeting - No Asbestos Detected

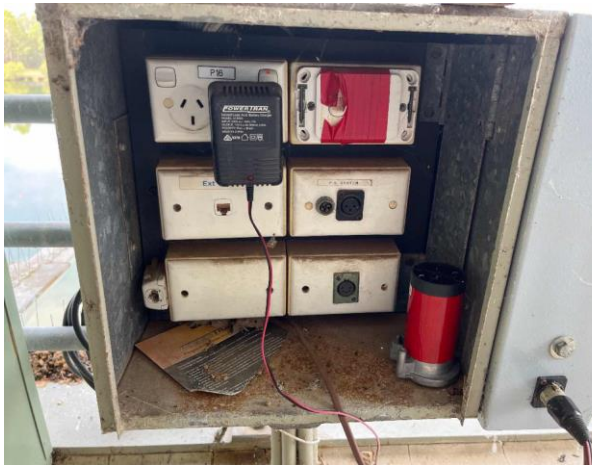
Line ID 3: External, Finish Tower, L3, Balcony, Switchboard, Bituminous Backing Board - No Asbestos Suspected

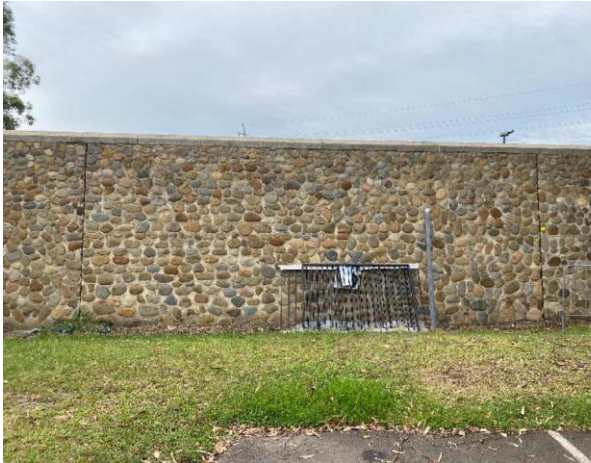
Line ID 7: External, Grounds, Entrance Wall, Expansion Gap, Bituminous Membrane - No Asbestos Detected

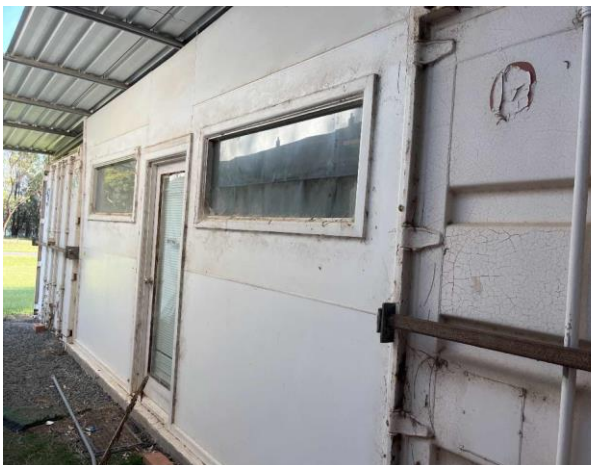
Line ID 10: External, Old Compound, North Building, Wall Between Containers, Fibre Cement Sheet - No Asbestos Detected

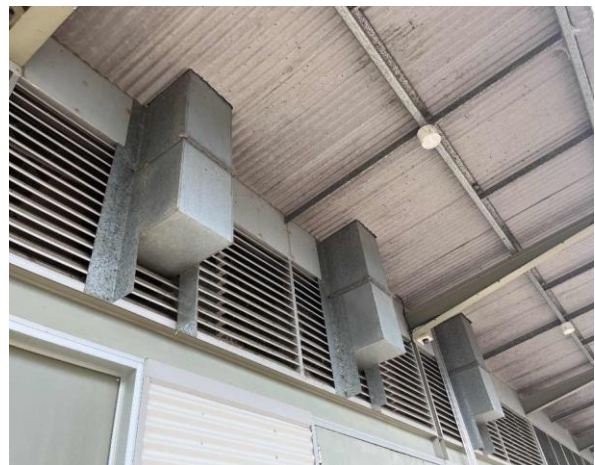
Line ID 11: External, Restaurant, Throughout, Fascia, Fibre Cement Sheet - No Asbestos Detected

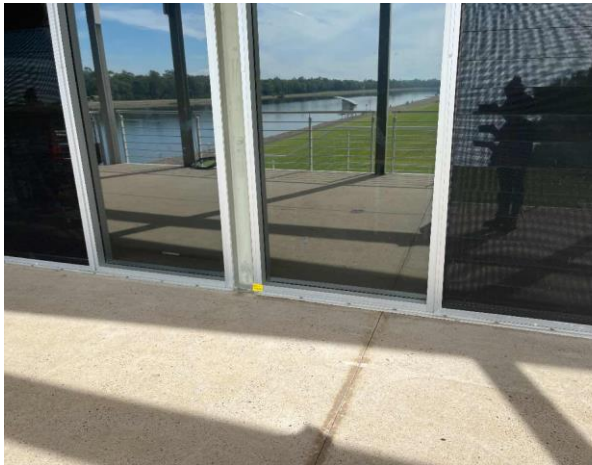
Line ID 12: External, Restaurant, Throughout, Window Frames, Mastic Sealant - No Asbestos Detected

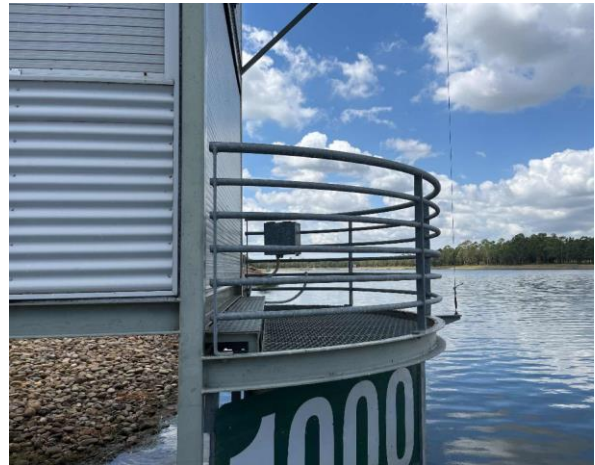
Line ID 13: External, Timing Towers, Tower at 1000m, Switchboard, Bituminous Backing Board - No Asbestos Suspected

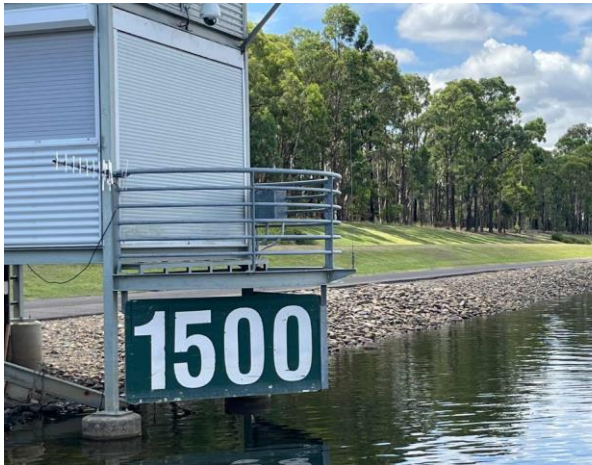
Line ID 14: External, Timing Towers, Tower at 1500m, Switchboard, Bituminous Backing Board - No Asbestos Suspected

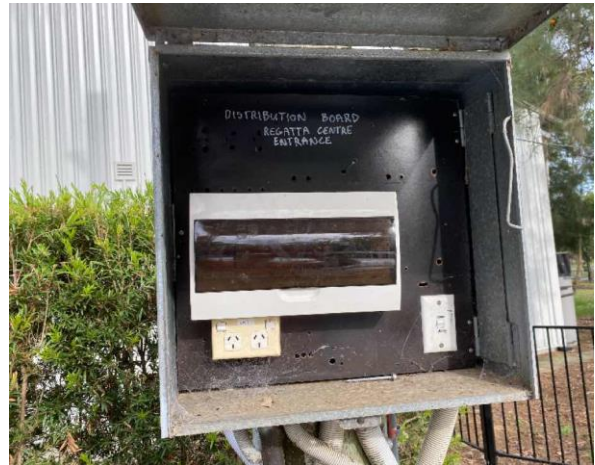
Line ID 15: External, Venue Operations Centre, Throughout, Electrical Pole, Bituminous Backing Board - No Asbestos Suspected

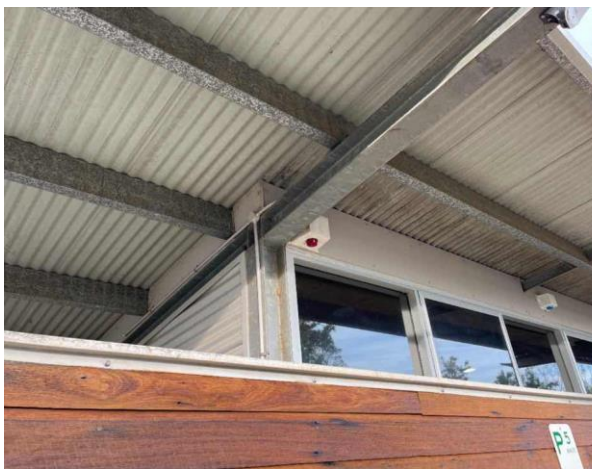
Line ID 16: External, Venue Operations Centre, Throughout, Fascia, Fibre Cement Sheet - No Asbestos Detected

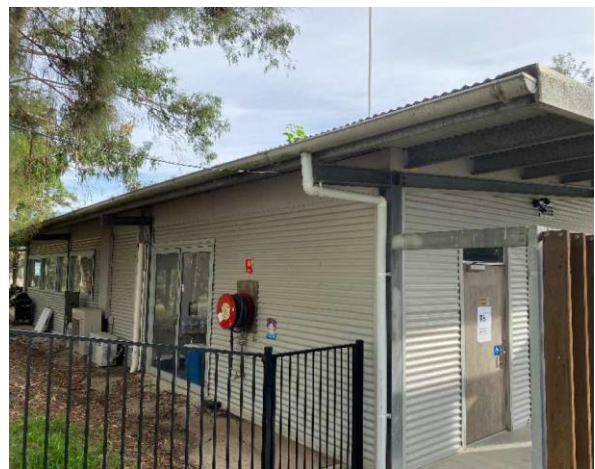
Line ID 16.1: External, Venue Operations Centre, Throughout, Fascia, Fibre Cement Sheet - No Asbestos Detected

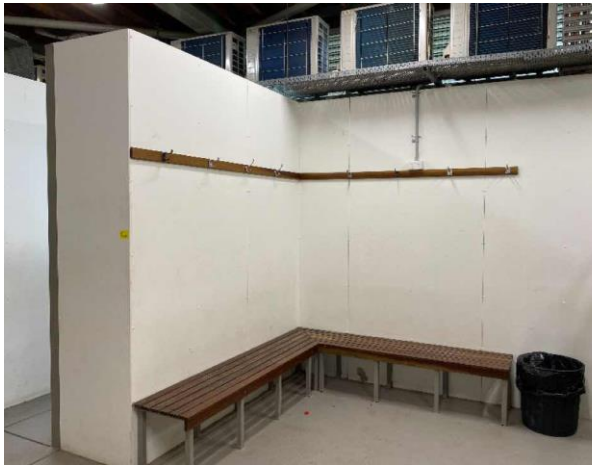
Line ID 17: Internal, Boatsheds, Female Toilets, Walls, Fibre Cement Sheeting - No Asbestos Detected

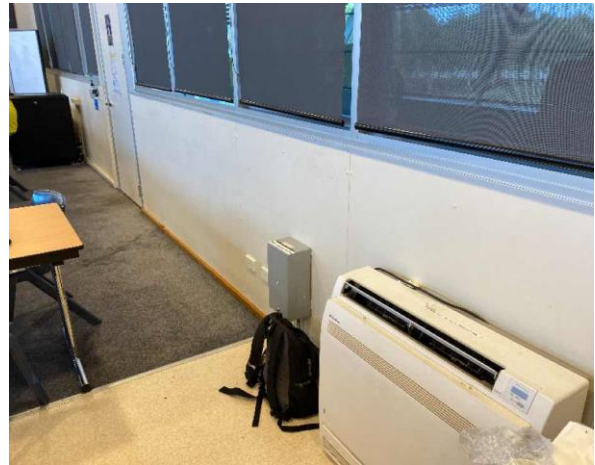
Line ID 18: Internal, Boatsheds, L1, Offices, Walls, Fibre Cement Sheeting - No Asbestos Detected

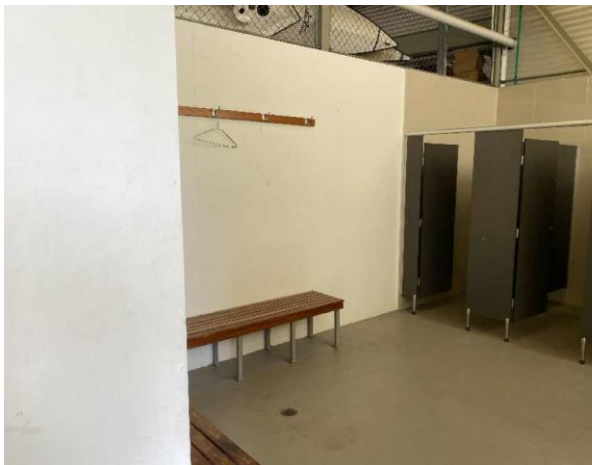
Line ID 19: Internal, Boatsheds, Male Toilets, Walls, Fibre Cement Sheeting - No Asbestos Detected

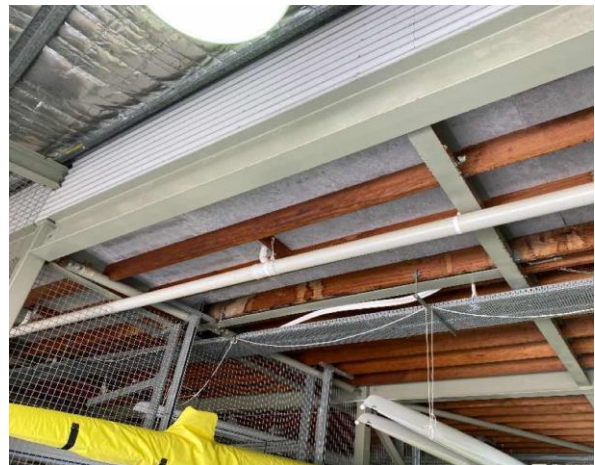
Line ID 20: Internal, Boatsheds, Throughout, Ceiling (Base of Veranda), Compressed Cement Sheeting - No Asbestos Detected

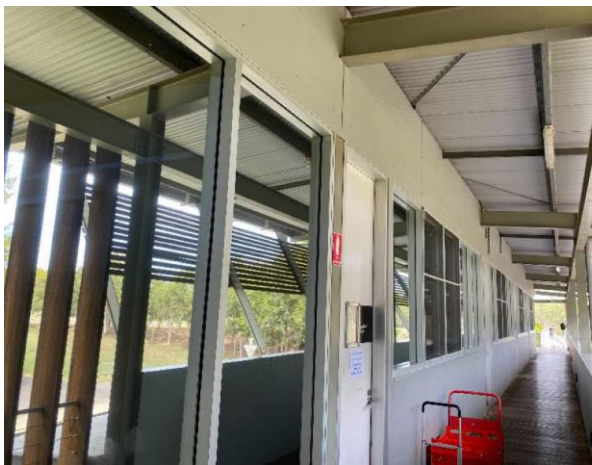
Line ID 21: Internal, Boatsheds, Throughout, L1, Fascia and Walls, Fibre Cement Sheeting - No Asbestos Detected

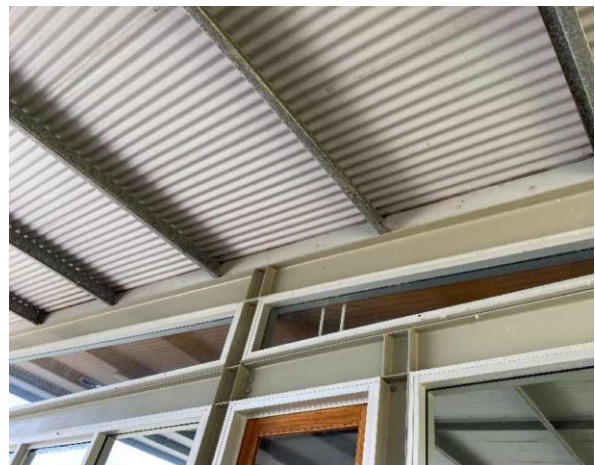
Line ID 21.1: Internal, Boatsheds, Throughout, L1, Fascia and Walls, Fibre Cement Sheeting - No Asbestos Detected

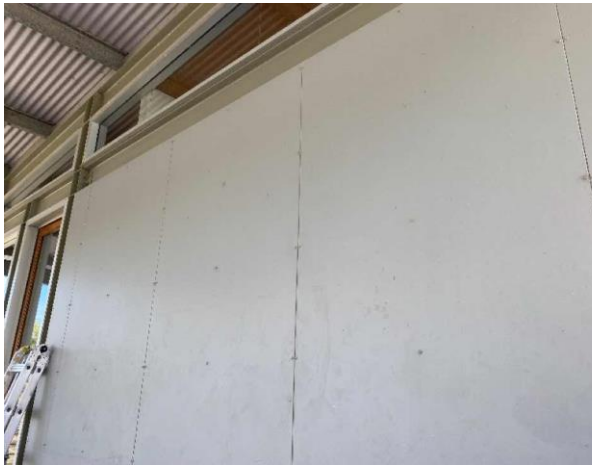
Line ID 21.2: Internal, Boatsheds, Throughout, L1, Fascia and Walls, Fibre Cement Sheetting - No Asbestos Detected

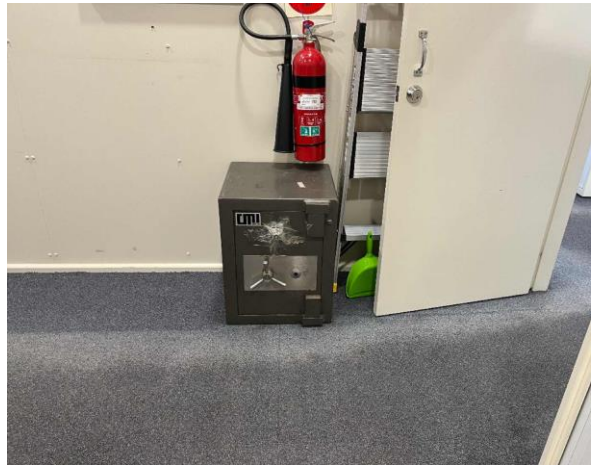
Line ID 22: Internal, Boatsheds, Venue Management Office, Within Safe, Internal Insulation - Suspected Asbestos

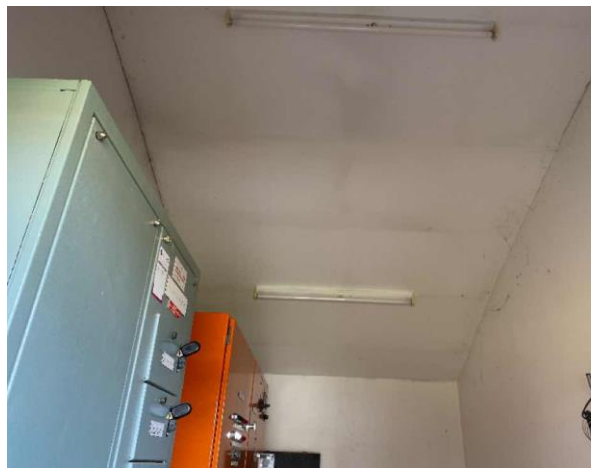
Line ID 25: Internal, Communications Building, Throughout, Main Switch Room, Ceiling, Fibre Cement Sheet - No Asbestos Detected

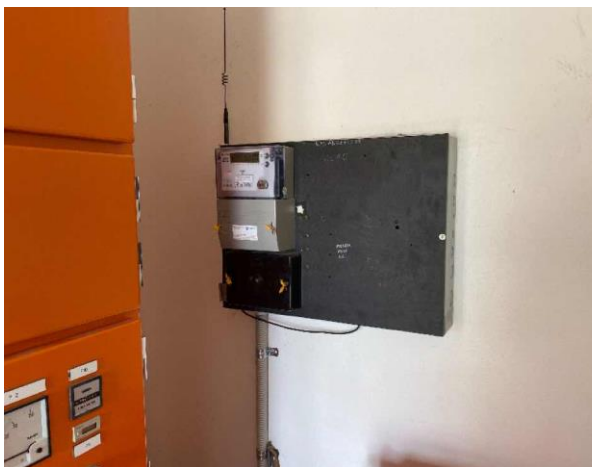
Line ID 26: Internal, Communications Building, Throughout, Switchboard, Bituminous Backing Board - No Asbestos Suspected

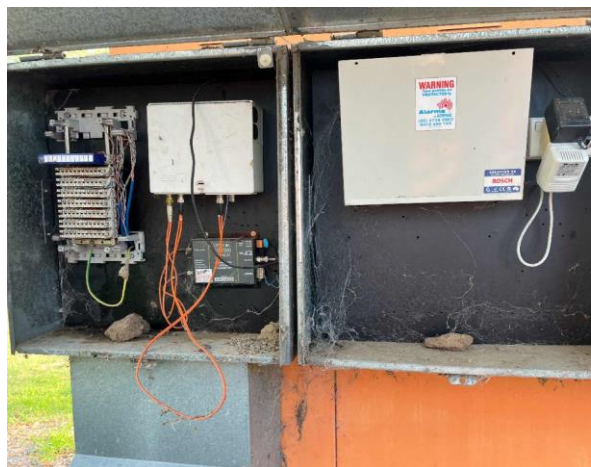
Line ID 27: Internal, Electrical Kiosk adj Gate B, South Side, Switchboard, Bituminous Backing Board - No Asbestos Suspected

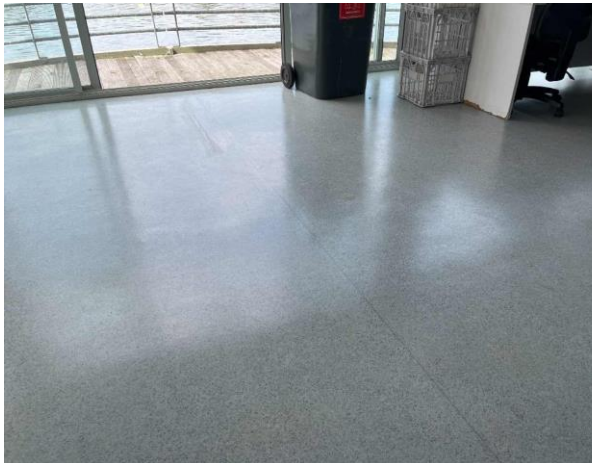
Line ID 28: Internal, Finish Tower, GF, Floor Covering, Blue Speckled Vinyl Sheet - No Asbestos Detected

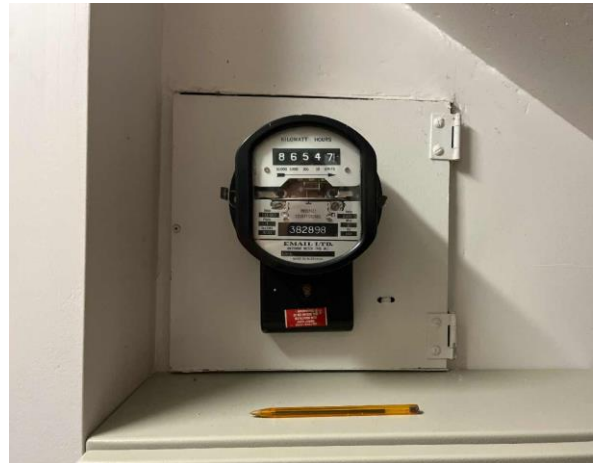
Line ID 29: Internal, Finish Tower, GF, Electrical and MDF Room, Electrical Meter, Mastic and Glazing - Suspected Asbestos

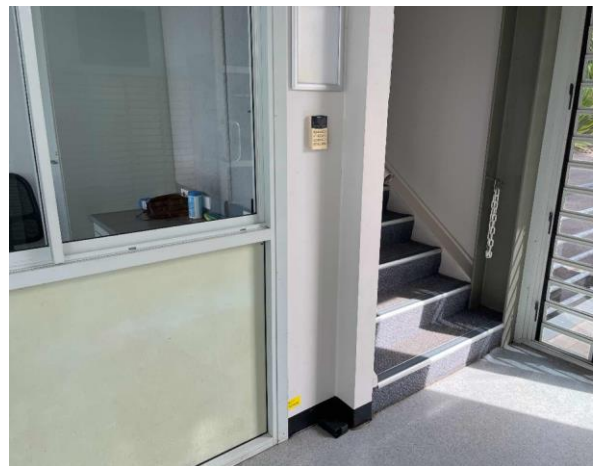
Line ID 31: Internal, Finish Tower, GF, Entrance Hallway, Walls, Fibre Cement Sheet - No Asbestos Detected

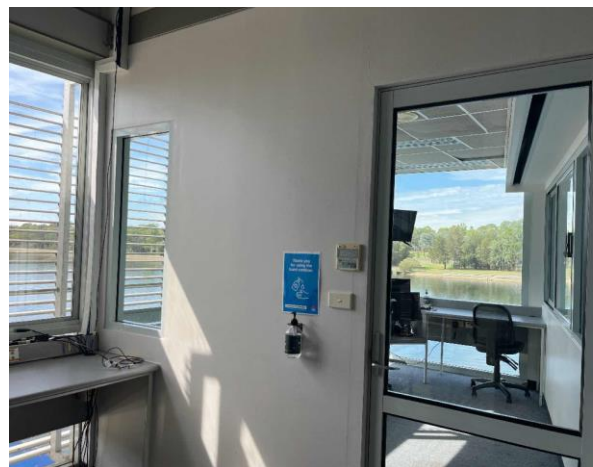
Line ID 33: Internal, Finish Tower, L2, Walls, Fibre Cement Sheet - No Asbestos Detected

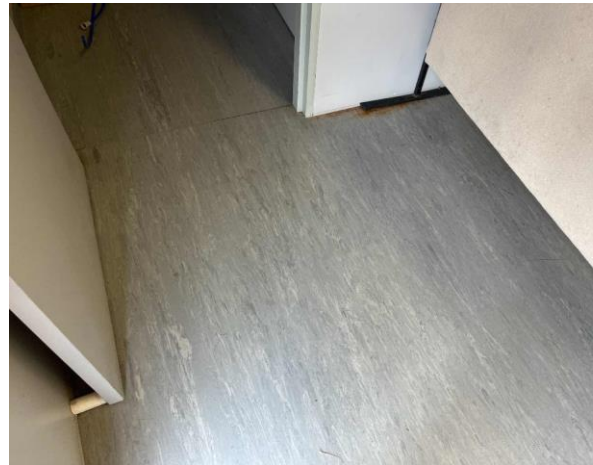
Line ID 35: Internal, First Aid Building, Throughout, Floor Covering, Blue Vinyl Sheet - No Asbestos Detected

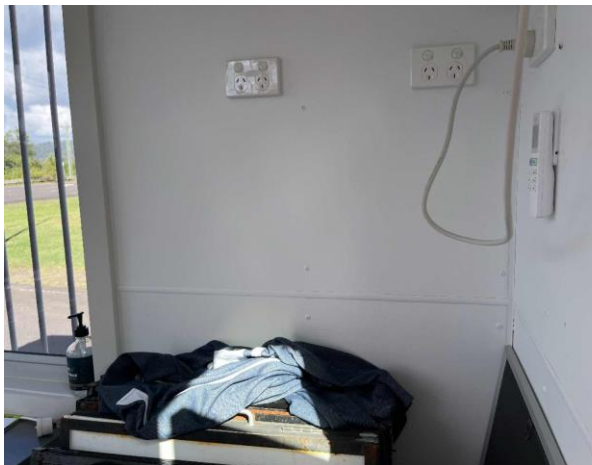
Line ID 36: Internal, Front Gate Security Office, Throughout, Walls, Fibre Cement Sheet - No Asbestos Detected

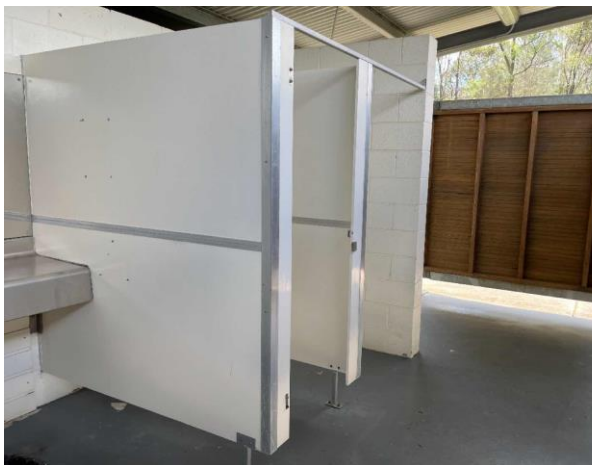
Line ID 38: Internal, North East Toilets, Throughout, Cubicle Partition Walls, Compressed Cement Sheet - No Asbestos Detected

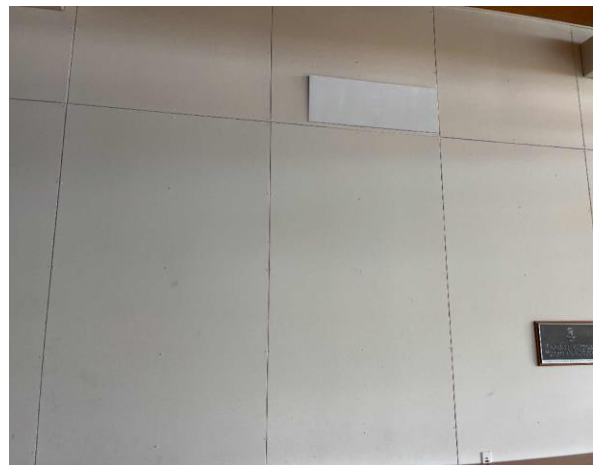
Line ID 39: Internal, Restaurant, East Dining Room, Walls, Fibre Cement Sheet - No Asbestos Detected

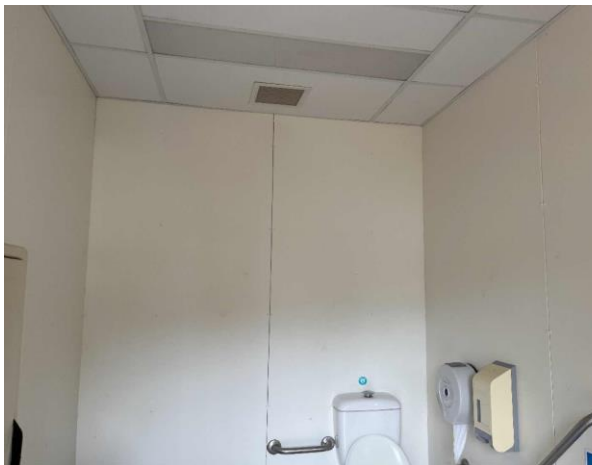
Line ID 42: Internal, Restaurant, North Externally Accessed Toilets, Walls, Fibre Cement Sheeting - No Asbestos Detected

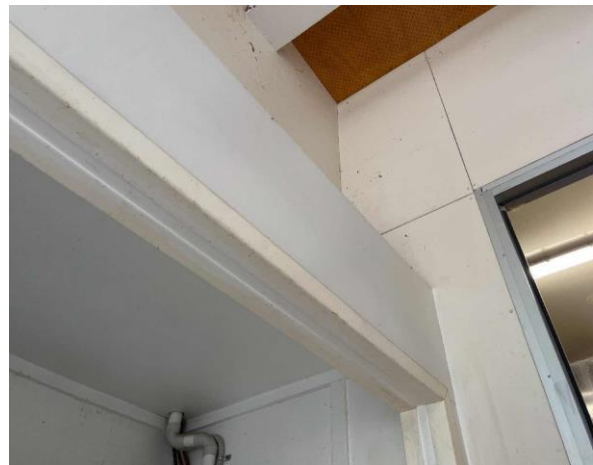
Line ID 43: Internal, Restaurant, North Storage Area, Walls, Fibre Cement Sheeting - No Asbestos Detected

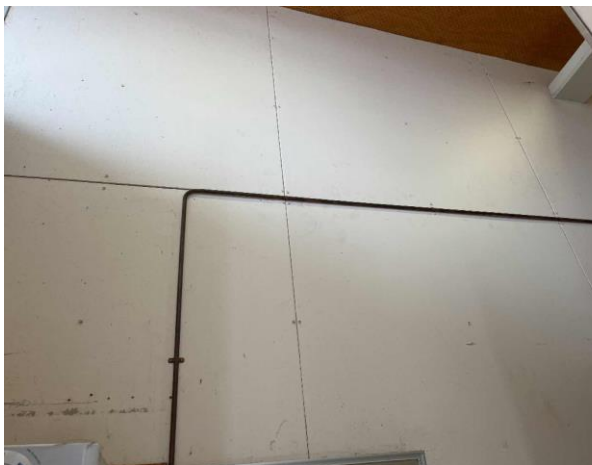
Line ID 44: Internal, Restaurant, North Toilet, Walls, Fibre Cement Sheeting - No Asbestos Detected

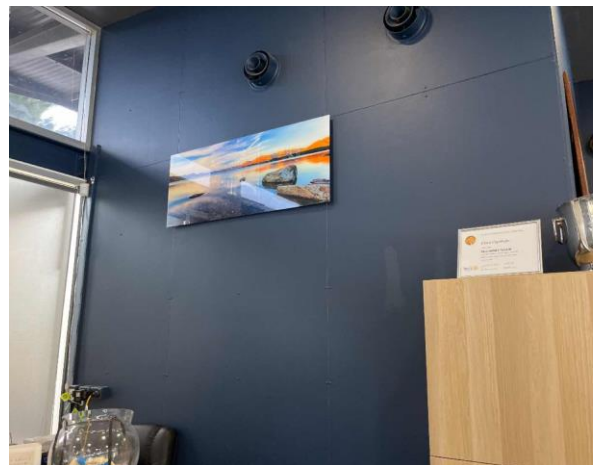
Line ID 45: Internal, Restaurant, West Dining Room, Walls, Fibre Cement Sheeting - No Asbestos Detected

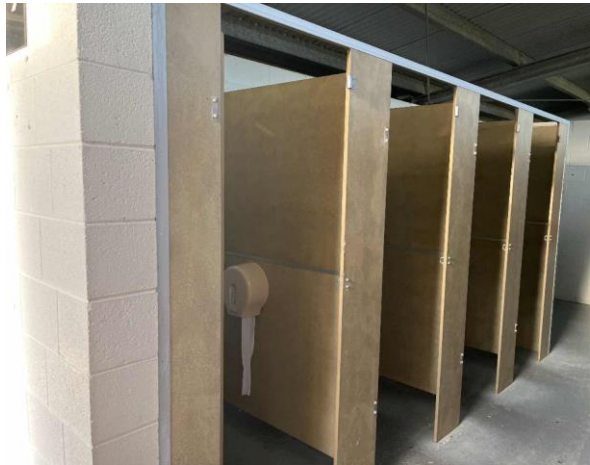
Line ID 47: Internal, South West Toilet Block, Toilets, Cubicle Partition Wall, Fibre Cement Sheet - No Asbestos Detected

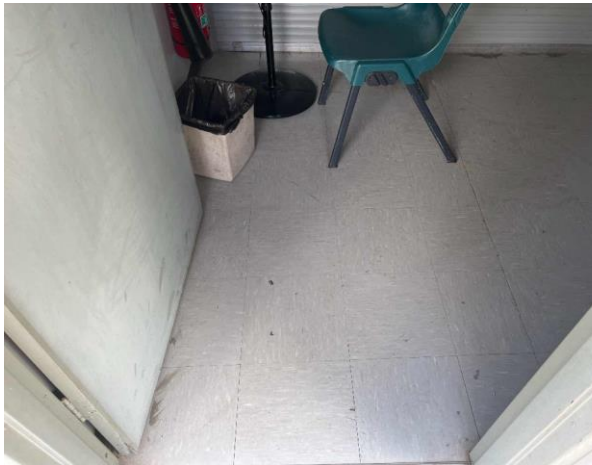
Line ID 48: Internal, Start Line Tower, Throughout, Floor Covering, Light Blue Vinyl Tiles - No Asbestos Detected

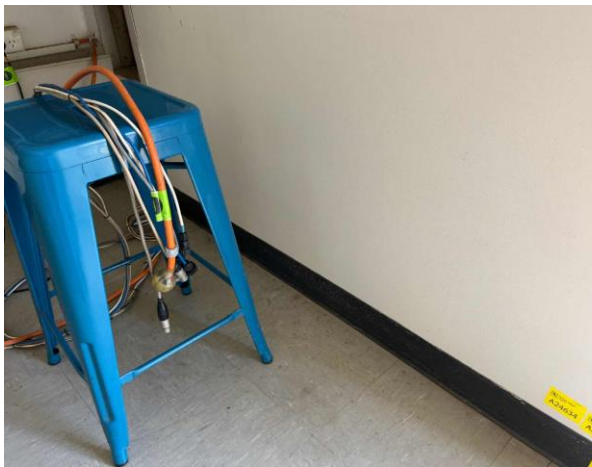
Line ID 50: Internal, Start Line Tower, Throughout, Skirting, Black Vinyl Sheet - No Asbestos Detected

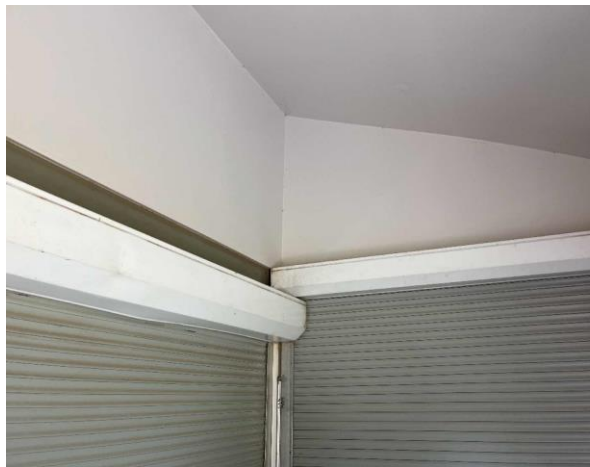
Line ID 51: Internal, Start Line Tower, Throughout, Walls and Ceiling, Fibre Cement Sheet - No Asbestos Detected

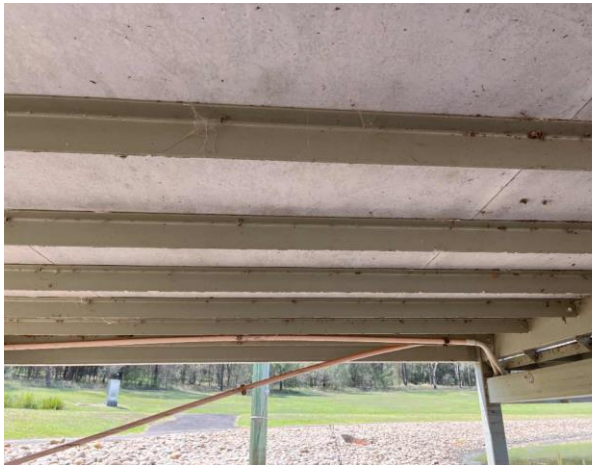
Line ID 52: Internal, Timing Towers, Tower at 0m, Floor, Fibre Cement Sheet - No Asbestos Detected

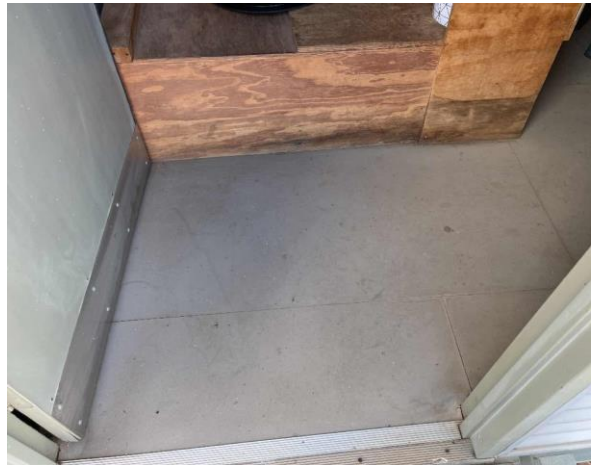
Line ID 53: Internal, Timing Towers, Tower at 0m, Floor Covering, Green Vinyl Sheet - No Asbestos Detected

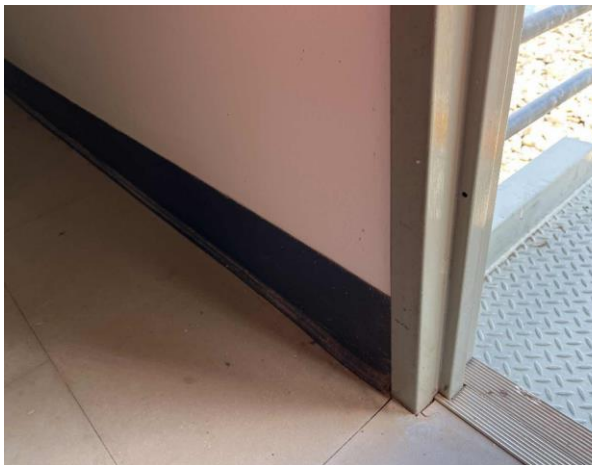
Line ID 54: Internal, Timing Towers, Tower at 0m, Skirting, Black Vinyl Sheet - No Asbestos Detected

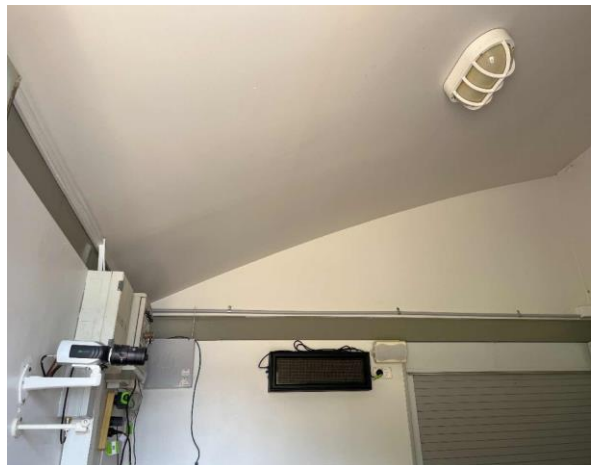
Line ID 55: Internal, Timing Towers, Tower at 0m, Walls and Ceiling, Fibre Cement Sheet - No Asbestos Detected

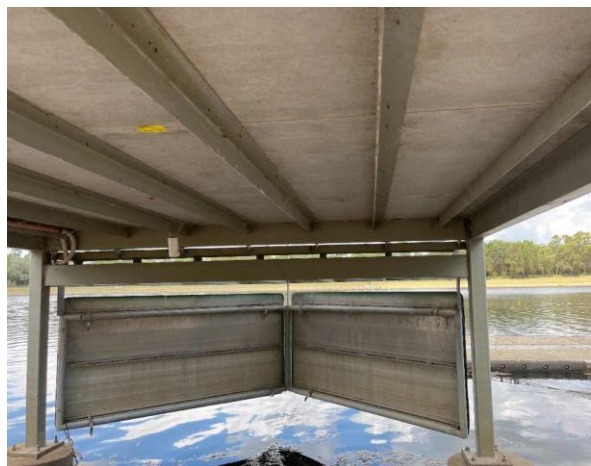
Line ID 57: Internal, Timing Towers, Tower at 1000m, Floor Lining below Vinyl, Fibre Cement Sheet - No Asbestos Detected

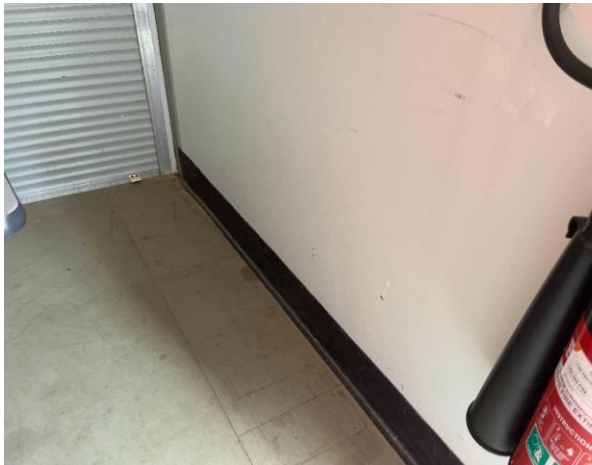
Line ID 58: Internal, Timing Towers, Tower at 1000m, Skirting, Black Vinyl Sheet - No Asbestos Detected

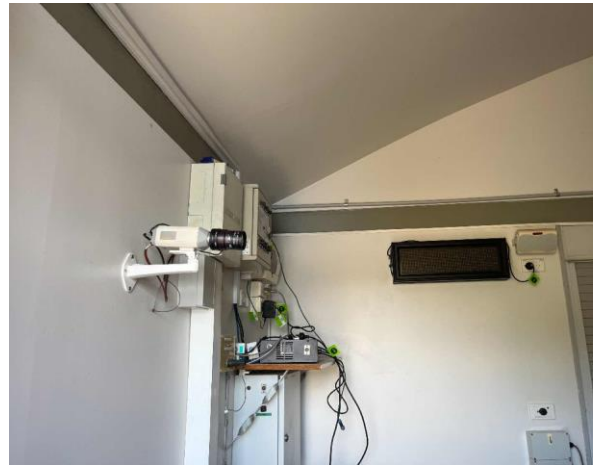
Line ID 59: Internal, Timing Towers, Tower at 1000m, Walls and Ceiling, Fibre Cement Sheet - No Asbestos Detected

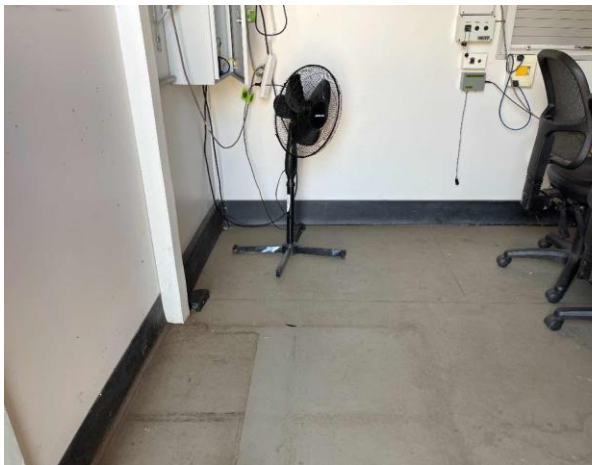
Line ID 60: Internal, Timing Towers, Tower at 1500m, Floor Covering, Green Vinyl Sheet - No Asbestos Detected

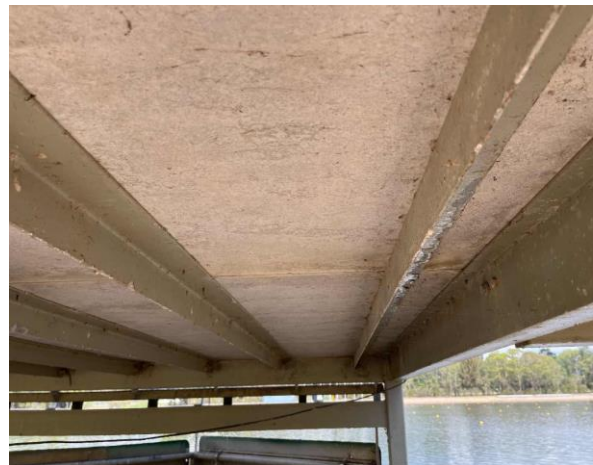
Line ID 61: Internal, Timing Towers, Tower at 1500m, Floor Lining below Vinyl, Compressed Cement Sheet - No Asbestos Detected

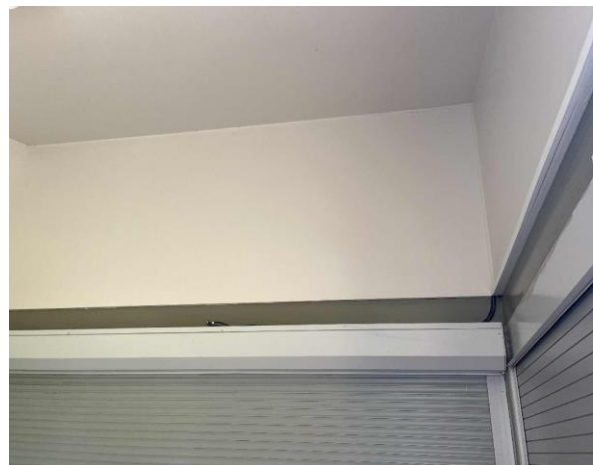
Line ID 63: Internal, Timing Towers, Tower at 1500m, Walls and Ceiling, Fibre Cement Sheet - No Asbestos Detected

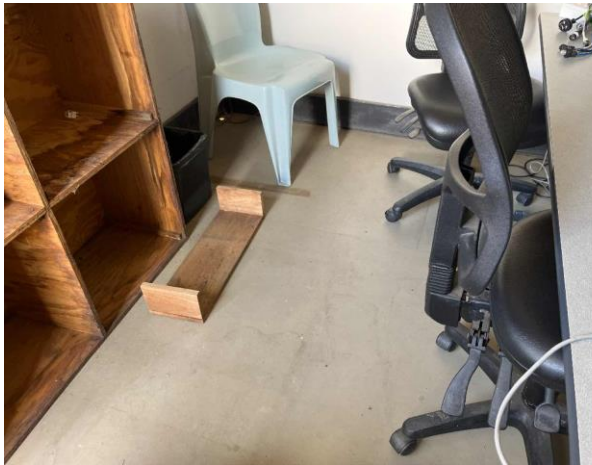
Line ID 64: Internal, Timing Towers, Tower at 1750m, Floor Covering, Green Vinyl Sheet - No Asbestos Detected

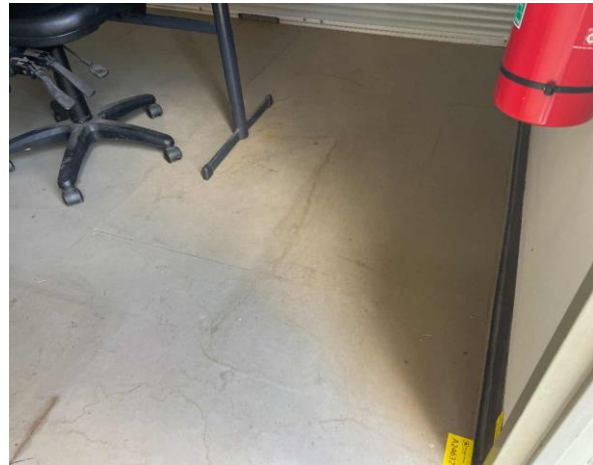
Line ID 65: Internal, Timing Towers, Tower at 1750m, Floor Lining, Fibre Cement Sheet - No Asbestos Detected

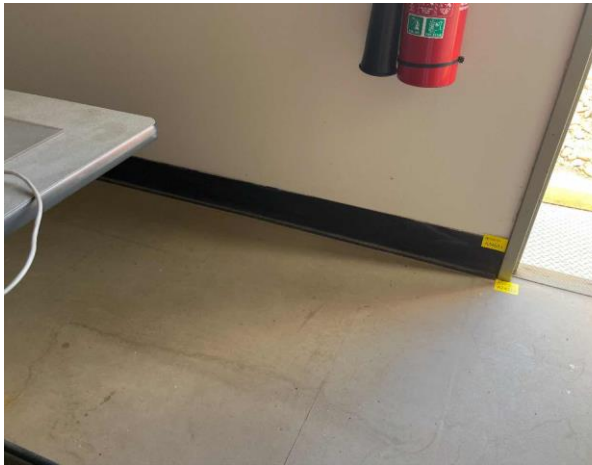
Line ID 66: Internal, Timing Towers, Tower at 1750m, Skirting Boards, Black Vinyl Sheet - No Asbestos Detected

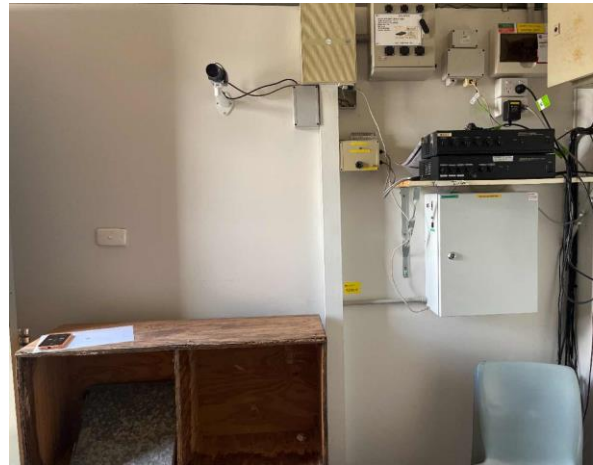
Line ID 67: Internal, Timing Towers, Tower at 1750m, Walls and Ceiling, Fibre Cement Sheet - No Asbestos Detected

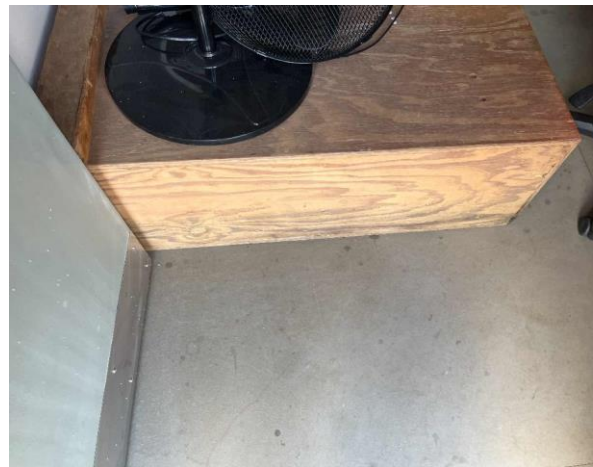
Line ID 69: Internal, Timing Towers, Tower at 500m, Floor Lining below Vinyl, Fibre Cement Sheet - No Asbestos Detected

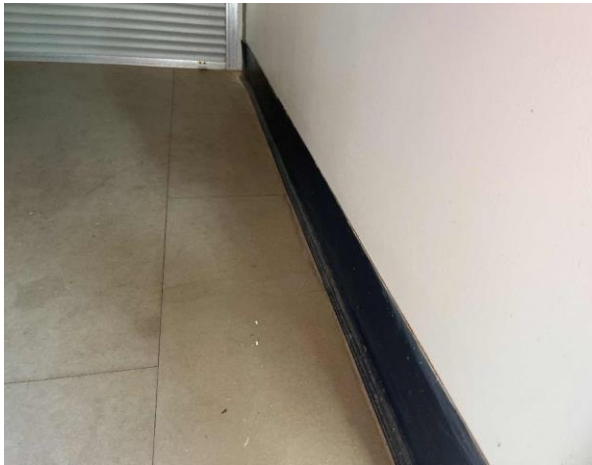
Line ID 70: Internal, Timing Towers, Tower at 500m, Skirting, Black Vinyl Sheet - No Asbestos Detected

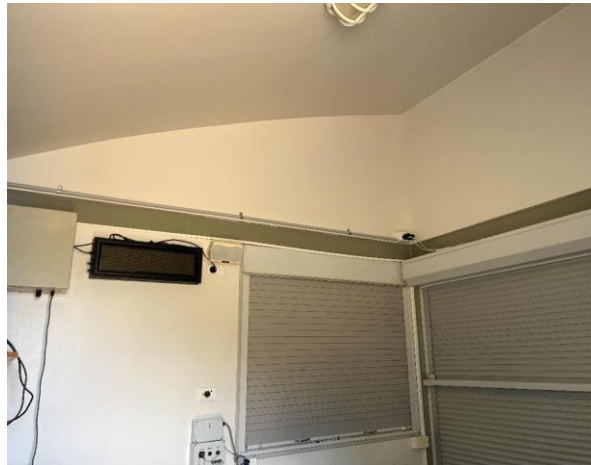
Line ID 71: Internal, Timing Towers, Tower at 500m, Walls and Ceiling, Fibre Cement Sheet - No Asbestos Detected

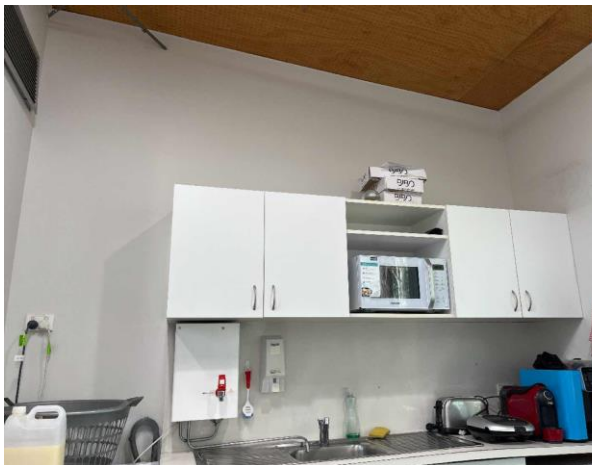
Line ID 72: Internal, Venue Operations Centre, Kitchen, Wall Behind Sink, Fibre Cement Sheet - No Asbestos Detected

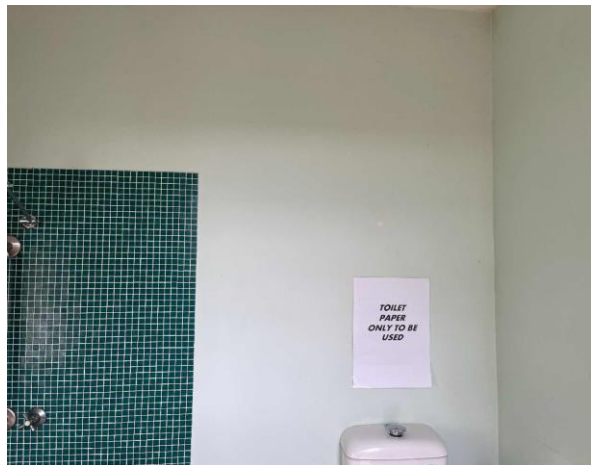
Line ID 73: Internal, Venue Operations Centre, Toilets, Walls, Fibre Cement Sheet - No Asbestos Detected

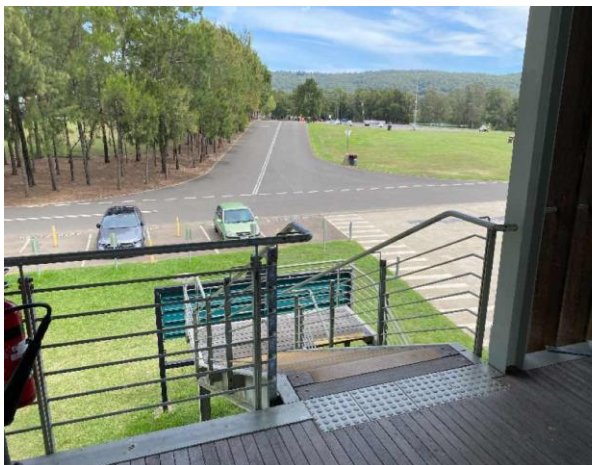
Line ID 74: External, Boatsheds, Throughout, Veranda, Steelwork and Railings, Green Paint - Lead Detected (0.058% w/w)

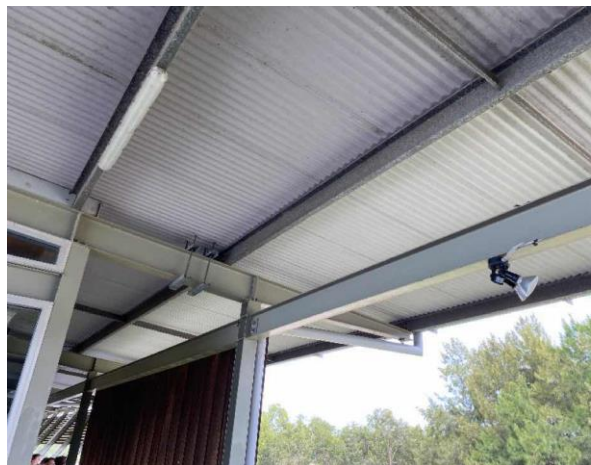
Line ID 74.1: External, Boatsheds, Throughout, Veranda, Steelwork and Railings, Green Paint - Lead Detected (0.058% w/w)

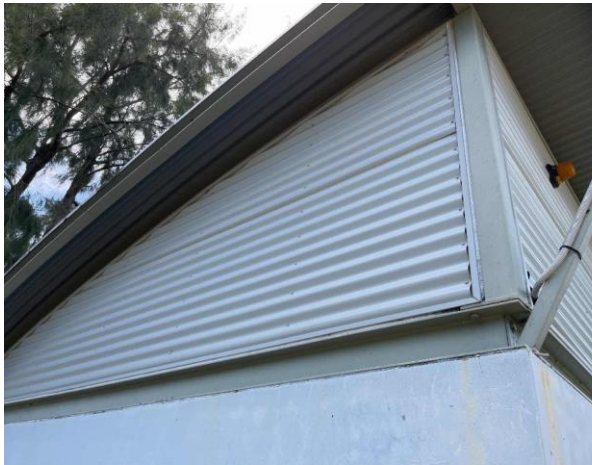
Line ID 75: External, Communications Shed, Throughout, Beams, Green Paint - Lead Detected (<0.005% w/w)

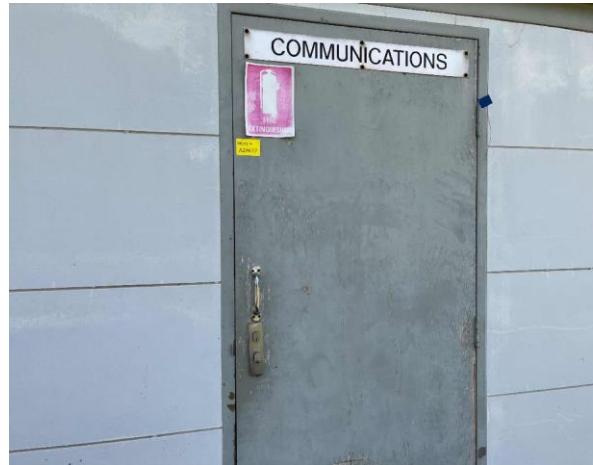
Line ID 76: External, Communications Shed, Throughout, Doors, Green Paint - Lead Detected (0.007% w/w)

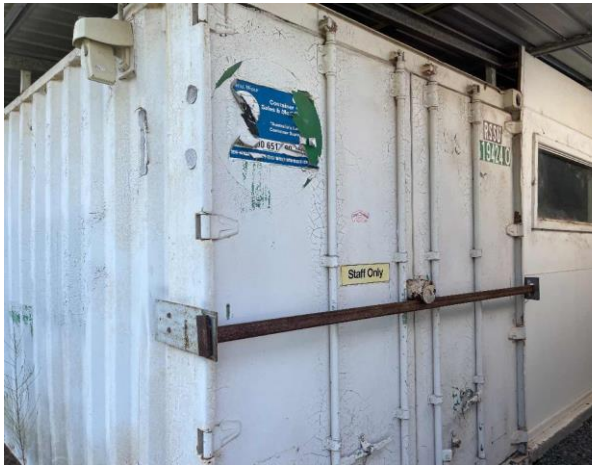
Line ID 77: External, Old Compound, Throughout, Shipping Container Walls, White Paint - Lead Detected (0.36% w/w)

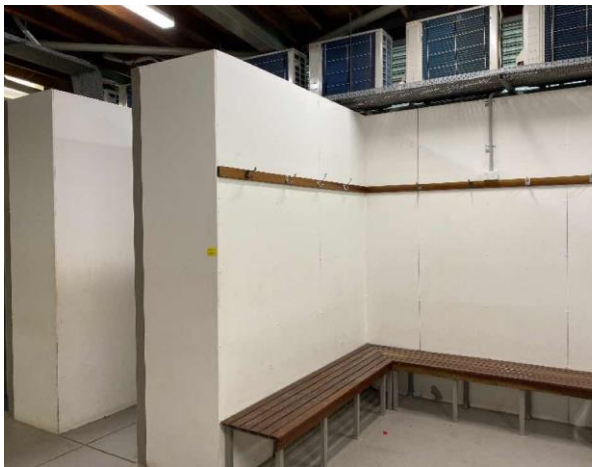
Line ID 79: Internal, Boatsheds, Female Toilets, Walls, White Paint - Lead Detected (<0.005% w/w)

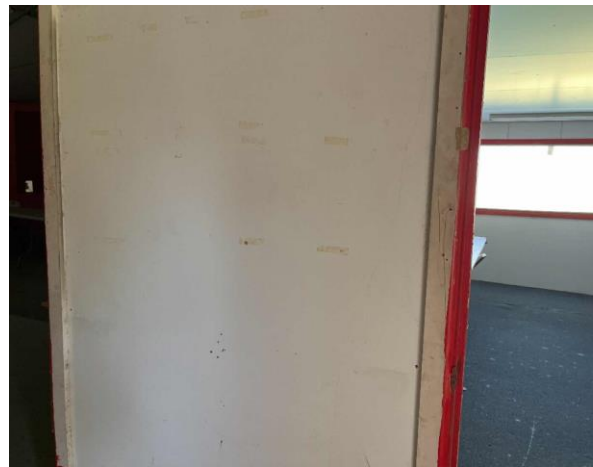
Line ID 81: Internal, Old Compound, Throughout, Walls, White Paint - Lead Detected (<0.005% w/w)

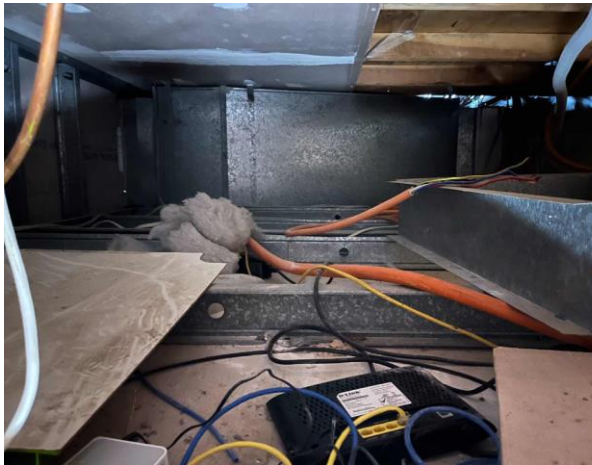
Line ID 82: Internal, Restaurant, Kitchen, Ceiling Space, Dust - Lead Detected (35 mg/kg)

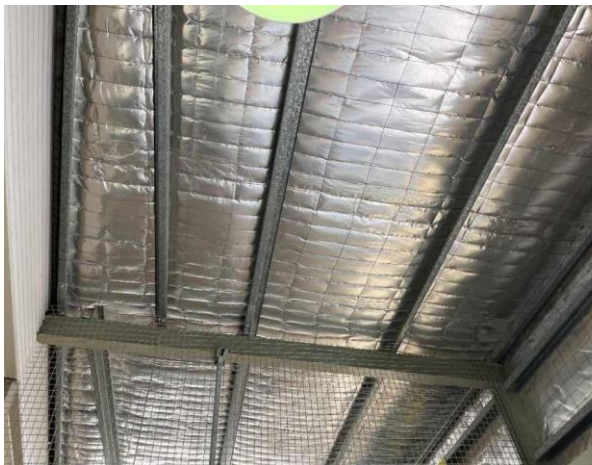
Line ID 84: Internal, Boatsheds, Throughout, Ceiling, Sarking Insulation - Suspected SMF

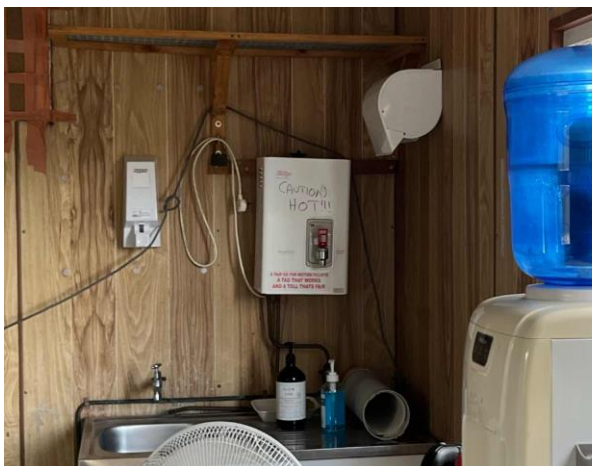
Line ID 86: Internal, Cleaners Office, Kitchenette, Above Sink, Hot Water Boiler, Internal Insulation - Suspected SMF

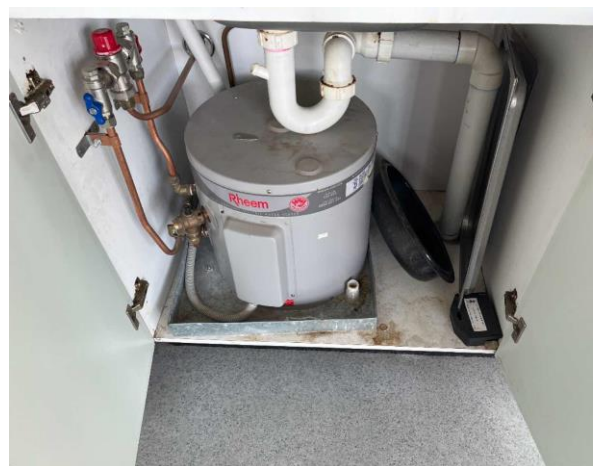
Line ID 88: Internal, Finish Tower, GF, Entrance Hallway, Hot Water Heater, Under Sink, Insulation Material - Suspected SMF

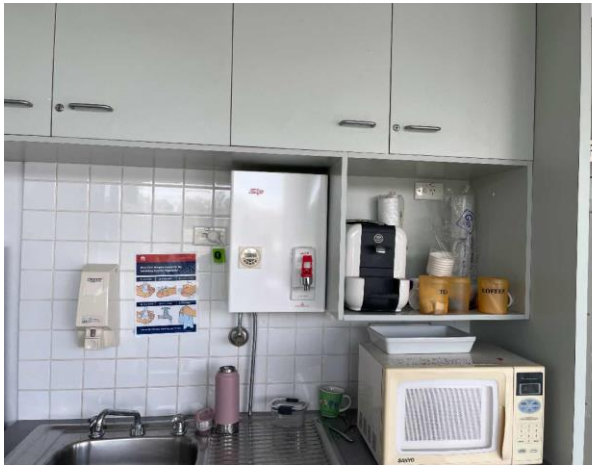
Line ID 89: Internal, Finish Tower, GF, Entrance Hallway, Zip Boiler, Internal Insulation - Suspected SMF

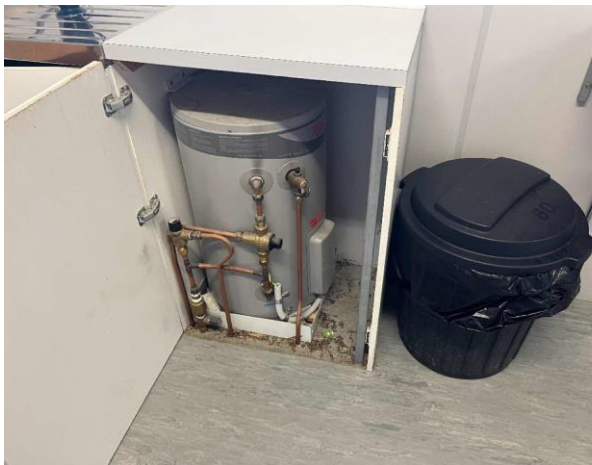
Line ID 90: Internal, First Aid Building, Throughout, Hot Water Boiler, Internal Insulation - Suspected SMF

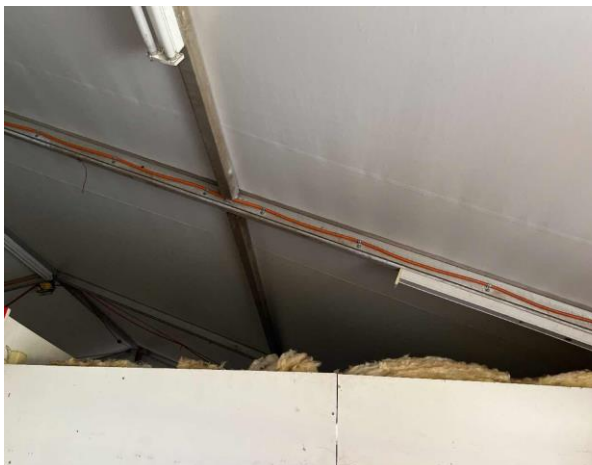
Line ID 92: Internal, Maintenance Shed, Office, Ceiling, Compressed Ceiling Tiles - Suspected SMF

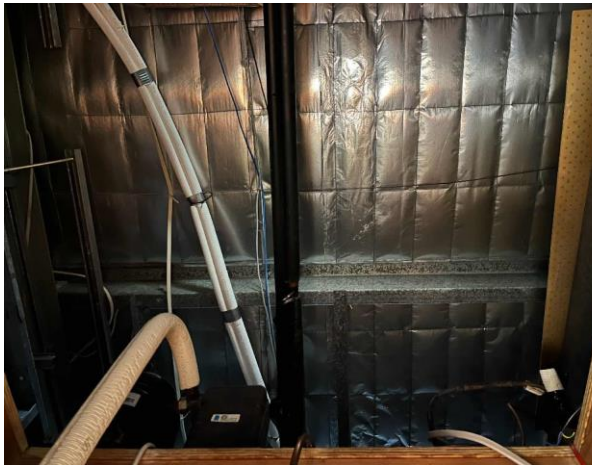
Line ID 94: Internal, Restaurant, Kitchen, Ceiling Space, Loose Insulation - Suspected SMF

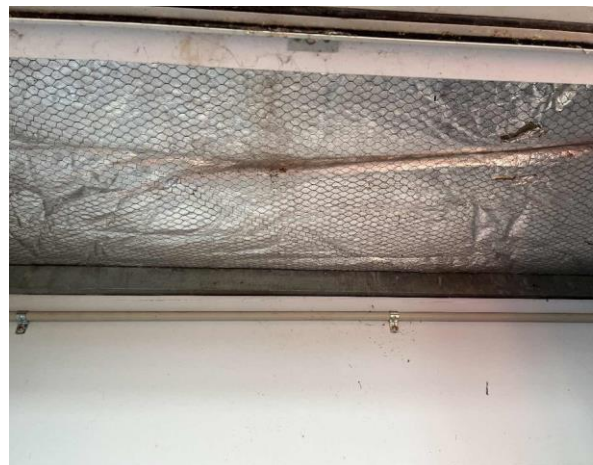
Line ID 99: Internal, Venue Operations Centre, Kitchen, Hot Water Heater, Insulation Material - Suspected SMF

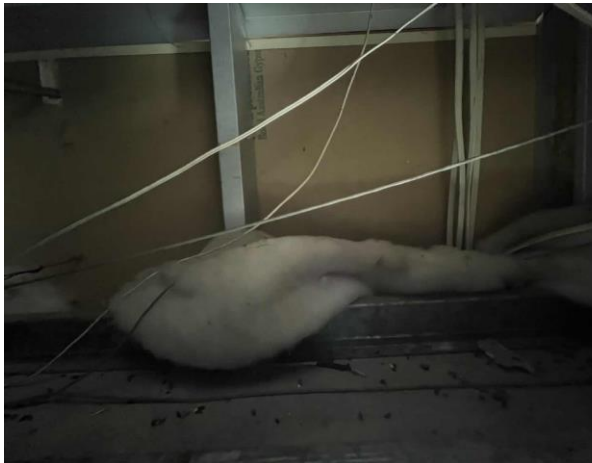
Line ID 100: Internal, Venue Operations Centre, Throughout, Ceiling, Sarking Insulation - Suspected SMF

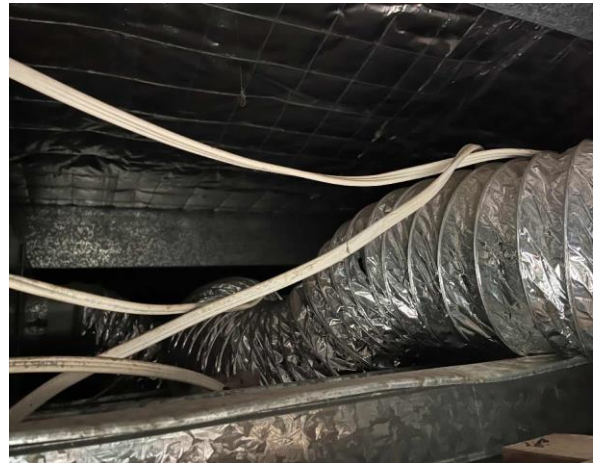
Line ID 101: Internal, Venue Operations Centre, Throughout, Ceiling Space, Insulation Batts - Suspected SMF
