# Asbestos and Hazardous Materials Reinspection Assessment

Sydney International Regatta Centre

28/03/2023

754-SYDEN311850 - Sydney International Regatta Centre - HMRR - 01032023

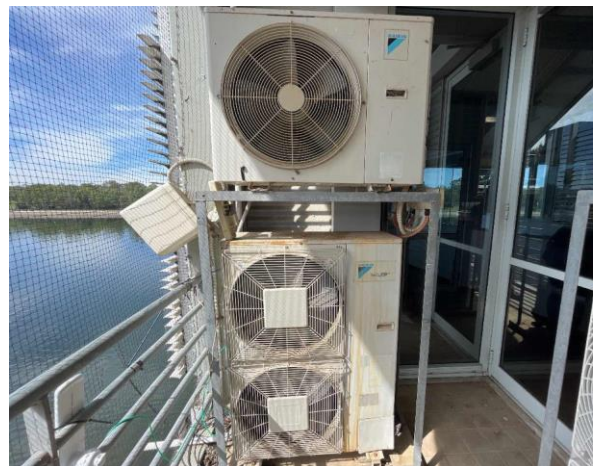
Line ID 105: External, Finish Tower, L2, Balcony, Daikin AC Unit, R410A Hydrofluorocarbon (HFC) - Non ODS Refrigerant

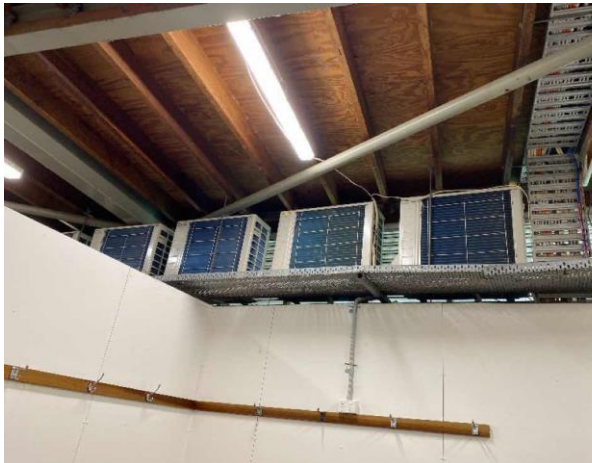
Line ID 112: External, Venue Operations Centre, South Side of Building, Panasonic AC Unit, R32 Refrigerant - Non ODS Refrigerant

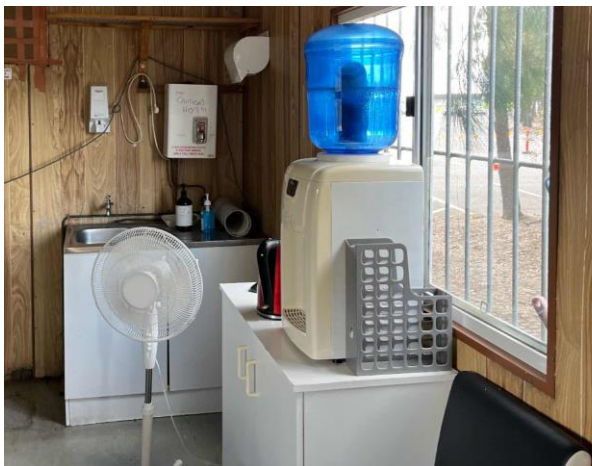
Line ID 114: Internal, Cleaners Office, Kitchenette, Water Cooler, R32 Hydrofluorocarbon (HFC) - Non ODS Refrigerant

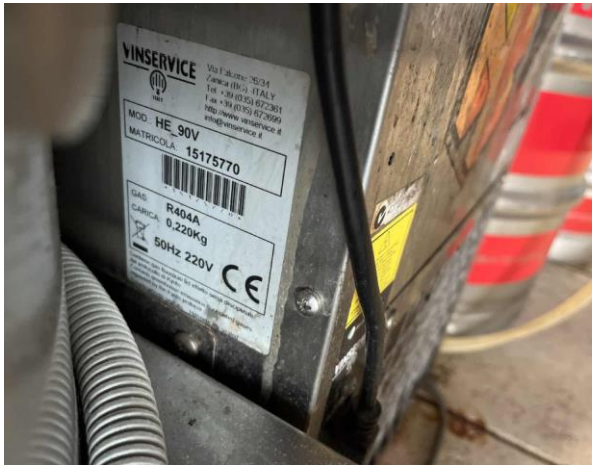
Line ID 117: Internal, Restaurant, West Dining Room, Bar Area, Under Bench Chiller, R404a Refrigerant - Non ODS Refrigerant
