Asbestos and Hazardous Materials Reinspection Assessment

Sydney Academy of Sport and Recreation

Wakehurst Parkway

03/02/2023

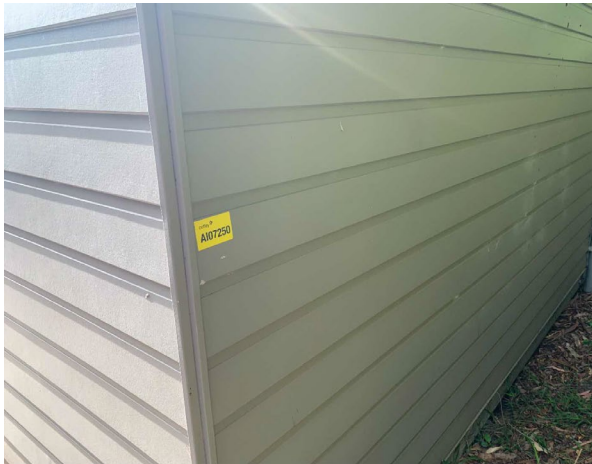
Line ID 8: External, Dorm Accommodation 1-12, Building Perimeter , Freshwater 1, Subfloor, Below Wet Areas, Compressed Cement Sheet - No Asbestos Detected

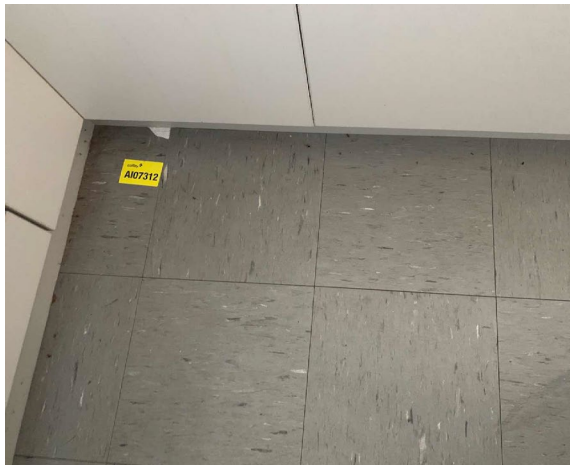
Line ID 32: Internal, Athletics Track Stand, Toilet Block, Behind Male Urinal, Bituminous Membrane - Suspected Asbestos

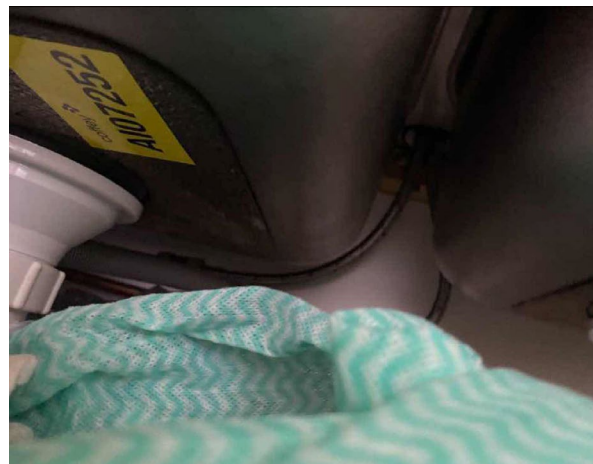
Line ID 38: Internal, Gymnastics, Training Area, Perimeter Walls, Construction Joint Mastic - No Asbestos Detected

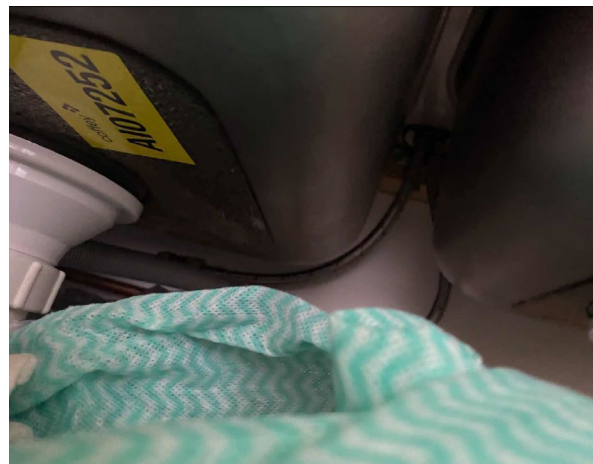
Line ID 40: Internal, Sea Eagles Coaching Offices, Kitchenette, Beneath Sink, Bituminous Sink Pad - No Asbestos Detected

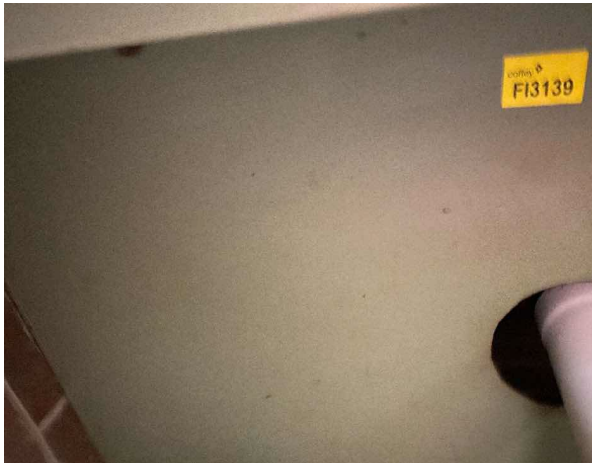
Line ID 45: Internal, Weights Room, Male Toilets, Behind Urinal, Bituminous Membrane - Suspected Asbestos

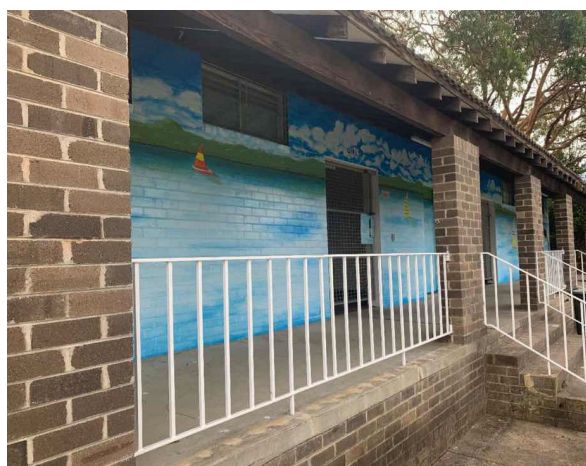
Line ID 52: External, Gymnasium, Building Perimeter, Guttering, Green Paint - Lead Detected (0.2% w/w)

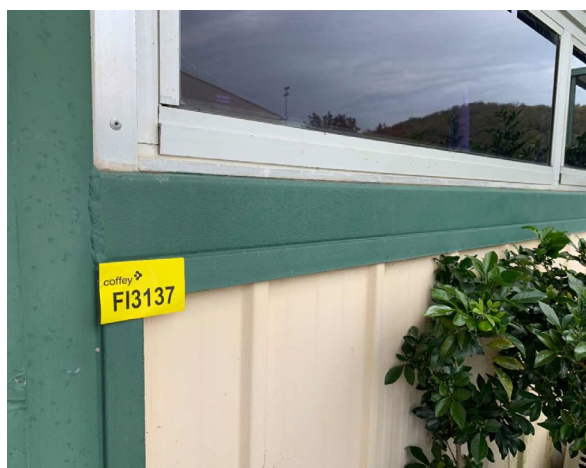
Line ID 56: External, Rugby Field Office, Perimeter, Timberwork, White Paint - Lead Detected (<0.005% w/w)

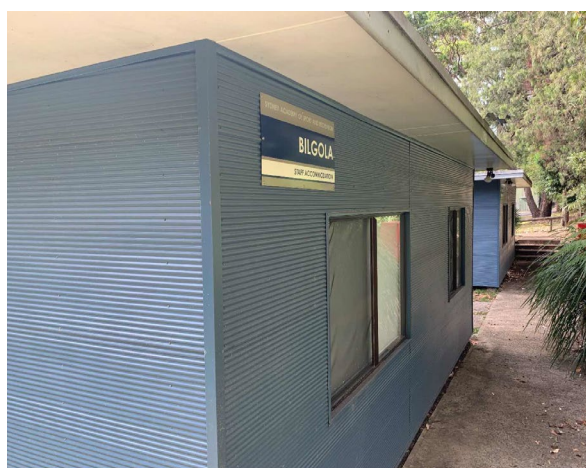
Line ID 58: External, Staff Accommodations (Five Domiciles), Elevations, Bilgoa, Eaves, White Paint - Lead Detected (0.41% w/w)

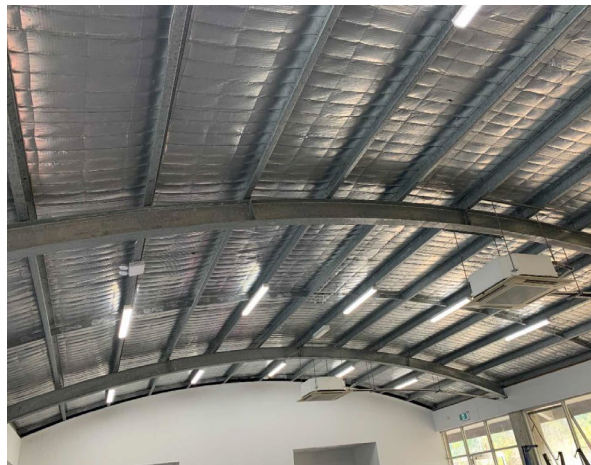
Line ID 83: Internal, Sports Science & Sports Medicine, Throughout, Underside of Roof, Sarking Insulation - None Suspected
