Asbestos and Hazardous Materials Reinspection Assessment

Sydney International Equestrian Centre

28/03/2023

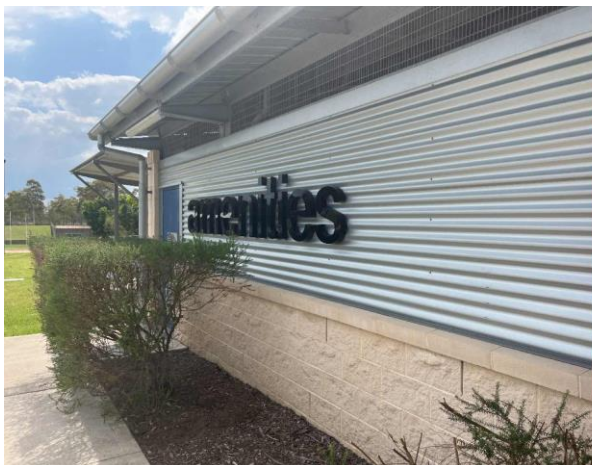
Line ID 98: Internal, Main Arena 1 Eastern Amenities, Amenities and Horse Wash
